## The Conservation and Reconstruction of the Islamic Bath at Volubilis, Morocco

*Alaa el Habashi, Tarik Moujoud, and Abdessalam Zizouni*

*The conservation of the early Islamic Bath at Volubilis in the North-West of Morocco led to the discovery of unknown aspects of the hydraulic system of the building in addition to the realisation of the first archaeological conservation work in the country which aimed to preserve the ruins and reconstruct the bath structures for future presentation to the public.*

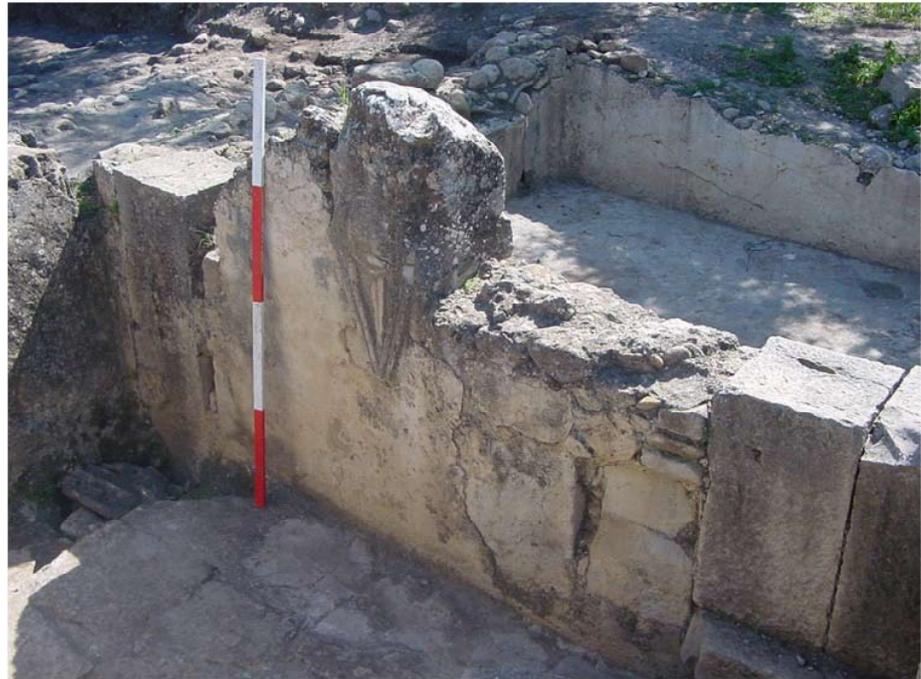
Fig. 3 Room 3, showing spoliated Roman relief (E. Fentress)

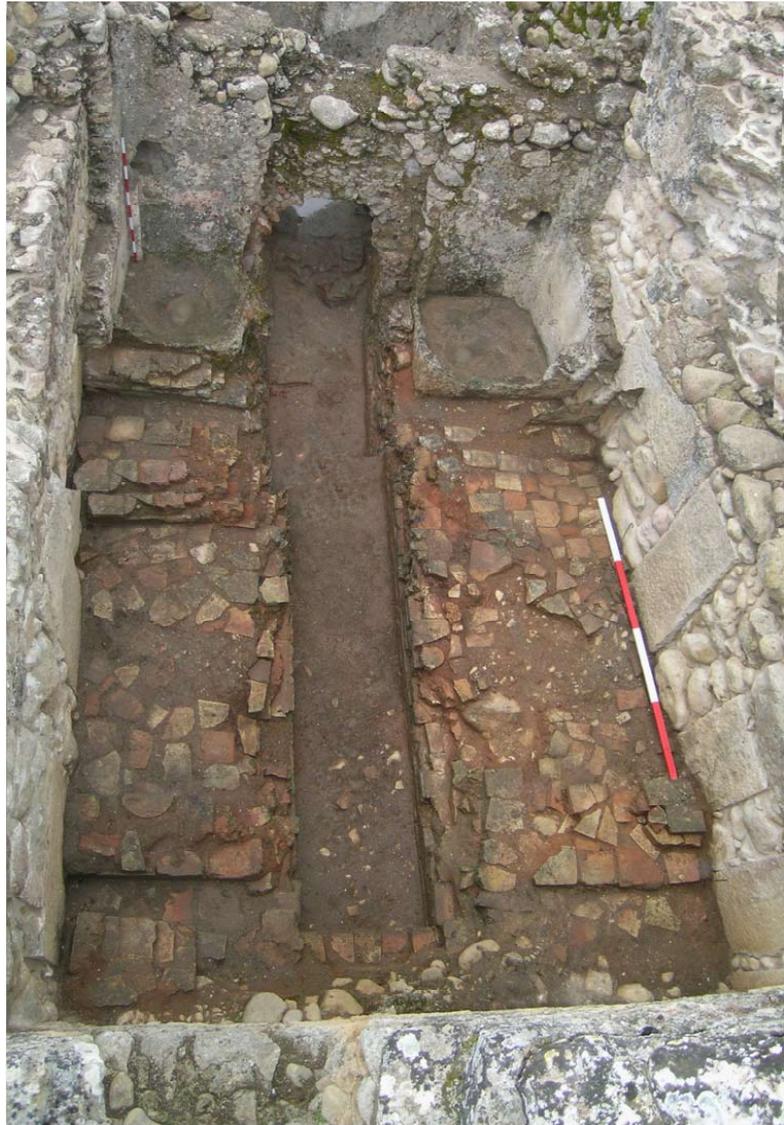
Fig. 4 Room 5 from the west (E. Fentress)

The baths were entered from a room (I) which corresponds to the *Apodyterium* of Roman baths, where the bathers get changed. This room has benches on both sides and was paved with hard limestone slabs, probably taken from other monuments and reused. To the south is a plunge pool (II) covered with a hydraulic mortar, with a canalisation running on the top of southern wall to provide water. The evacuation of the used water is ensured by a drain situated in the northeast angle of the pool. The access to the third room (III) is ensured by a small entrance directly from the first room. This served as a transitional space into the hot rooms, and was decorated with a relief of a Roman shield, spoliated from the triumphal arch of Caracalla in the center of town (fig. 3). The fourth room is covered with a vault with two tiny window pierced in it to allow light to come through and to aerate the room. The fifth room is heated by a hypocaust system (fig. 4). The heated floor was supported by series of brick supports.

A longitudinal canal allows the circulation and repartition of the heat beneath the floor. In the same room, at the east end of the room two small basins are preserved in the corners. These were fed from water heated over the furnace, in space VI.

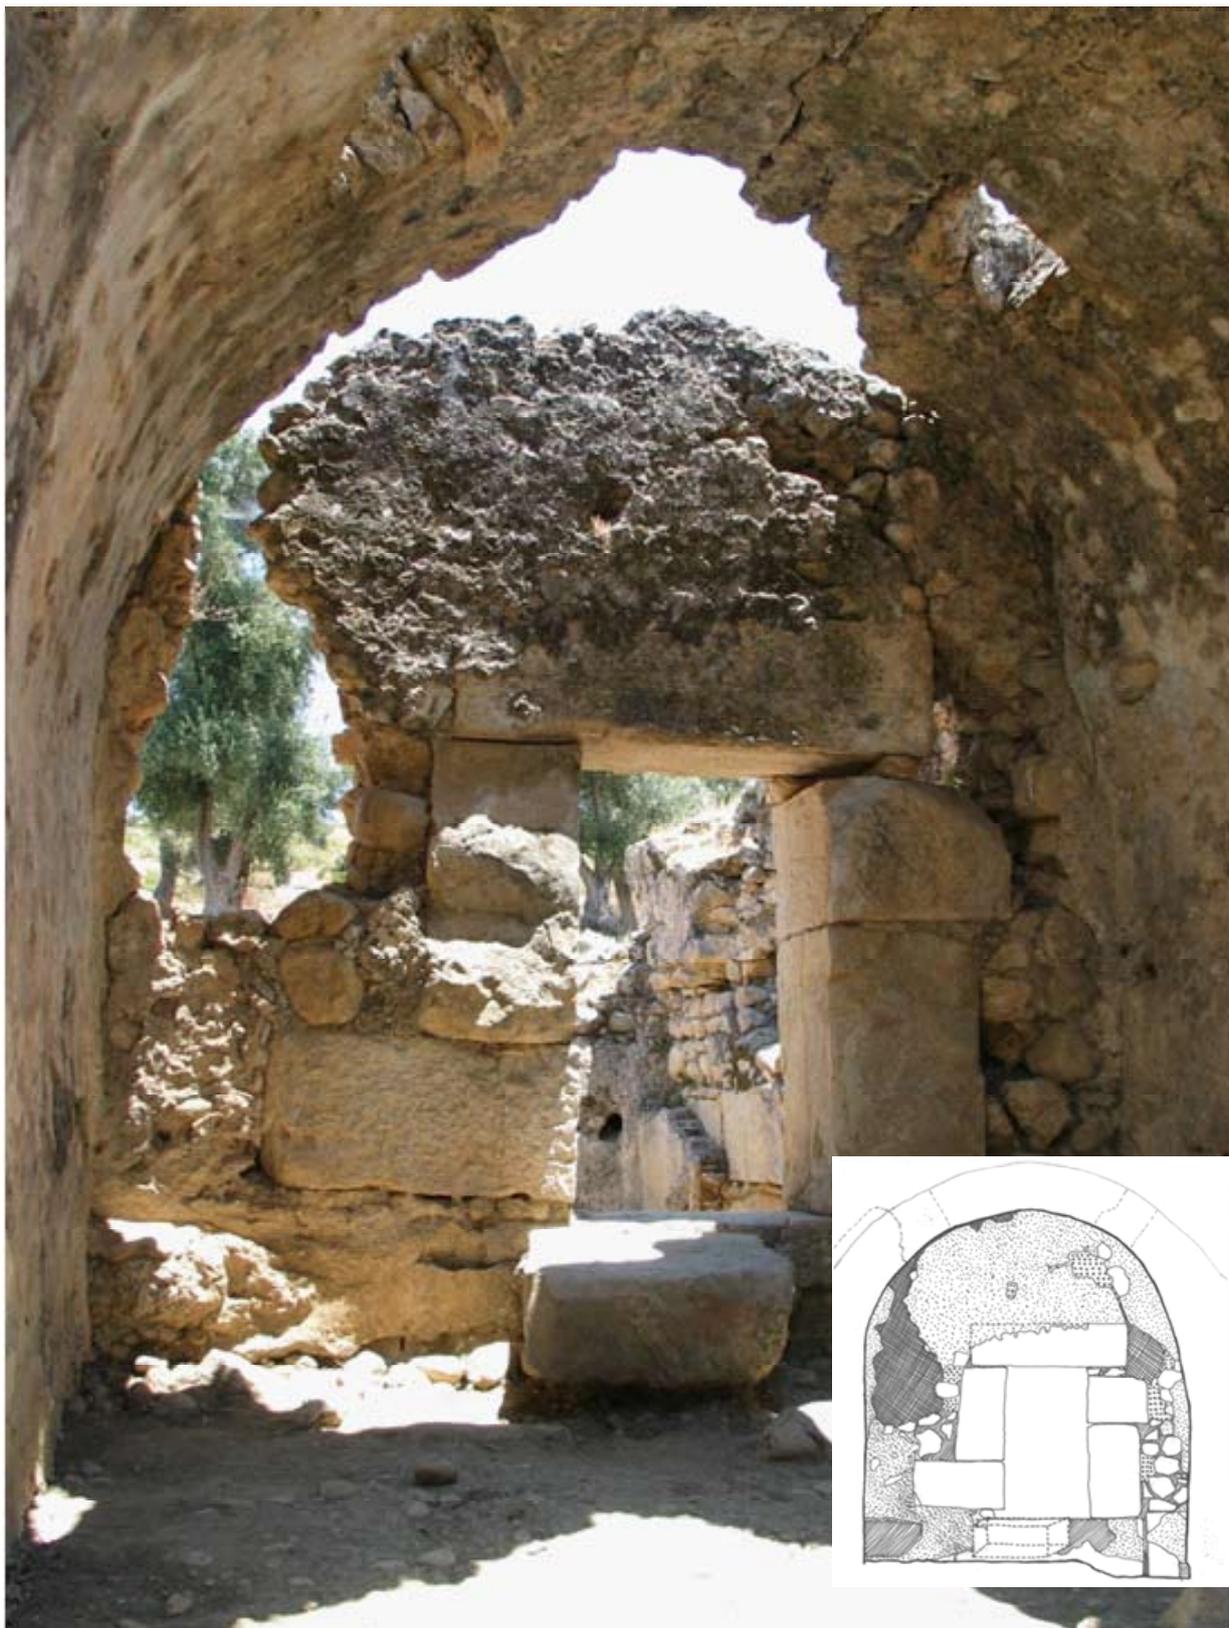
Fig. 5. Room IV, from the east and Fig. 6. Documentation of Room IV (A.el H)

The building as it was found was fully documented in photographs and 1/20 drawings (figs. 5 and 6). A condition survey of each element was made to identify locations of all deterioration procedures: missing masonry that leaves the wall with either partial loss of building material, or a total loss and creating wide voids and gaps in the walls. Another problem is the activities of insects that develop nests in the voids and the gaps of the wall and keep widening them weakening the bonding mortars, and eventually risking the structural stability of the structure; the detachment, partial and total loss of plaster layers; the manifestation of critical cracks in crucial stone lintels, and roofs; the growth of different kind of vegetation within the masonry joints; and the microbiological (such as lichens) attacks on the different kinds of building materials. In addition, an inventory of the building materials locally available was made, and samples were collected for tests. The purpose of this exercise was to re-construct the types of mortars that were used in the construction of the bath and the different plasters used in its spaces, especially those hydraulic ones used over the roof, and in the hot and cold basins. Several mortar samples were collected from different bath, and were analyzed in a local laboratory to confirm that the mortars could be reconstructed, so that homogeneity of any newly introduced building materials with the existing ones would be assured.

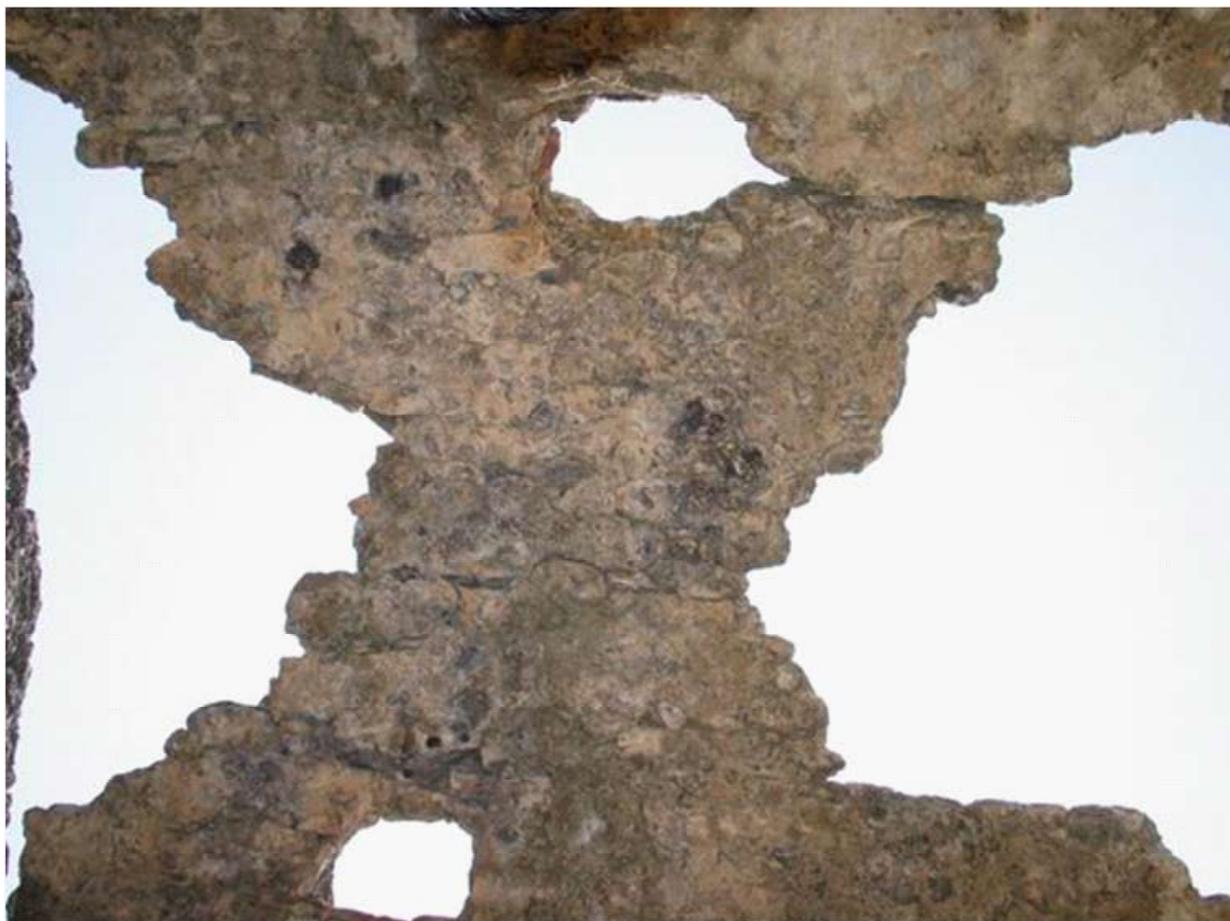
*Fig. 7. The vault in room IV (A.el H)*

For the purpose of this paper, only the intervention that proved to be the most debatable is detailed here, the partial reconstruction and restoration of the vaults in rooms IV and V. The remains of the vault of room IV (the warm room) were partially reconstructed following its traditional construction technique. Such intervention was mandatory in order to prevent the sudden collapse of the existing, very lacunose portions of the vault. (fig. 7) The intervention consisted of stabilizing and consolidating the lateral walls, and the partial restoration of the vault in order to complete its load transfer system only in the minimum required sections of the vault. A wooden formwork was erected following the exact profile of the existing vault, using a wooden scaffolding and a compacted fill of sand and earth. Traditional fired bricks

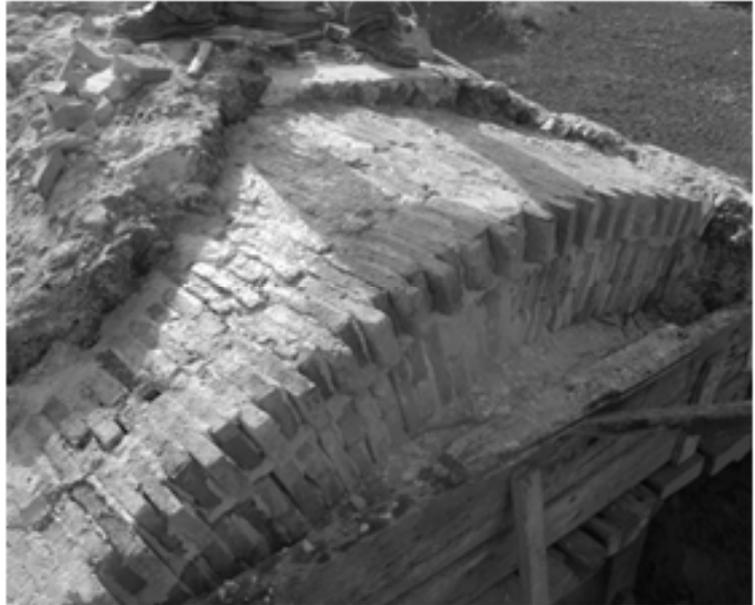
Fig. 8 The bricks used in the reconstruction (A el H)

were used in the construction as shows (fig 8). At the edge of the reconstructed area, the bricks were left in their keying position in order to hint on a possible continuation, and to make the intervention distinguishable.

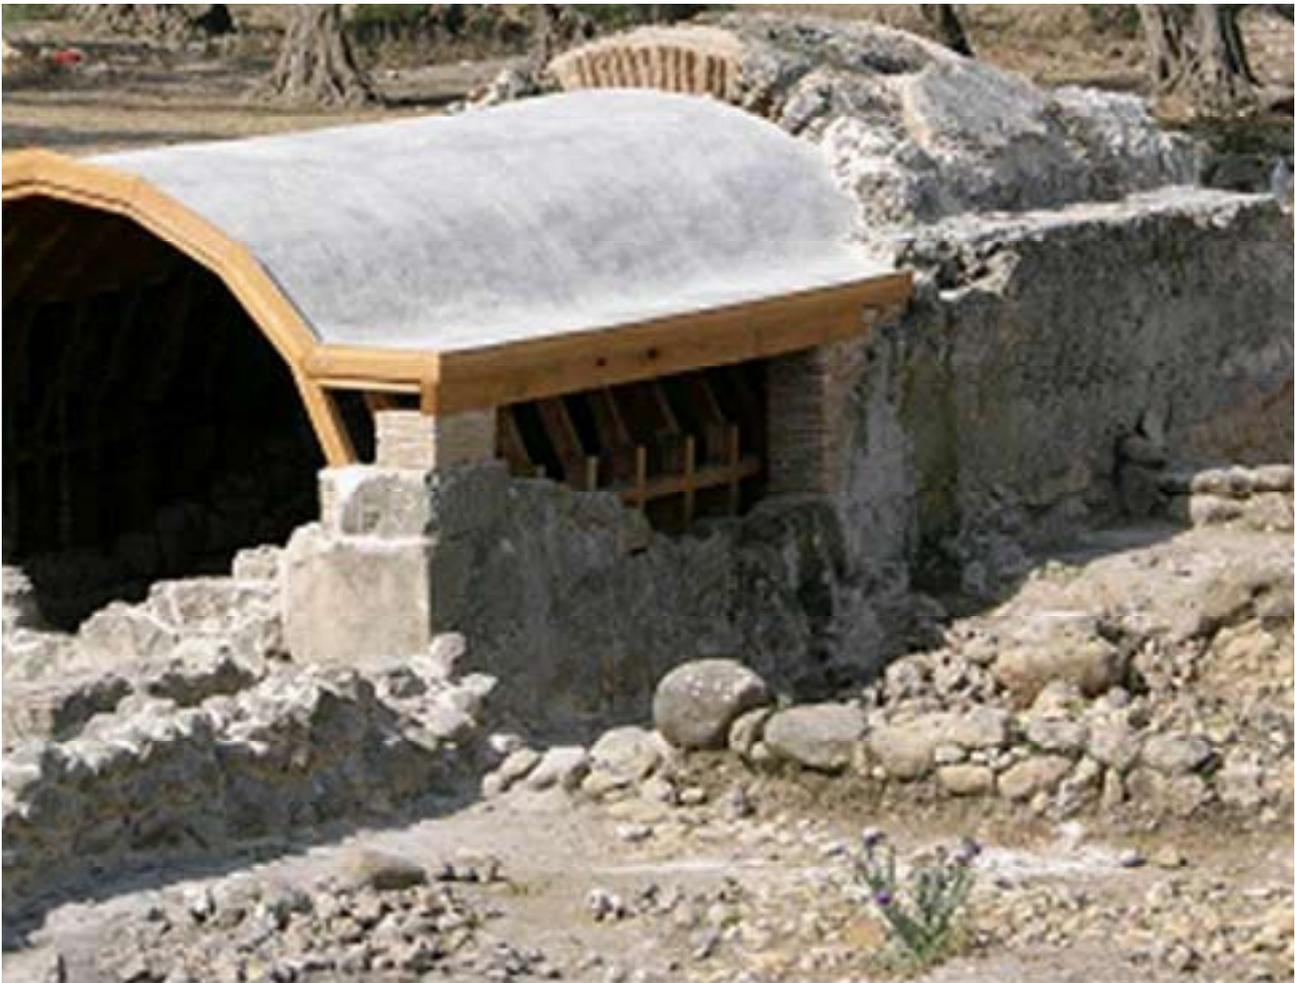
*Fig. 11 The wooden vault covered with planking and waterproof membrane (A el H)*

Initially, a very lightweight vault was constructed. A reed mat covered the formwork, followed by a layer of plaster and a mortar layer. However, this proved far too fragile, and it failed to survive the harsh environment, so that it was removed in the subsequent season, and a new covering devised, starting with wooden planking. The wooden planks of the roof were then fixed onto the frames using brass screws (fig. 11). The planks sat on the southern wall of room V and on a wooden beam that marks the northern ends of the exterior of the vault

profile. The reason for using this beam at the northern side of the wall was to prevent having to reconstruct the northern wall to reach the level of the vault. A waterproof membrane reinforced with fibreglass mesh was then laid on top of the planks. The edges of the membrane are protected with a wooden fascia. A protective screed was, then, applied on top of the waterproof membrane. Over the planking it was planned to place a layer of hollow bricks and roof plaster (fig. 12). The color and constituents of the roof plaster would be similar to those

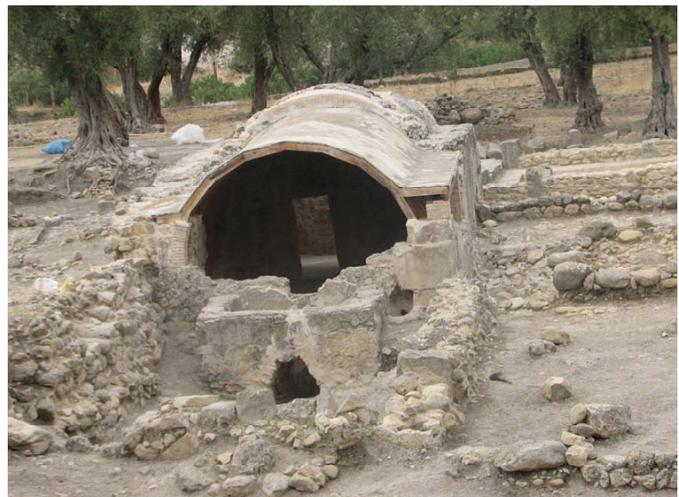
Fig. 13. The structure in 2015.

However, for various reasons - chiefly uncertainties about its weight - the hollow bricks were never added to the vault, and today it is topped by the protective screed, which has held up reasonably well (fig. 13). The ensemble was to be completed by one of two panels designed for the site: in the event only one was put up. (fig. 14). This has now been defaced, probably by the local shepherds at a time of conflict with the director of the site.

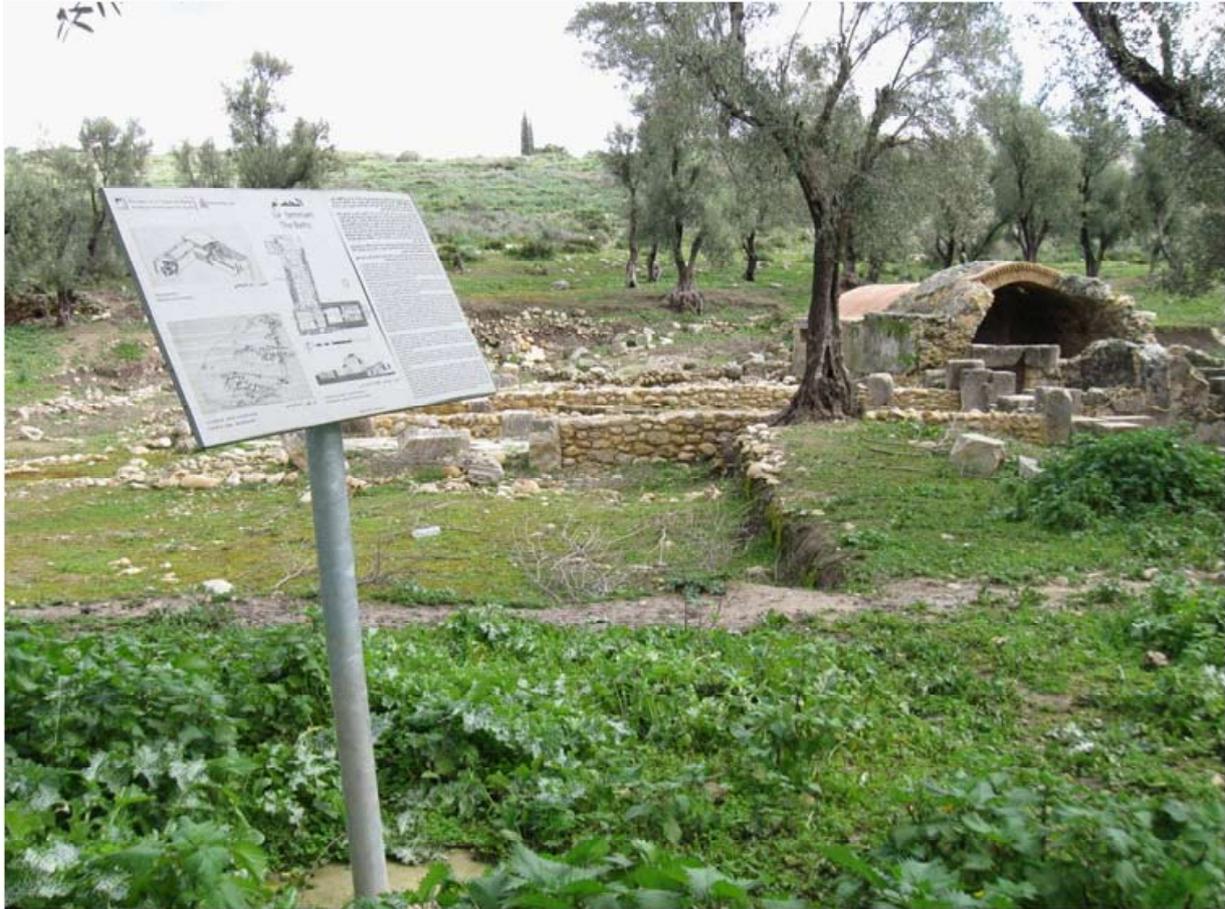
Fig. 14. The explanatory panel – too far from the site- before its defacement (TM)
