## The 2012 Excavation Season at the Villa San Marco, *Stabiae*: Preliminary Field Report<sup>1</sup>

Taco T. Terpstra

*In the summer of 2012, Columbia University, in collaboration with H2CU (Centro Interuniversitario per la Formazione Internazionale) followed up on its successful 2011 pilot season in ancient Stabiae as part of the “Advanced Program of Ancient History and Art” (APAHA). The Program performs stratigraphic excavations in the Villa San Marco, one of the largest and most opulent villas in Campania, investigating both the Villa as a Roman elite structure and the pre-79 AD history of the site. The goal of the excavations is to give a full archaeological account of the stratigraphy from the eruption layers of Mt Vesuvius down to virgin soil. Building on the results from the previous year, the 2012 campaign had two main research goals: investigating the Villa’s system of water-supply and drainage, and clarifying the Villa’s relationship with the road that marks its northern limit. The results were on the one hand the discovery of a work area in the northern sector of the Villa, and on the other the clarification of the temporal relationship between the Villa and the road

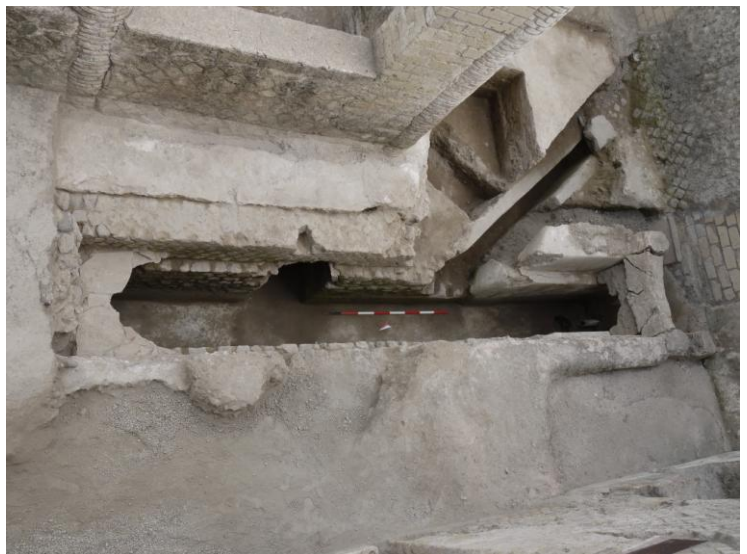
Fig. 2. Room 68, southwestern corner. Drains, shallow basin of work area.

layer of cement (figs. 2 and 3). However, this material appeared not to rest directly on the ledges running along the channel’s length but to “float” about 5 cm above them on both ends, touching only the channel walls (fig. 3). This suggests that the lower part of the original roof was constructed in wood that has now decayed, leaving a void. With these rebuildings the channel walls reached the considerable height of 140 to 160 cm, with the inside height of the channel at ca 95 cm. However, the channel walls were never replastered and always remained covered only up to a height of about 30 cm from the bottom (fig. 3), so the raising of the channel walls seems not to have been intended to increase the drainage capacity of the feature. Instead, the reason seems to have been a desire for access, perhaps for cleaning purposes; at the point where the channel makes its 90° turn west towards the southern latrine, there is a rectangular shaft measuring around 50 by 40 cm and leading straight down into the channel. The shaft was covered by a roughly-cut and badly-fitting capstone, which was found *in situ* by the 2008 team. This shaft and capstone show that access to the inside of the drain was considered important during the final phase. After the height of the large channel had been raised twice, a narrower channel (circa 25 cm in width, 53 cm in height on the inside) was added, leading from the atrium (room 44) through the southern wall, and joining the wider channel at an oblique angle to drain the atrium’s rainwater (figs. 1 and 2). This event seems to be contemporary with a more comprehensive restructuring of the southern end of the large channel, which was probably cut and blocked at this time, creating the cut in the channel floor ca 15 to 25 cm from the southern wall, mentioned above. Almost certainly, this event is associated with the construction of the outdoor swimming pool on the other side of the wall (room 42a). The large drain’s floor is at approximately the same level as the floor of the swimming pool, which explains why the drain had to be cut when the pool was dug. However, a direct connection between the pool and the drain seems to have been created by a section of lead water pipe, running through the southern wall and serving as a drain for the pool. A drainage hole can be seen at the bottom of the pool, roughly at the level of the *fistula* on the other side of the wall. However, at the bottom of the channel, the *fistula* was found completely buried within a layer of sediment on the channel floor, so if the *fistula* did indeed serve to empty the pool, by 79 AD this had not happened for probably a considerable length of time.

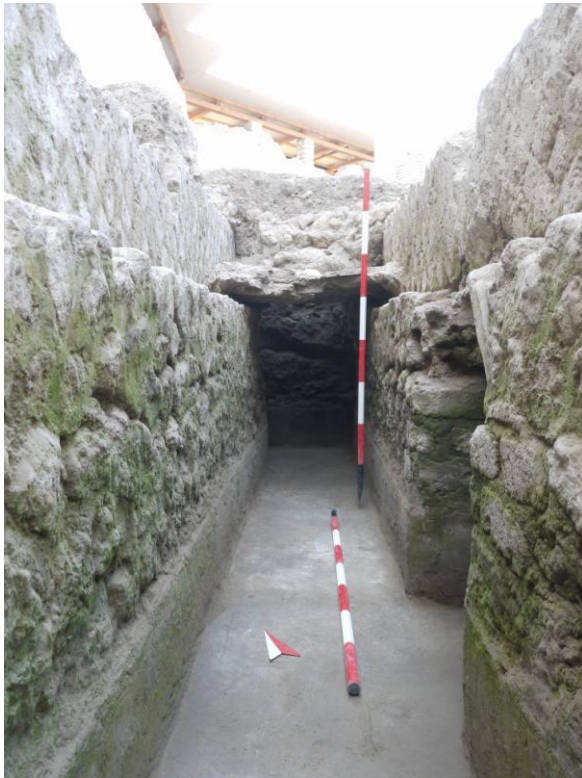
Fig. 3. Room 68, southwestern corner. Large drain.

The walls of the large drain were raised twice, both times associated with floor-raising events. The second reconstruction happened at a greater width of 80 cm, which created ledges to support a covering of ceramic tiles and other building material such as bricks and a fragment of undecorated white marble revetment, all set into a thick

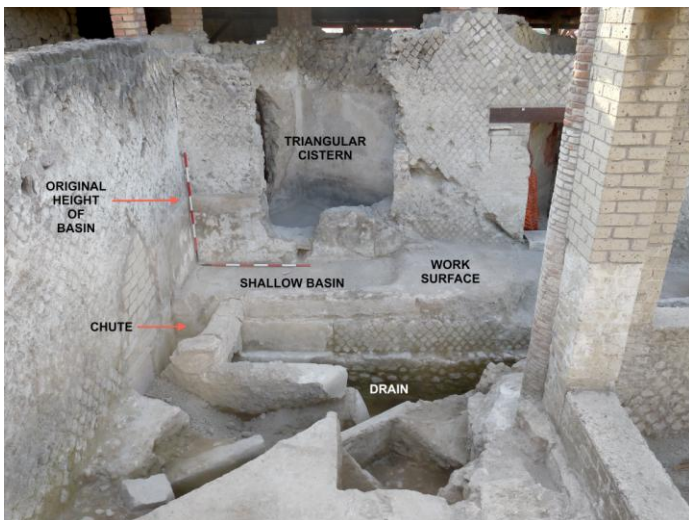
Fig. 4. Room 68, southwestern corner. Work area: triangular cistern, shallow basin with work surface, chute, and drain.

the chute (fig. 4). Originally 110 cm in height, the basin was subsequently made much shallower, around 20 cm in height; so shallow in fact that it seems hard to conceive of any practical use. The waste chute as well had been modified at least once with the placement of two roughly-cut stones forming a “bridge” over the channel. These stones are certainly a later addition, resting as they do upon a layer of waterproof plaster; they seem to have been intended to reduce the size of the chute. In 79 AD, the chute was no doubt open, which is the reason why the channel was discovered filled with volcanic material. North of the chute though, the channel was probably completely covered by the tiles and cement described earlier, a remnant of which can be seen in figs. 2 and 3. However, much of the covering had been destroyed by the Bourbon excavators in the process of extracting lead pipes, which

The large channel served a work area consisting of a triangular cistern supplying water, a basin with a work surface, and a chute to drain the waste water; a hole in the basin’s southeastern corner connects it to

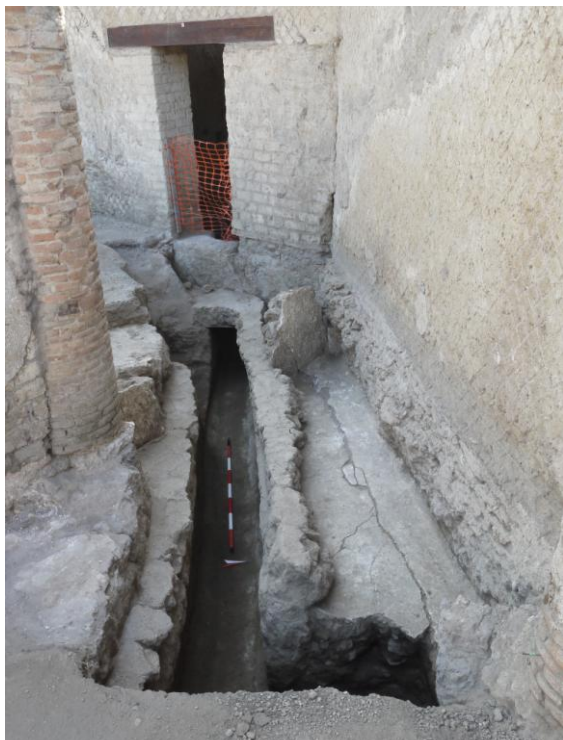
Fig. 5. Room 68, northwestern corner. Drain, destroyed tank, foundation of northern wall intruding into tank.

In the northwestern corner of room 68, a large channel was discovered, the continuation of the feature found last season (fig. 5)<sup>7</sup>. This channel runs into the northern latrine underneath the threshold, leaving no doubt about its use as a drain. Its incline is much steeper than that of the drain in the southwestern corner: around 27 cm over a span of 4.5 m. This drain had also been disturbed by the Bourbon excavators; its roof and walls had been partly destroyed, and the inside was filled with modern backfill. The explanation for this disturbance is the robbing of the water pipe that must have lain at the bottom of the channel. The results from the 2011 APAHA season had already shown that during the Villa's final phase a *fistula* entered the room from the street, turning west from the entrance and running along the northern wall<sup>8</sup>. The 2012 results show that this pipe then turned south, running along the latrine wall towards the room's southwestern corner. In the relatively narrow passageway between the corner of the colonnaded open space (room 67) and the northern wall, the drain and the *fistula* joined, the pipe running through the drain for a short section of about 3.5 m. The *fistula* seems to have entered the drain from the northeast, exiting it again to the southwest, which is why the drain's walls and roof between those points were destroyed by the Bourbon excavators (figs. 5-6).

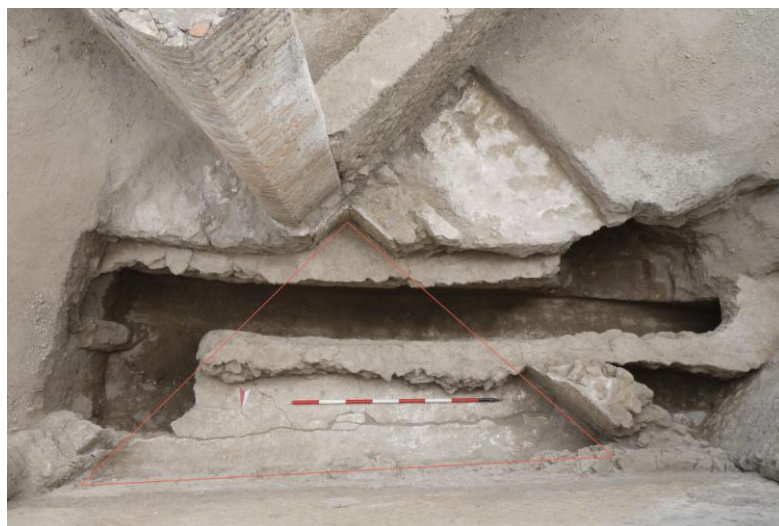
Fig. 6. Room 68, northwestern corner. Destroyed tank (shape marked with red lines) and drain.

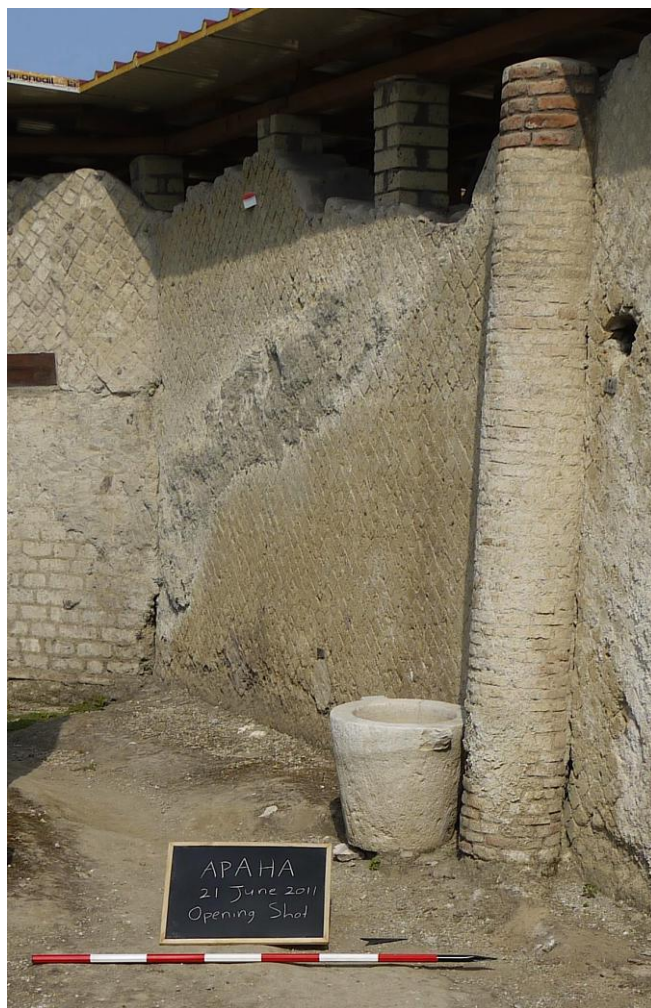
Fig. 7. Room 68, northwestern corner. Limestone mortar.

To sum up, the main events seem to have been: the construction of a wall separating the street from the villa; a first phase with a work area in room 68, which probably occupied both its northwestern and southwestern corners; a second phase with the work area in the northwestern corner going out of use with the construction of a new northern wall, and the one in the southwestern corner being restructured. The cumulative evidence of the southwestern and northwestern corners seems to suggest that room 68 was, at least partially, used for productive purposes of some sort<sup>9</sup>, a hypothesis supported by the presence of a conical, limestone mortar of around 54 cm in height and 61 cm in maximum diameter, found in 2008, standing up against the northern wall (fig. 7).

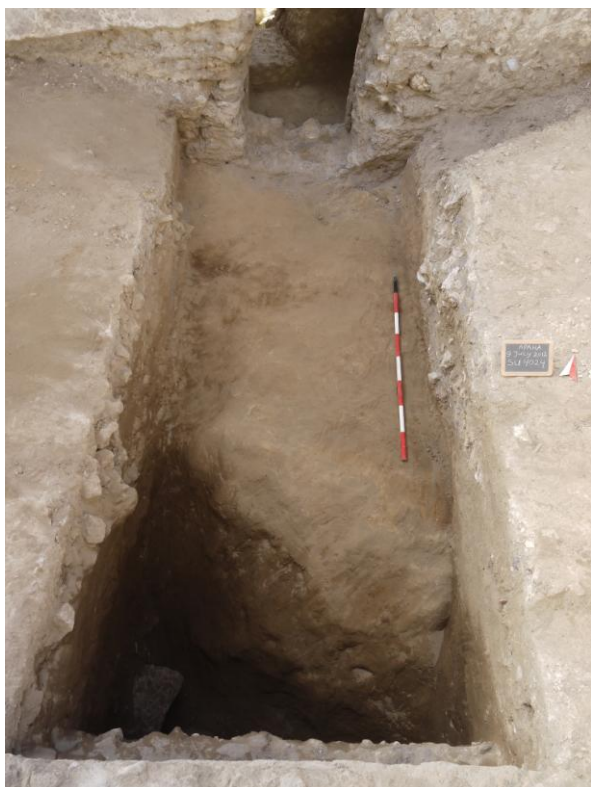
Fig. 8. Street. Layer of yellow paleosol, Bourbon robber hole.

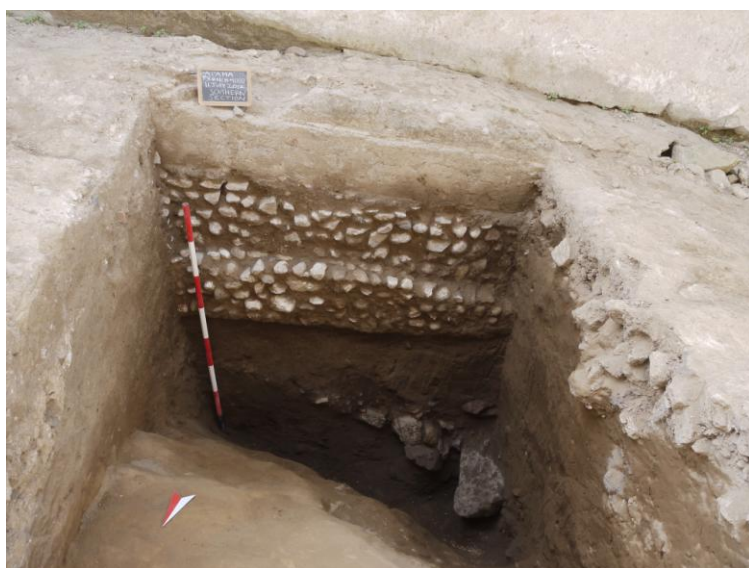
Fig. 9. Street. Southern section with drain.

9). This steep slope could be the result of the natural shape of the paleosol, but could equally well be the product of a quarrying event. The natural layer is probably the result of an earlier eruption of Mt Vesuvius, and is visible also in the villa across the street. A section of the western substructure of that building has collapsed and slid down the hill, exposing the same paleosol; the exposed sections created by the collapse show that this layer is at least a meter thick. In the APAHA trench, the space created by the steep downward slope of the paleosol was filled with a layer of dark soil containing relatively little cultural material. Apart from some ceramic sherds, this layer contained bigger and smaller chunks of soft lavastone as well as a large number of rooftile fragments. A preliminary study of the ceramics (which included a fragment of blackfigure ware) and the rooftiles suggests the layer is early in date, belonging roughly to the sixth century BC<sup>11</sup>.

with cement, soil, and pebbles visible in fig. 9. It seems likely that the drain, when first constructed, was not completely buried, but stuck out above the road surface. Its top section of about 40 cm of cement is smooth and flat, and seems to have been poured against wooden planks rather than soil. The team did not investigate the inner channel, but the drain's outside dimensions are circa 85 cm in width, 120 cm in depth. Through a hole in the Villa San Marco's northern wall, this drain was fed by the wastewater coming from the latrines. The sewage from both large channels in room 68 described above as well as the rainwater from the colonnaded open space (room 67) and the atrium (room 44) thus ultimately ran through it<sup>13</sup>. It seems likely that the drain was constructed at the same time as the Villa San Marco, or shortly afterwards; if indeed the large drain in the southwestern corner of room 68 is more or less contemporary with the construction of the Villa, then the streetside continuation of the drain likely dates to the Villa's first construction phase as well. After the walls of the villas lining the street went up, the road surface seems to have been raised incrementally until it became level with the top of the drain.
