The 2012 Field Season at I.1.1-10, Pompeii: Preliminary report on the excavations

Steven J.R. Ellis – Allison L.C. Emmerson – Kevin Dicus – Gina Tibbott – Amanda K. Pavlick

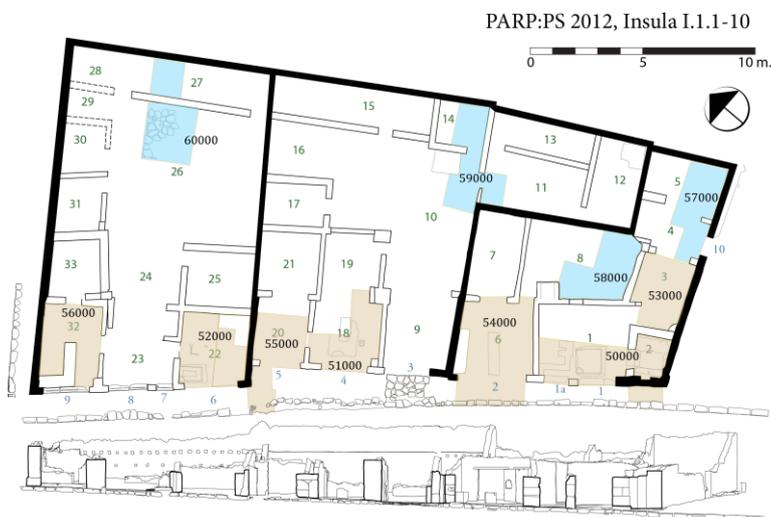
Fig. 1. Location of the 2012 trenches (in blue) in insula I.1.1-10.

The Pompeii Archaeological Research Project: *Porta Stabia* (PARP:PS) undertook its eighth and final campaign of excavations during the summer of 2012, during which four trenches were opened across the extent of I.1.1-10 (fig. 1); these followed from the seven trenches that were excavated in *insula* I.1 during our 2010 and 2011 field seasons¹. Our excavations of those trenches had established a phased development of the *insula* that was not unlike that already established from our excavation of VIII.7 during our 2005-2009 field seasons². The briefest sketch of the overall development of the area is as follows³: some sparse occupation can be attributed to the 6th and 4th centuries BCE, with notably less activity in the 5th and 3rd centuries (the most significant being a pottery production facility from the 3rd century)⁴; urban development escalated rapidly and notably through the 2nd century BCE, with most of the buildings appearing at this stage and operating cottage-scale industries (notably fish-salting and tanning); those activities ceased during the

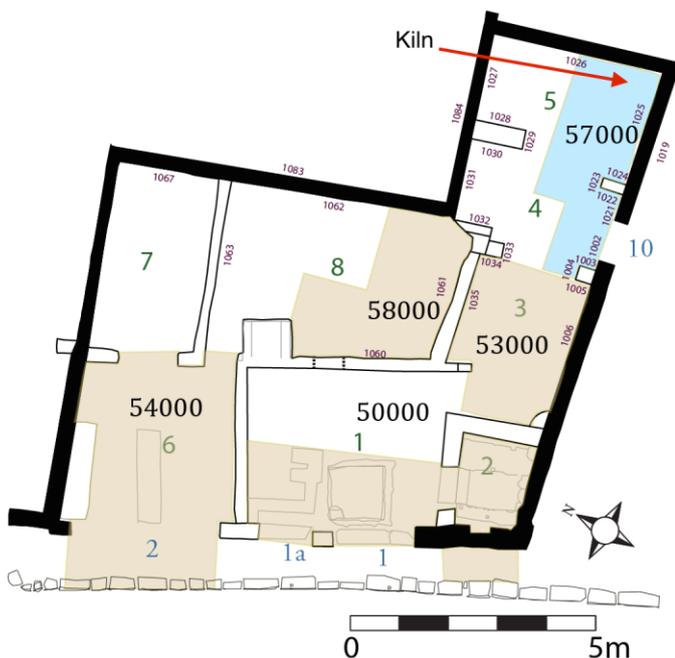
Fig. 2. Plan of Trench 57000.

Trench 57000 comprised the southern halves of Rooms 4 and 5 in property I.1.1/10 (fig. 2)⁷. The location was chosen to satisfy two research objectives. First, we aimed to establish the occupational phases of these two back rooms in order to construct a stratigraphic sequence that encompassed the entirety of property I.1.1/10. Second, given that our excavations in the 2011 field season placed the construction of these rooms within a relatively late phase (late 1st century BCE)⁸, we sought a clearer understanding of the early activities that took place here when the area was still public space. How this area related – structurally and socially – with the *Porta Stabia* was also of interest. Each room was excavated down onto natural volcanic deposits, being an ash paleosol of a light grey friable matrix.

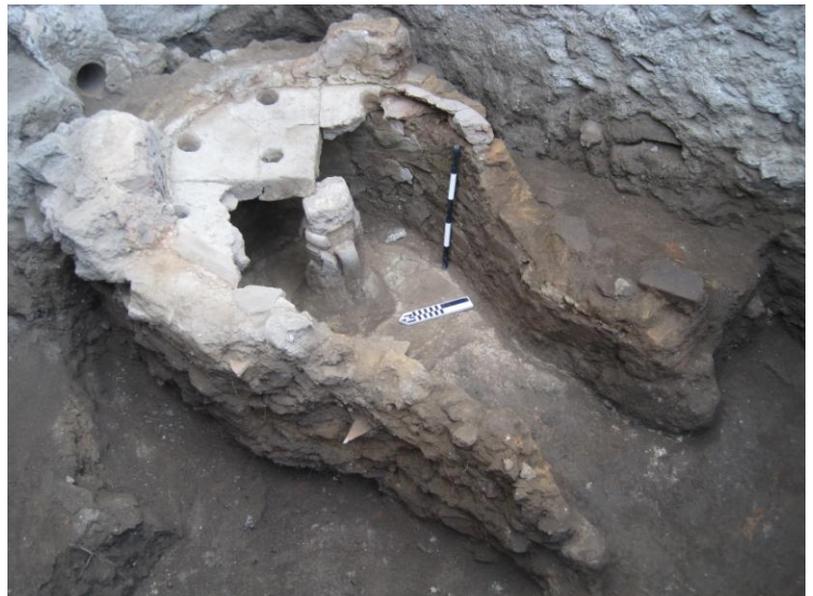
Fig. 3. View of the kiln, looking southeast.

The kiln was aligned east-west, and retained a narrow *praefurnium* that ran eastward approximately 60 cm from the west-facing stokehole, within which a deposit of ash – thus the remains of the final firings of the kiln – was recovered. The *praefurnium* opened up to a rounded combustion chamber, of which the diameter was just over 1 m. The combustion chamber's floor was composed of tile and clay, which supported a central pedestal. This support was constructed from the upper parts of an amphora, cut width-wise across the body¹⁵. The pedestal supported the perforated oven floor, 45 cm above the combustion chamber floor. The oven floor was made by three, and possibly four, thick (ca. 10 cm) terracotta perforated wedges extending from the inner edge of the rounded oven wall; remarkably, three of the oven floor pieces survived *in situ*, providing an opportunity to observe elements of a kiln's structure that rarely survive to this degree. The inner points of the wedges met at the center, supported by the central pedestal. The pottery would have been stacked on the oven floor, the perforations acting as vents to draw the heat from the combustion chamber below. Very little of the oven wall survives, and nothing of its (domed) roof.

The kiln parallels those of Class 1a in Ninina Cuomo di Caprio's typology of pre-Roman and Roman kilns of south Italy and Sicily¹⁶. Kilns of this class were circular and contained central supports. It is one of the most common kiln types, primarily because it is the simplest solution of supporting the perforated oven floor, guaranteeing "a strong support to the central (and therefore weakest) part of the oven floor"¹⁷. The kilns of this sort from south Italy

The kiln abuts a corner created by N-S and E-W running walls (WF 1026 and 1025, respectively) that supported the rear (eastern) and southern sides of the kiln and provided a built space for the pottery production facility. A terracotta tube (damper), used to control the draw of the kiln, ran from the rear of the kiln through the N-S wall (WF 1026). The presence of this damper could indicate that the structure had a permanent domed roof; that none of the roof survived could otherwise indicate the use of a temporary domed structure, of a type known elsewhere²⁰. Materials from the kiln's destruction were found packed within the tube itself, demonstrating that the kiln and the walls were contemporaneous.

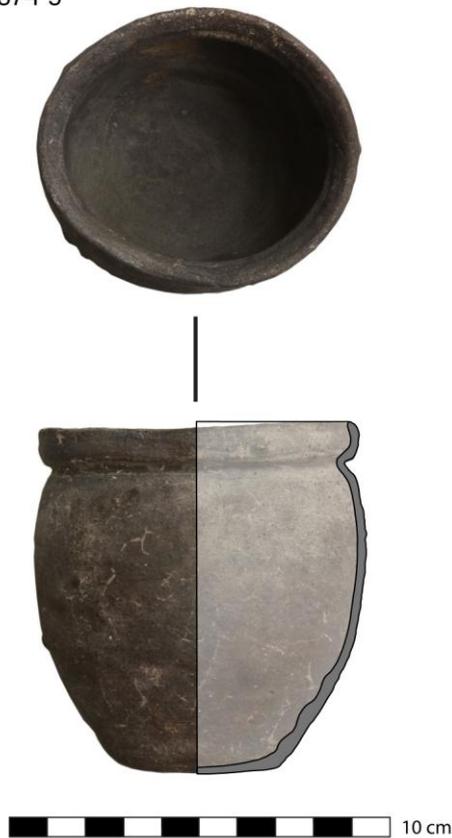
Fig. 4. One of the juglets produced in the kiln (Drawing by Nicole Gross and Gina Tibbott; Photo by Jennifer Stephens).

The artefact assemblages associated with the kiln are equally of interest. Of the many fragments of pottery found within the destruction layer of the kiln, the vast majority was of a form of common ware juglet of variable, but all small, sizes (fig. 4). In form they are most similar to those of Marabini III and, especially, Marabini IV²¹. The juglets represent the final batch of vessels fired in the kiln, during which time the kiln underwent a significant failure after which it remained inoperable. One miniature votive cup recovered from the layer of ash on the *praefurnium* floor, perhaps dedicated (unsuccessfully, it seems) to protect the kiln, or perhaps also being fired, was the only notable different form²².

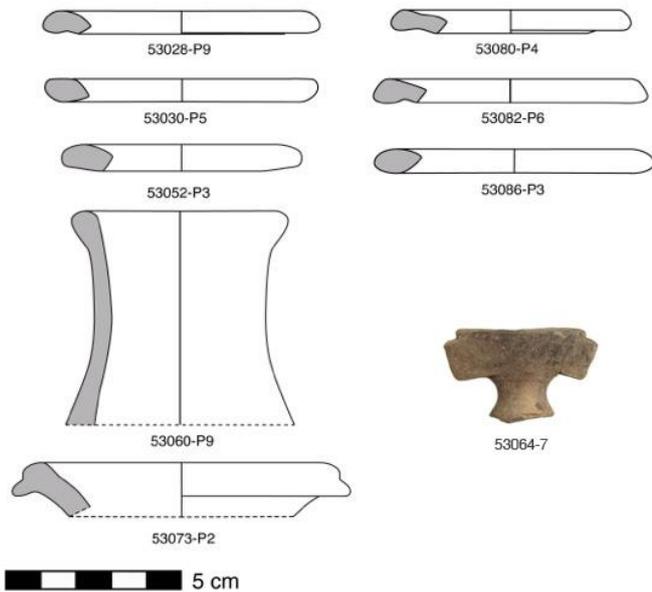
Fig. 5. Some of the cylindrical vessel supports and an example of the type of votive cup (Drawings by Nicole Gross, Jenny Kreiger, Sedef Kinacioglu and Gina Tibbott; Photo by Jennifer Stephens. All images to same scale).

dical vessel supports from a kiln (fig. 5). Vincenzo Cracolici, in his study of the typology of vessel supports at Metapontum, dates similar examples from the 5th to the 3rd centuries BCE²⁴. The walls of the low-walled structure were lined with heavily burned refractory clay; the masonry in the walls was equally discolored from repeated high temperatures. Over its base was a significant layer of ash. Combined with these assemblages, as well as the stratified sequence itself, it would now appear that the structure was in use at the same time as the kiln from 58000, the 3rd century BCE, and that the structure was not sacred in nature, as our preliminary ideas had led us due to the presence of so many votive materials, but rather was a form of kiln in operation with the pottery production facility. This low-walled kiln became inoperable first, however, and was dismantled. The remains of its structure were then used as a pottery dump, filled with misfired vessels from the kiln in Trench 58000.

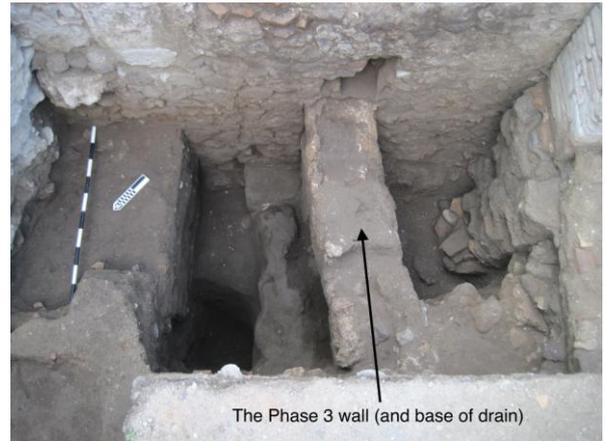
Fig. 6. Opus incertum wall of Phase 3 in Trench 57000; the same wall served as the base of a drain in Phase 4.

A large *opus incertum* wall, oriented NW/SE, on the same alignment as the *pappamonte* block of Phase 1, was built in the third phase of activity in Room 4 (fig. 6). Its width was 40 cm and it ran the extent of the trench, continuing through the northern baulk toward the northern wall (WF 1031/1035) that separates I.1.1 from I.1.2. Spatial

In Room 4, a doorway accessed the alley running west toward the *via Stabiana*. A drain was built under the threshold, using the uppermost course of the dismantled wall from Phase 3 as a foundation (see fig. 6). It ran southward into the alley, presumably leading to another drain with an outlet onto the *via Stabiana*; later activities destroyed all remains of the drain's northern course in Room 4.

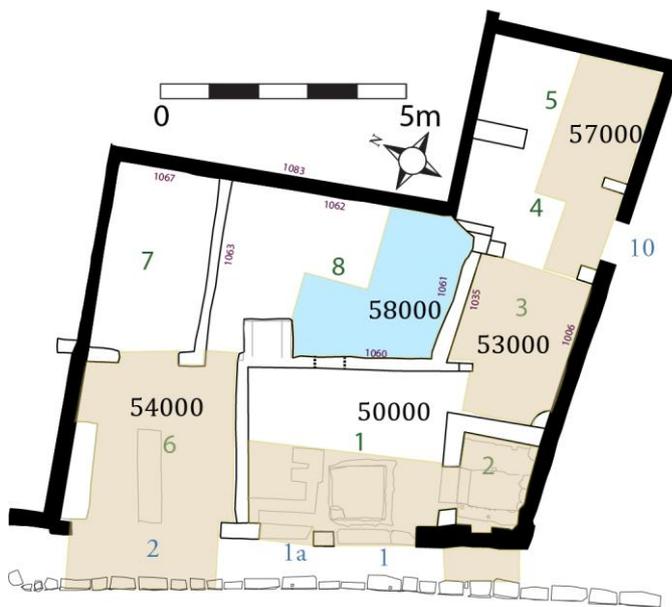
Fig. 7. Plan of Trench 58000.

Trench 58000 was located in the back room (Room 8) of property I.1.2 (fig. 7)³⁴. Given the location of this space, being at the junction of three separate properties, as well as the trench's spatial and physical relationship to other trenches (especially 50000 and 53000), the aims of this excavation was to connect the stratified sequences of different spaces in the development of the southern part of the *insula*. It was also apparent, from architectural analysis alone, that this part of the property (I.1.2) had originally been spatially connected to – or part of – the two now neighbouring properties of I.1.1 and I.1.3-5; the development of this structural relationship would hopefully be identified in the building sequences uncovered in the trench.

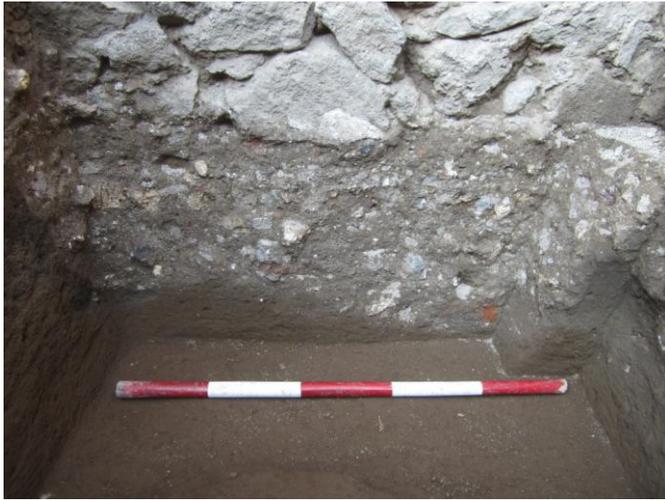
Fig. 8. Excavated section of the mortar slurry foundation to WF 1062.

The other two walls – WF 1060 (the NE wall) and WF 1062 (the SW wall) – were built to abut WF 1061, but very likely as part of the same construction event. Both walls were built in a style, visible only in their foundations, that has been detected elsewhere in this *insula*³⁷. Whereas the architecture of the northern part of the *insula* could often be founded upon a shallow lava bedrock, a significant drop in bedrock elevation occurs somewhere around the division between properties I.1.3-5 and I.1.6-9 (thus between doorways 5 and 6). The loss (or drop) of that bedrock in this part of the *insula* meant that a different approach to support the foundations was taken. The foundations for the two walls (WFs 1060 and 1062) were constructed upon a poured base of a lime-rich slurry. This slurry was poured into the bottom of a construction trench that was approximately 20 cm wider than the foundations it was intended to accommodate (fig. 8). The slurry was around 20-30 cm deep. The ultimate effect was a very hard, flat, and stable base. A continuation of the poured foundation associated with WF 1062 was identified in Trench 59000, further to the north, from the eastern side (WF 1083) of this wall (see Phase 2 in Trench 59000, below); it was also located in Room 20 of the same property³⁸.

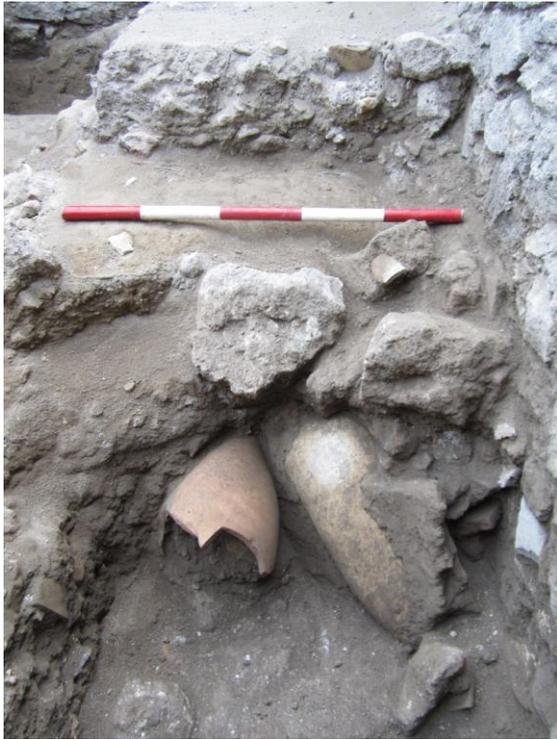
Fig. 9. Some of the amphorae used in the deep leveling fill.

The third phase of activity was marked by an effort to level the difference in elevation between each side of Room 8 (or the divided space, as it may have been, in Phase 2). A large fill of mostly broken, recycled amphora laid on their sides was used to fill the volume (fig. 9). The amphorae varied in typology and quality, but with several Dressel 1 vessels of the late 2nd century BCE. Some vessels were complete or near-complete, while others were only partial or noticeably fractile. The remainder of the fill material was of brick, tile, cookware, and coarseware; the assemblage, as well as the total lack of finewares, speaks to the nature of selectivity in the choice of recycled waste material for the leveling and construction of floor surfaces³⁹. So poor was the quality of materials used in this debris that some of the amphora fragments were so mis-fired that it was possible to flake away the fabric with one's fingernail.

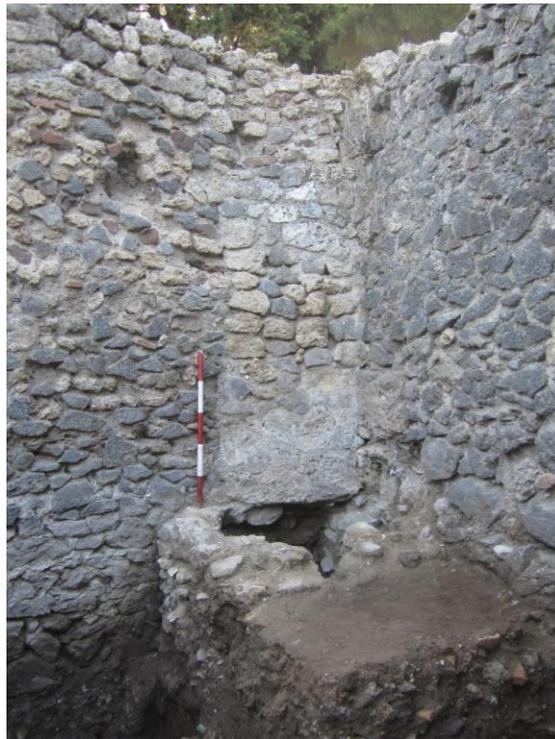
Fig. 10. Cesspit in the southeast corner of Room 8, beneath the buttressing to WFs 1061 and 1062.

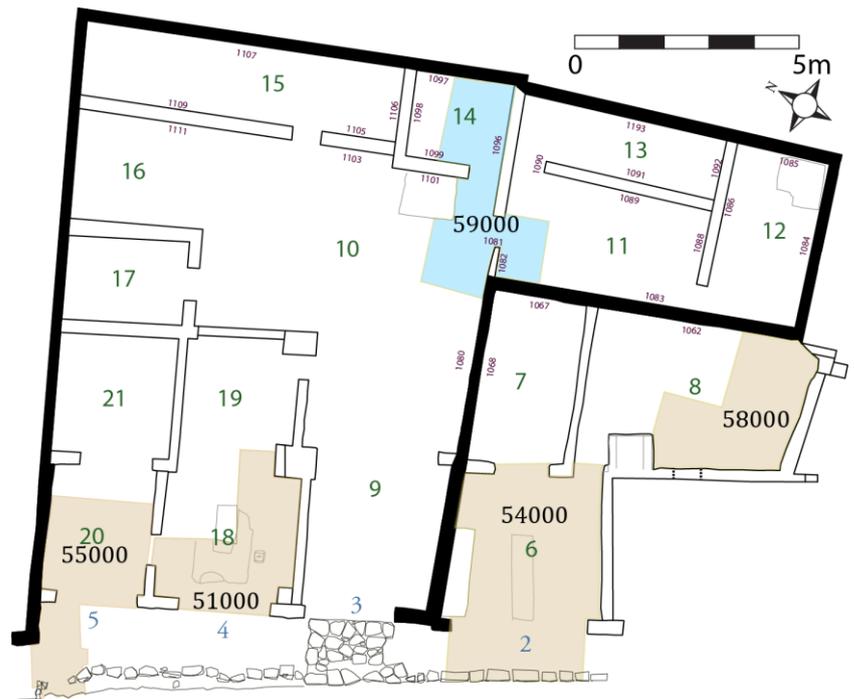
Fig. 12. Plan of Trench 59000.

Trench 59000 was excavated across three rooms at the rear of property I.1.3-5, being the large central space (Room 10) and two smaller spaces to its east and south (Rooms 11 and 14; fig. 12)⁴⁴. In addition to the general aim of furthering our understanding of the diachronic development and use of property I.1.3-5, we specifically targeted this area in order to explore the delineation of the original footprints of the property and its southern neighbour, I.1.2, while at the same time investigating several subterranean features that had been revealed by geophysical surveys we carried out in the *insula* in December 2011⁴⁵. The trench was excavated down to the prehistoric volcanic deposit of yellow sandy silt with white lapilli inclusions, likely the result of a Mesolithic eruption of Mt. Vesuvius (7070-6770 BCE). This deposit of Mer-cato ash has been encountered elsewhere in *insulae* I.1 and VIII.7 overlying a layer of grey lava with white inclusions, which is best dated to a Late Pleistocene (ca. 12000 BP) eruption of the Pompeii volcano⁴⁶. The grey lava was not encountered in Trench 59000. Previous seasons have shown that its depth varied across the *insula* (as mentioned in Phase 2 of Trench 58000, above); here it must have been deeper than 8.082 masl, the lowest level reached in the trench⁴⁷.

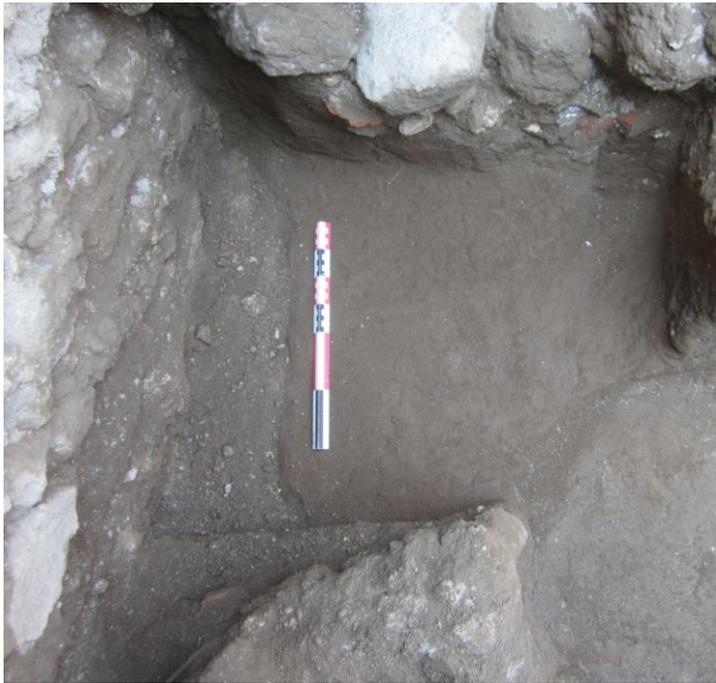
Fig. 13. Mortar foundations to WF 1067, at left (scale = 40cm); cf. fig. 7.

The area of property I.1.3-5 remained unoccupied in Phase 2. Immediately to the south, however, the rear (easternmost; WF 1067) wall of property I.1.2 was constructed, reflecting the foundation of the property as a whole. The sequence revealed against the east side of the wall (WF 1067) matched that found against its west side (WF 1062) in Trench 58000 (See Phase 2 of Trench 58000, above). The construction trench for the wall – exhibiting the same signature style of mortar poured foundations – cut through the Phase 1 terracing deposits (fig. 13)⁵⁰. A

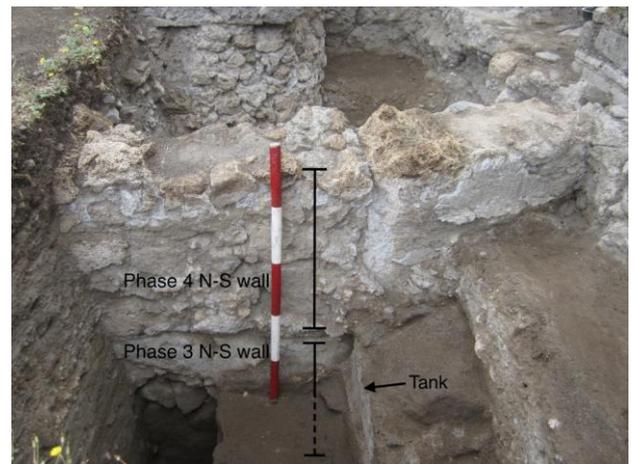
Fig. 14. The Phase 3 (underlying) and Phase 4 (overlying) N-S aligned walls in Room 10.

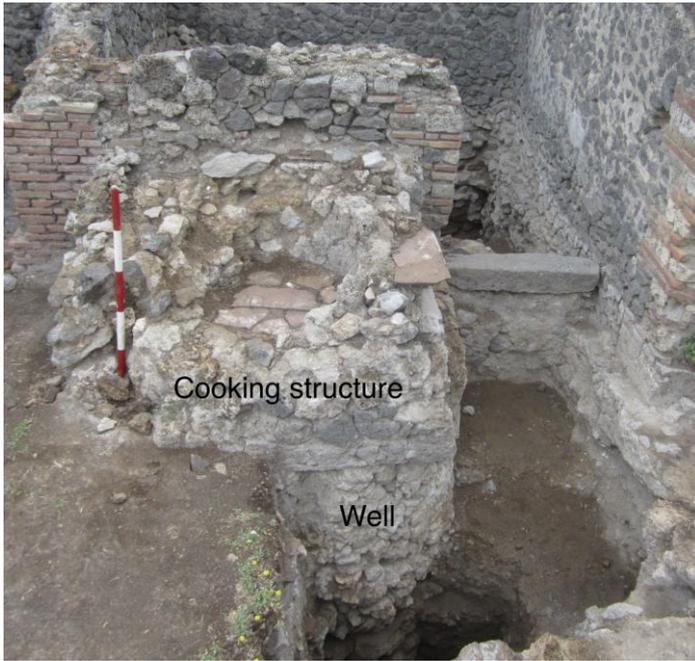
Fig. 15. Remains of the Phase 4a well beneath the Phase 7 cooking structure in Room 10, looking east.

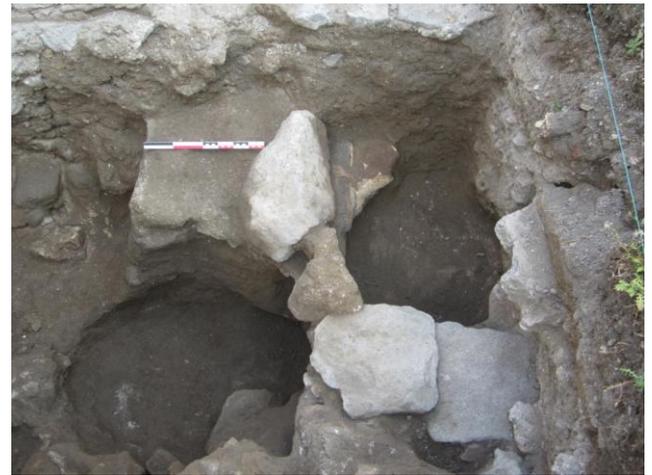
Fig. 16. Poorly preserved remains of the mouth of the Phase 4a waste-pit, at right.

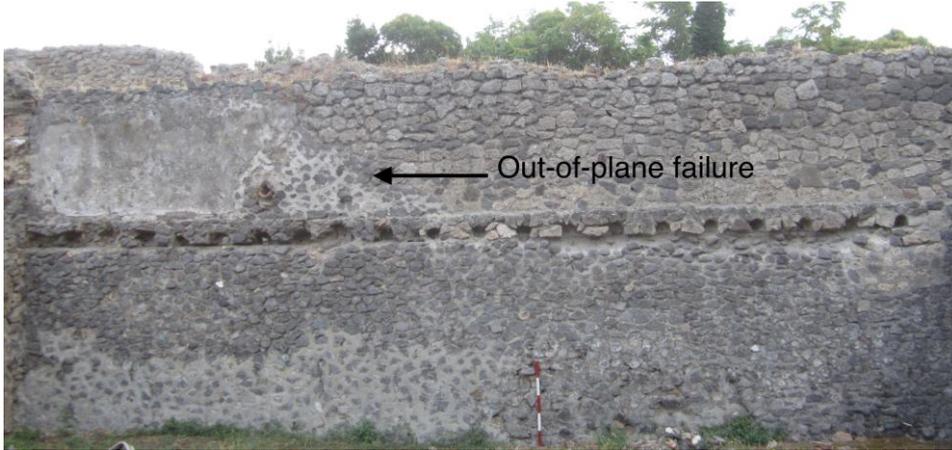
Fig. 17. The rear, easternmost wall (WF 1107) of property I.1.3-5; note the out-of-plane failure.

The final phase of ancient activity in Trench 59000 was missing from the stratigraphy of the trench, having been cut away or otherwise destroyed by modern activity, but traces of it were preserved in the surrounding architecture. In the long rear wall of the property (WF 1107), a massive repair was made after much of its upper half fell away. The repair showed the distinctive curved signature of earthquake damage – out of plane failure – and repre-

sents reconstruction following the earthquake/s of 62/63 CE (fig. 17)⁶². Beyond this repair, new walls were added in Phase 7, including WFs 1093, 1086, 1089, and 1084. With these walls, property I.1.3-5 now enclosed the last of the open, outdoor space of the *insula*, occu-

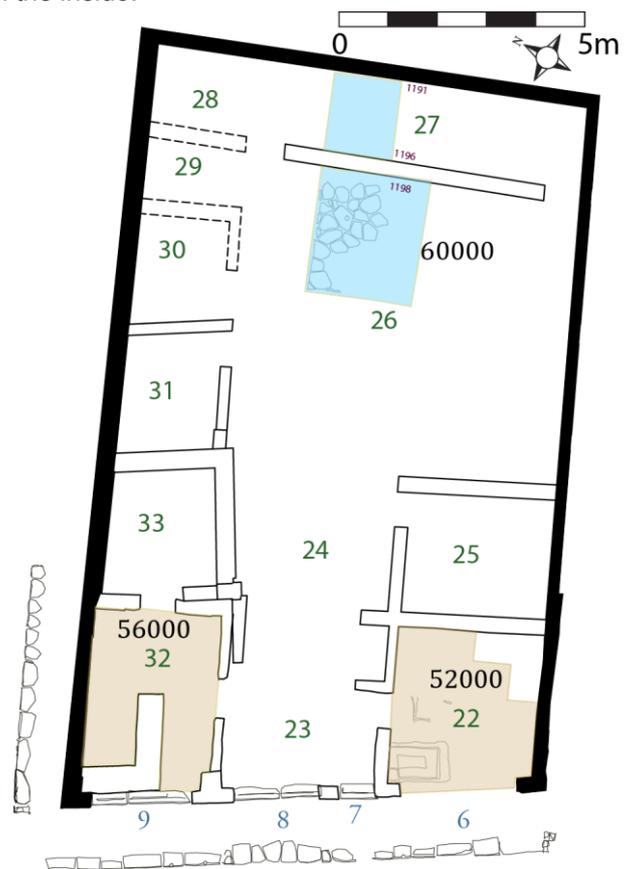
Fig. 18. Plan of Trench 60000.

Trench 60000 was located at the rear of property I.1.6-9, covering parts of rooms 26 and 27 (fig. 18); the two spaces were separated by a low (ca. 1 m) wall (WFs 1196 and 1198), if only – we would discover – from a very late phase (see Phase 3, below)⁶³. The location of the trench was selected to provide necessary structural information on the development of the eastern limits of the property; we hoped this information would connect to the results from two trenches already excavated at the western, street-side frontage of the property (Trench 52000 in Room 22 and Trench 56000 in Room 32, respectively)⁶⁴. From the architectural and spatial configuration alone, Room 26 clearly had become a large courtyard space, the largest such space in the *insula* (88m²), while Room 27 served as a long room that separated the property from the (unnamed) alley behind.

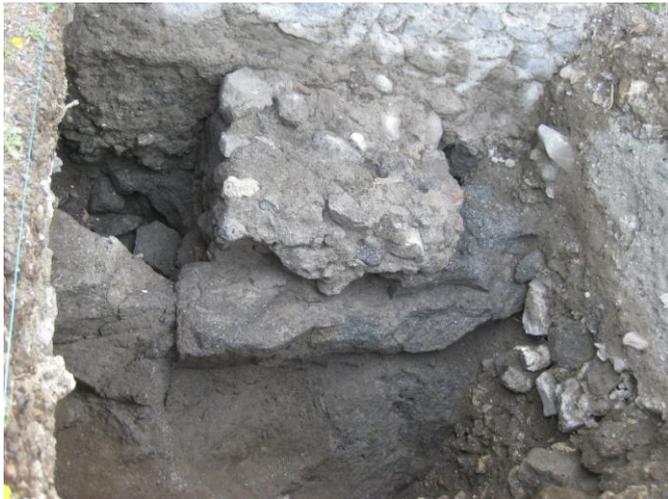
Fig. 19. The quarrying platform built onto the lava in Trench 60000.

A short time after this activity – perhaps immediately after – the bedrock in the center of Trench 60000 was prepared for quarrying. The rock was fire-broken to create penetrative cracks in the lava; a fire was made on the surface of the lava and then doused with cold water so that the rapid temperature change caused cracks and fissures in the lava. The ash that resulted from this process was discarded onto the fill that had closed the area of the first quarrying. The bedrock in this central area was then cut and removed, creating ridged formations in the lava to the west and east and a u-shaped depression that sloped downward to the south. The quarry's overall size is difficult to detail, given that it extended beyond the limits of the trench, but it had at least covered most of this back area and was at least a couple of meters deep.

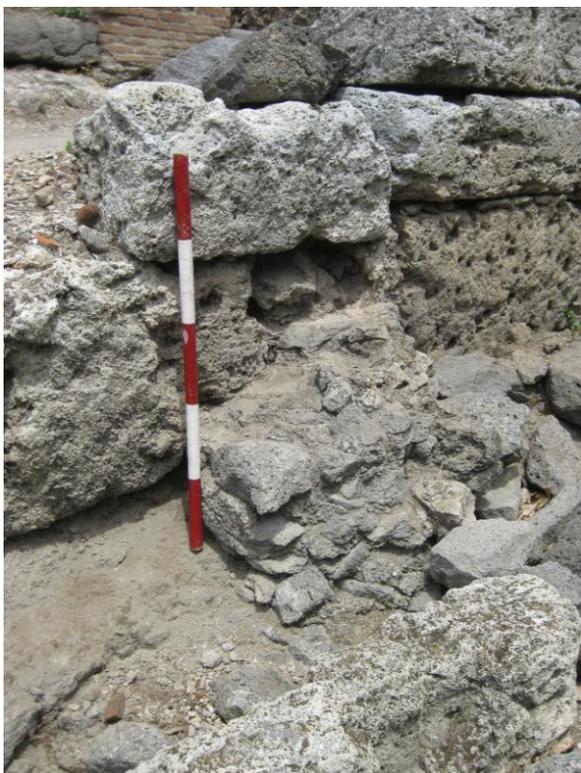
Fig. 20. The quarrying platform on the north side of the vicolo del Conciapelle.

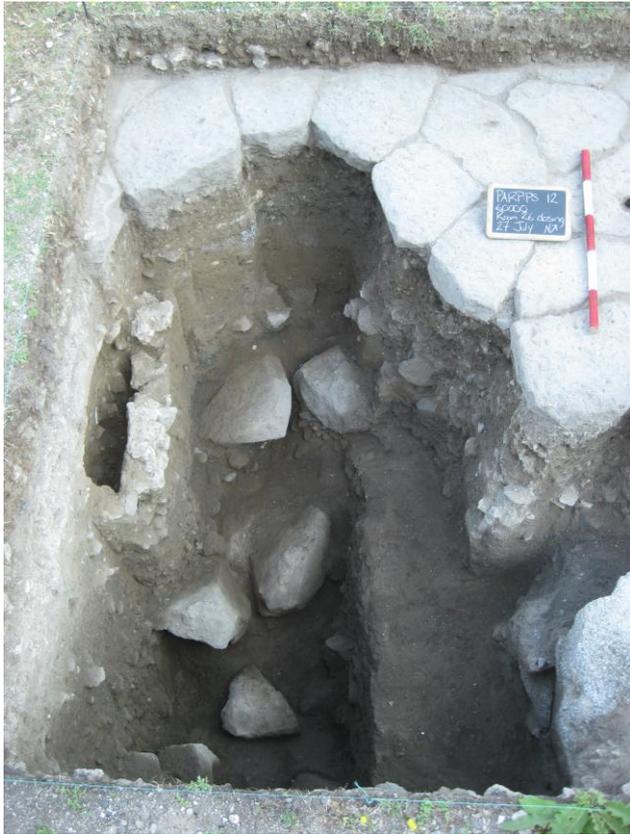
Fig. 21. Lava boulders in the fill of the quarry in Phase 1 (below); partial remains of the Phase 2 tank (in section at left); lava pavers of Phase 3 (above).

found within the property – was filled. Large lava boulders (up to 35 cm in diameter) were discarded in the bottom of the void, over which a fill of Mercato ash, cultural material, and lime was (re)deposited. A surface was laid over this levelling fill, abutting the central wall. This surface was up to ca. 40 cm thick and highly durable, made of a slurry of soil and lime poured over the sub-surface fill. In spite of the levelling of the area and creation of a new surface, the quarrying platform from Phase 1 remained exposed.

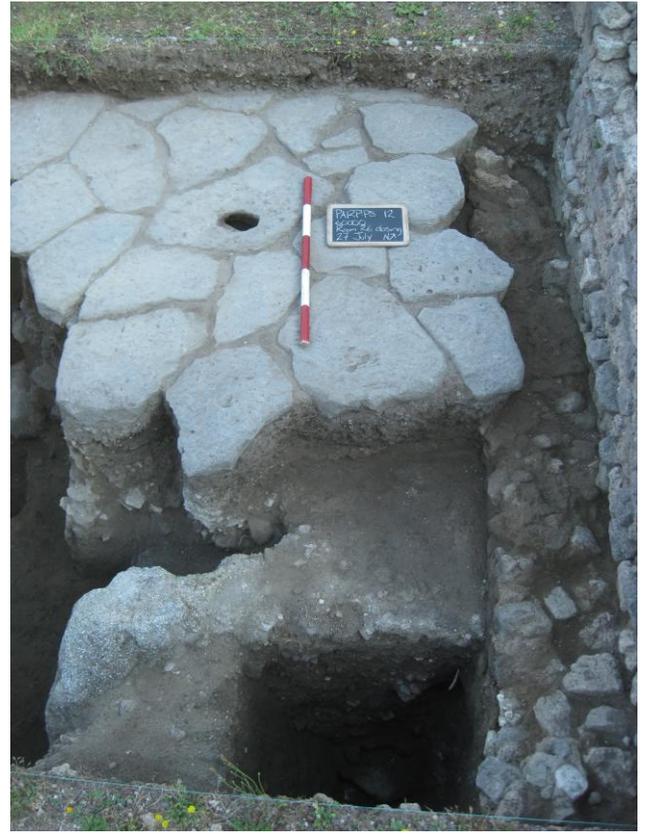
Fig. 22. Base of the *opus incertum* wall, at right, beneath the Phase 3 lava paving stones and wall (WF 1196/1198).

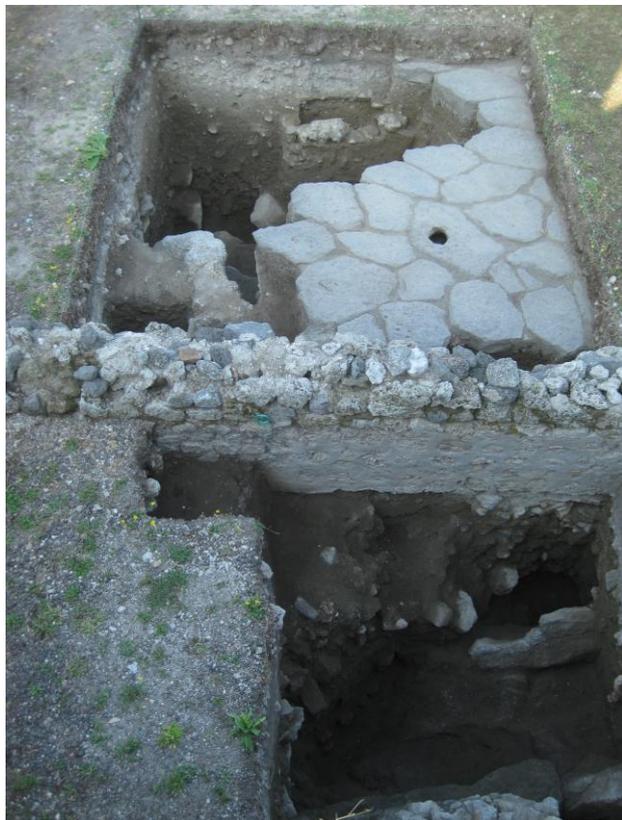
Fig. 23. Phase 3 opus incertum wall (WF 1196/1198) running across the middle of the trench (as seen from the east, looking toward WF 1196).
