Preliminary Report on the 2017 Season of the American Excavations at Morgantina: Contrada Agnese Project (CAP)

Andrew Tharler – D. Alex Walthall – Elizabeth Wueste – Christy Schirmer – Ben Crowther – Jared Benton – Randall Souza – Katharine P.D. Huemoeller

Introduction

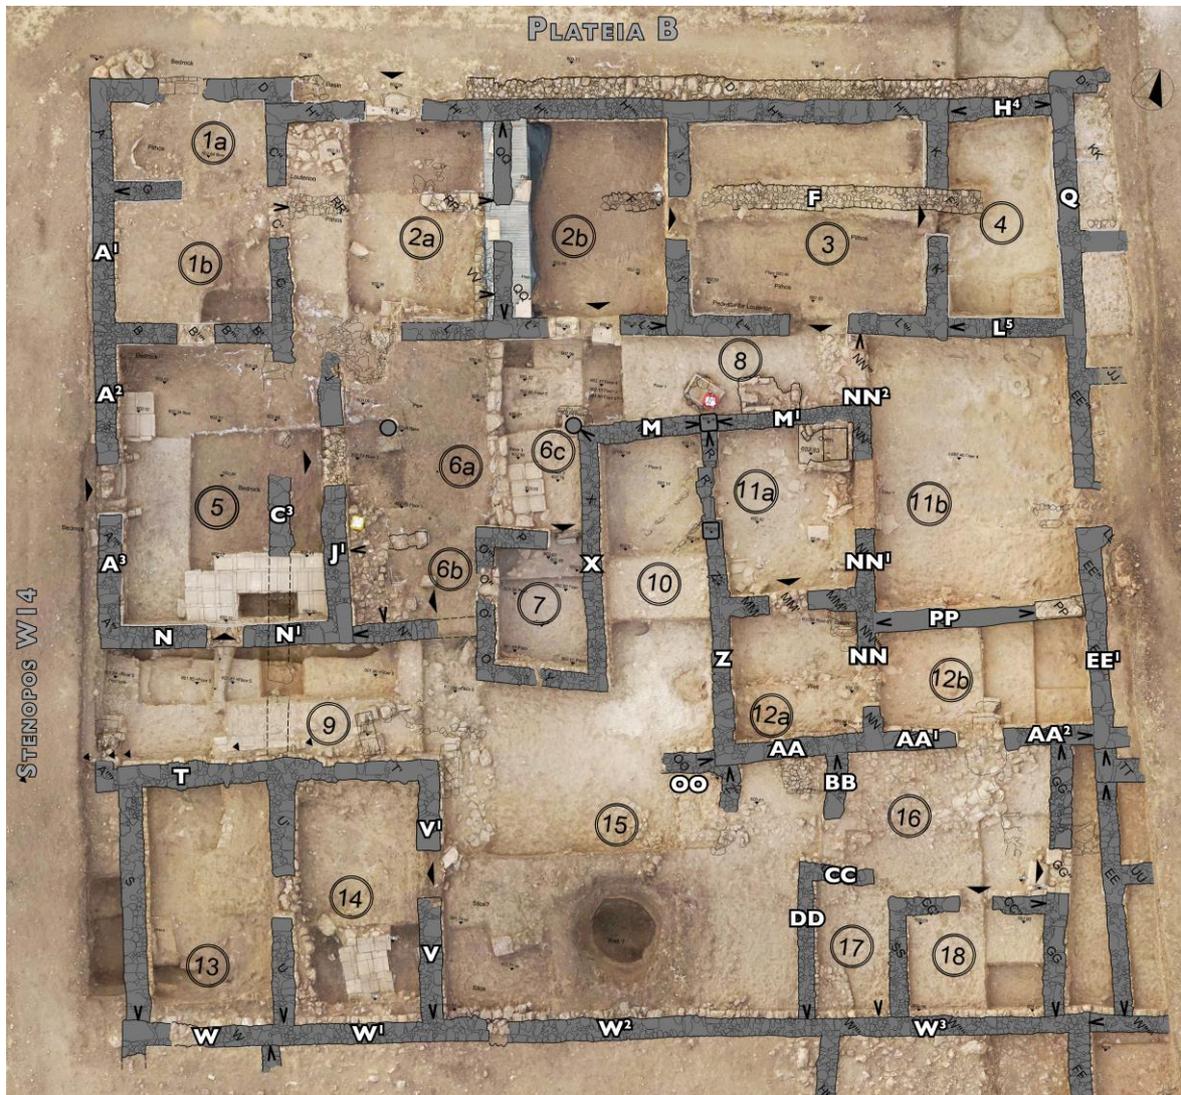
Fig. 1. Orthorectified aerial photo of the Southeast Building, with overlaid state plan, indicating room numbers and wall names. Drawing by G. Filantropi.

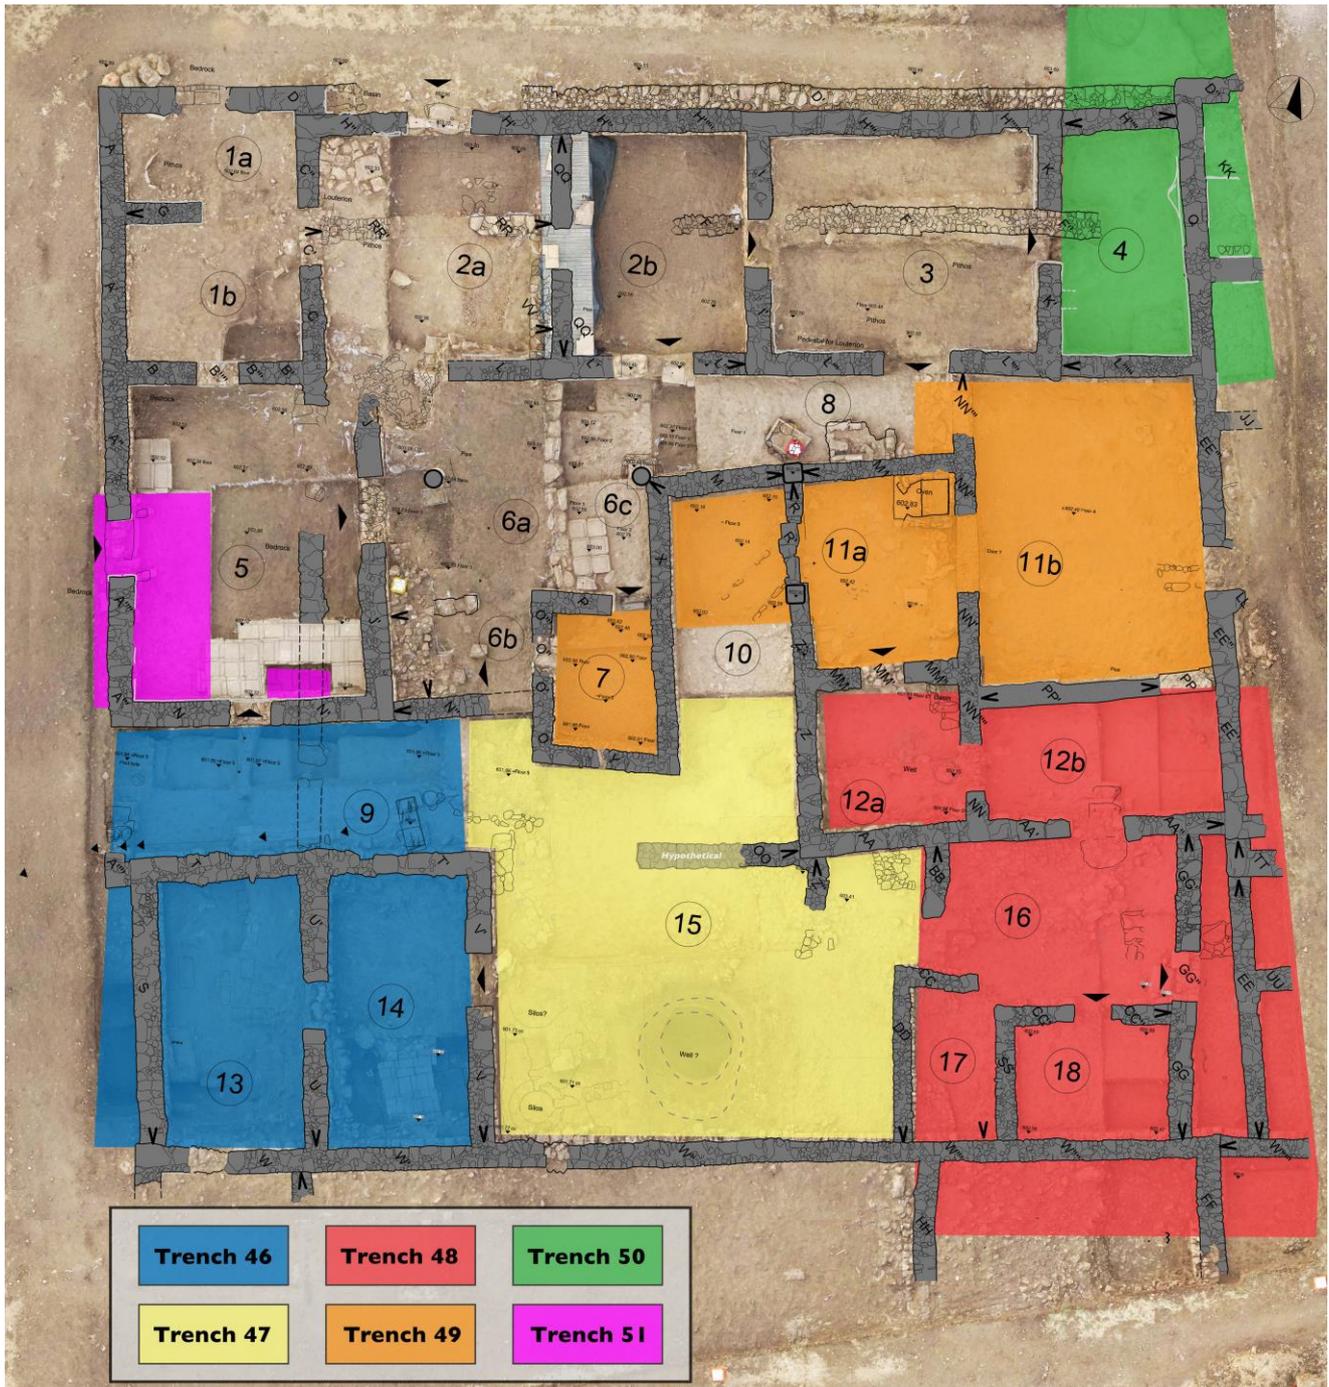
Fig. 2. Locations of 2017 trenches.

- Trench 46 was positioned over the building's southwest rooms in order to refine our understanding of their relationship to the rest of the house. The trench focused especially on Room 9, which we believe formed the building's principal entrance throughout its many phases of occupation. It also included Rooms 13 and 14, where excavators encountered backfill from earlier excavations of the 1970s as well as from more recent clandestine activity⁹.

- Trench 47 focused on Room 15, a large, open-air courtyard in the southern part of the building, which had been only partially explored in 2016. Objectives included probing the relationship between Room 15 and adjacent spaces, clarifying its appearance in earlier phases of the building's development, and dating the construction of the southern boundary wall. Excavations in the southern part of the courtyard were complicated by the discovery of a large circular pit, measuring over two meters in diameter, that cut through the modern soil horizon and ancient stratigraphy down into the sterile sandy bedrock.¹⁰

- Trench 48 centered on Room 12, which was quickly determined to be in fact two rooms, Room 12a and Room 12b. This trench also stretched into the southeast corner of the lot, where excavators defined the stratigraphic sequence for a cluster of rooms (Rooms 16, 17, 18) that had been added late in the lifetime of the building.

- Trench 49 investigated the central and central-eastern portions of the building (Rooms 7, 10, 11a, and 11b). Excavations focused on clarifying the development of interior spaces following the initial construction phase, as the building's courtyard was gradually diminished by the addition of new internal rooms.

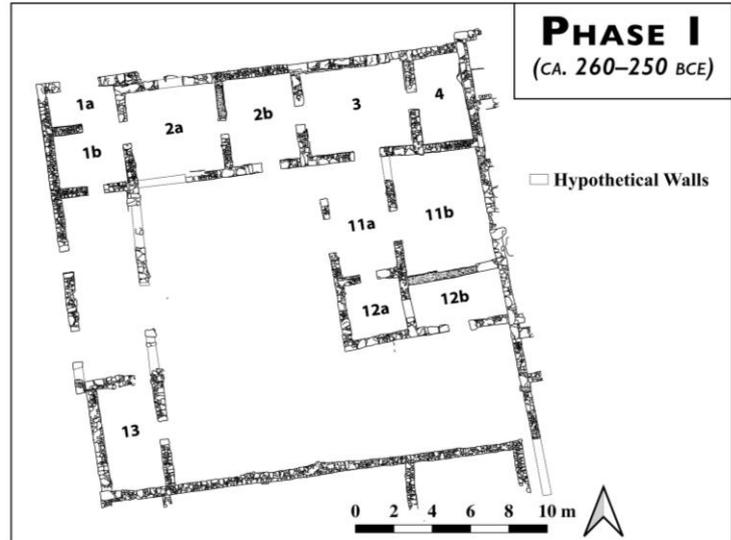
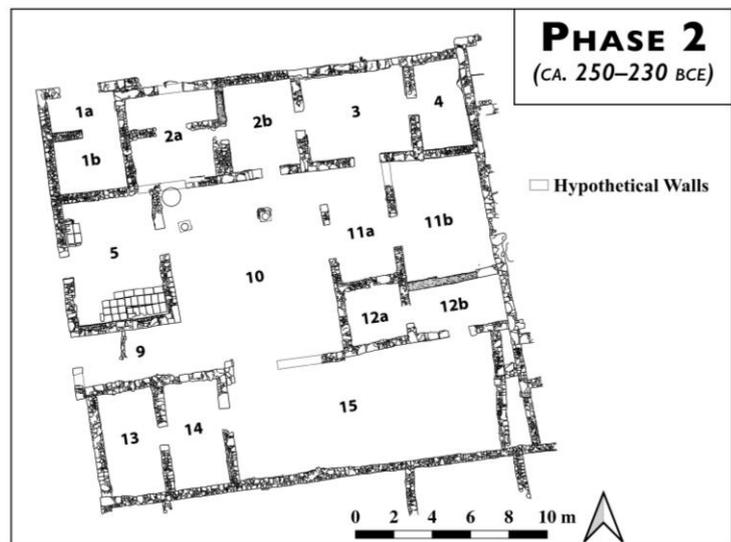
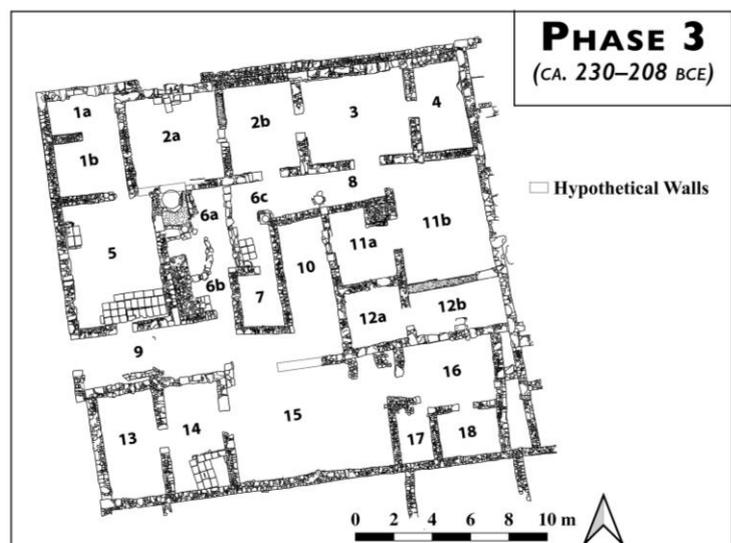
Fig. 3. Construction phases (1-3) in the Southeast Building. Drawing by G. Filantropi & J. Benton.

The results of the 2017 season generally accord with the chronology proposed after the 2016 excavations. For several of the main phases, we have proposed a date range based on inferences drawn from the relative sequence of stratigraphic contexts, as the absolute dates attached to many of the diagnostic materials (i.e. coins, ceramics, terracotta figurines) are often only broadly defined by quarter- and half-century intervals. While this has posed certain constraints on our ability to assign absolute dates for each period, the relative sequence of the building's phasing is not in question (fig. 3).

Phase 1 is defined by the earliest construction activity in the house, consisting primarily of rooms arranged around a large central courtyard (see fig. 3). Excavations in 2016 had revealed a suite of rooms (Rooms 2a, 2b, and 3) that ran along the north side of the building in this phase. Room 4 can now be added to this suite based on the results of Trench 50. Excavations inside this room reached an uneven layer of natural bedrock on which the walls of the room were founded, in similar fashion to those of Rooms 2a, 2b and 3. Wall Q, which formed the east side of Room 4 and part of the eastern boundary wall of the house, was bonded with the room's southern wall (Wall L5). Wall H4, which defined the north side of Room 4, was added before a beaten earth surface (6050024) was laid down across the room¹². This early floor surface in Room 4 shared the same elevation as the earliest surface in the adjacent Room 3, to which it is connected by a doorway, indicating that Room 4, like the neighboring rooms to the west, belongs to the initial construction phase of the house.

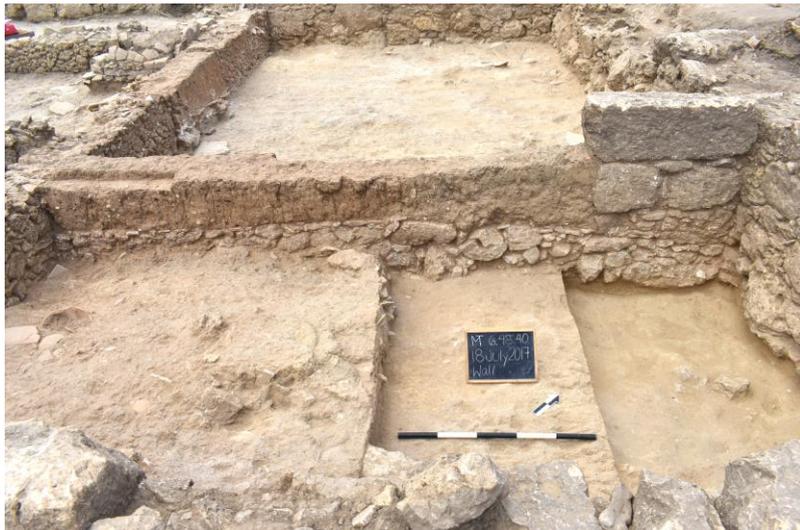
Fig. 4. Wall PP separating Rooms 11b and 12b, looking north. It is composed of a lower foundation of stone courses supporting a pisé superstructure. In Room 12b in the north, the earliest Phase 1 surface of redeposited yellow bedrock aggregate is visible.

Room 11b was corroborated by Trench 48. Notably, this wall was constructed of pisé or rammed-earth set atop a low stone socle (fig. 4). Walls of similar construction had been previously identified as part of Phase 1 construction in Room 2 during the 2016 season¹⁴. As in that case, portions of white wall plaster were discovered intact on the vertical face of Wall PP along its northern side. A surface of redeposited yellow bedrock aggregate (6049063) served as the earliest floor in Room 11b.

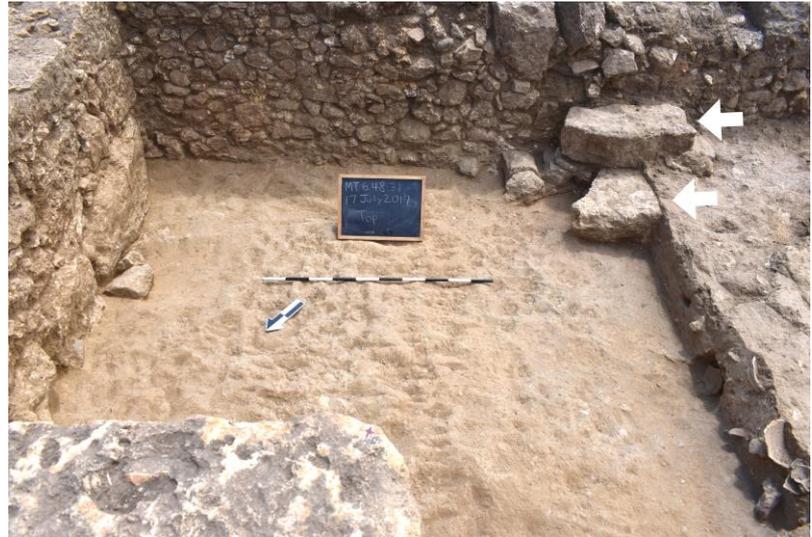
Fig. 5. Room 12b, looking south. Phase 1 beaten earth surface with stone steps leading up to Room 16.

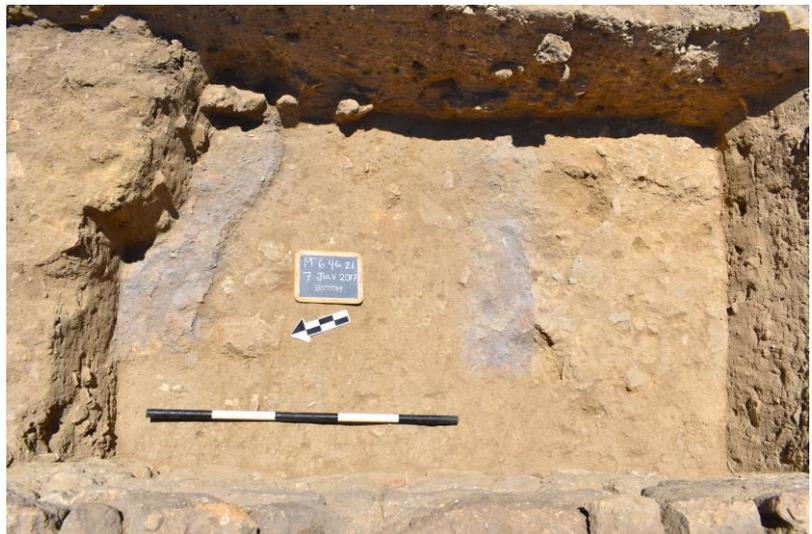
Fig. 6. Room 9, looking south. Phase 1 surface of unconsolidated bedrock and bluish substance resembling kiln dust.

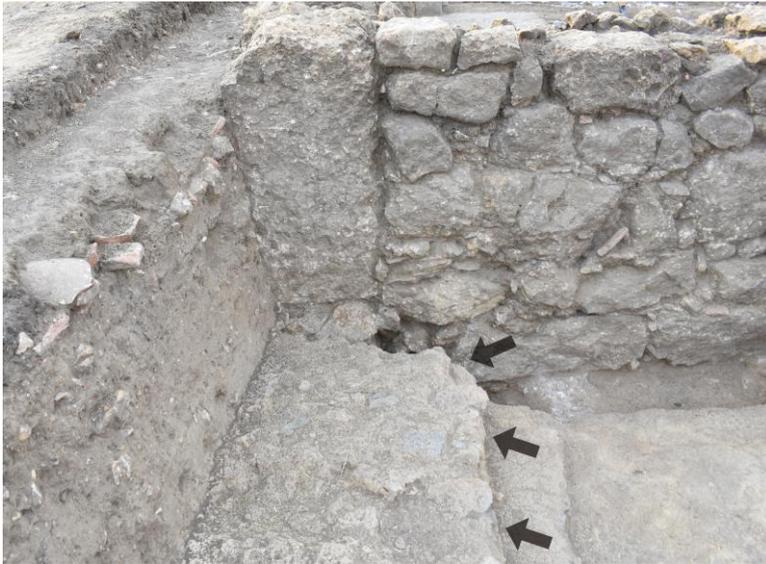
Fig. 7. Room 9, looking north. Phase 1 concrete-like pavement at entrance from stenopos W14, indicated by arrows.

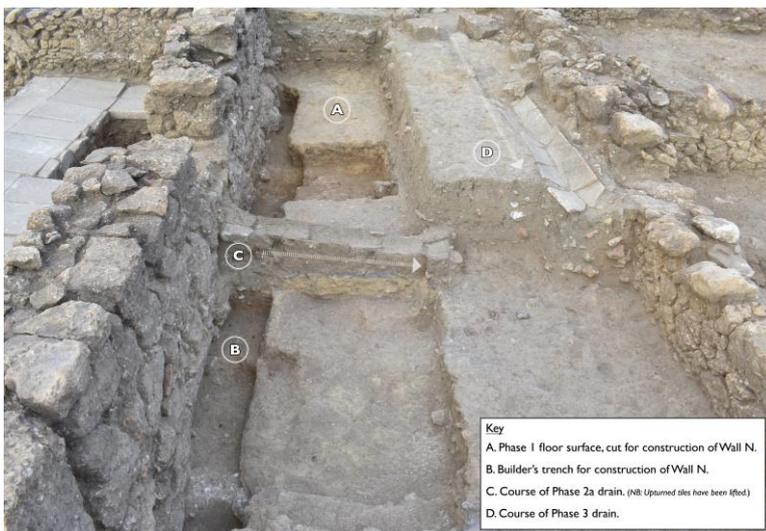
Fig. 8. Room 9, looking east. All building phases exposed, including: (A) Phase 1 floor surface, (B) Phase 2a construction trench for Wall N, (C) Phase 2a drain, and (D) Phase 3 drain.

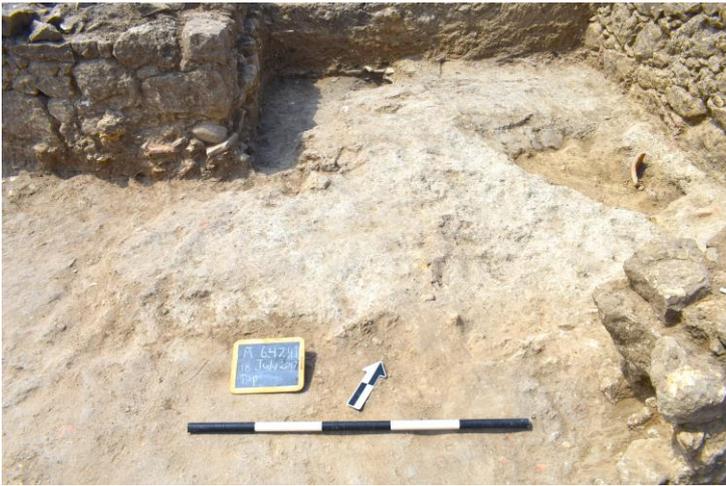
Fig. 10. Room 10/15, looking north. Phase 2a surface of compacted mortar and plaster in the courtyard.

The northern part of the central courtyard, i.e. Room 10, also yielded evidence of modest occupation without substantial alteration to the building's architecture. A highly-compacted surface of mortar and plaster (6047041) abutting Walls Z and OO represents the earliest identifiable floor in the southern part of Room 10 (fig. 10). In the northern part of Room 10, Trench 49 documented successive resurfacings of yellow bedrock aggregate (6049018, 6049041), which raised the level of the open courtyard by about 30-40cm. It is possible that the accumulation of ash created by repeated burning activities prompted the inhabitants of the house to periodically resurface the area at higher and higher levels. In that case it must be asked why the waste from this burning activity was not disposed of elsewhere.

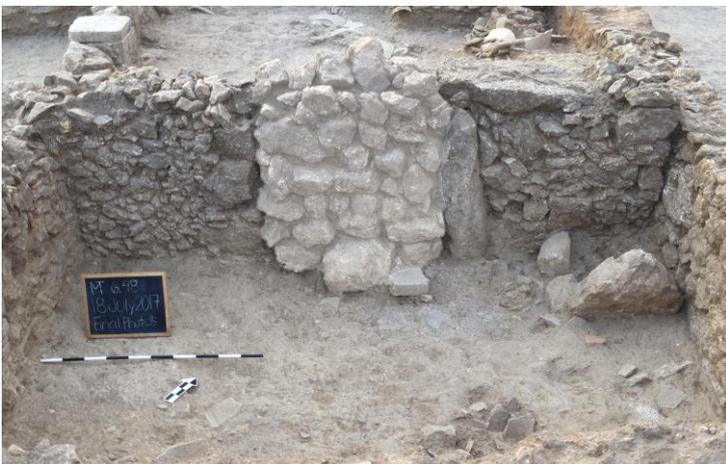
Fig. 11. Room 12a, looking north. Phase 2a blocked doorway (highlighted in white) between Rooms 11a and 12a.

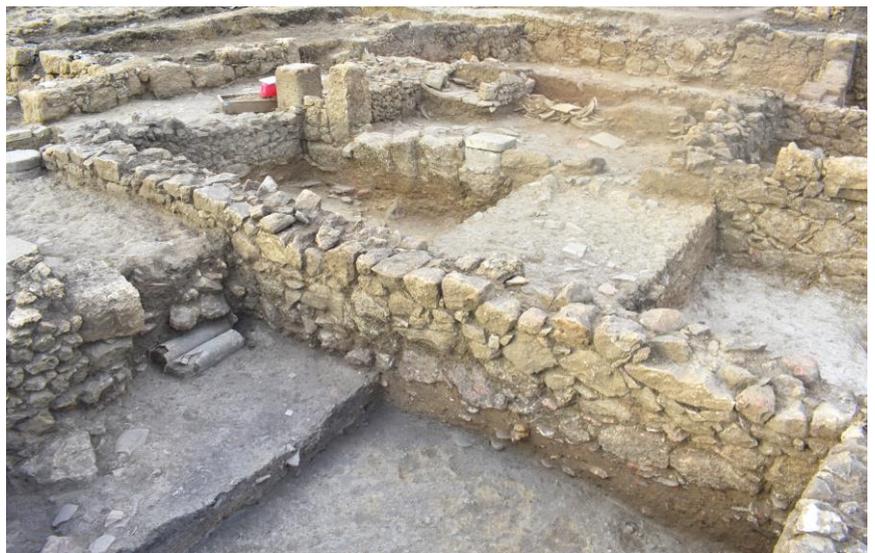
Fig. 13. Photo taken from the southwest corner of Room 7, looking northeast into Room 10 and beyond. In the foreground, Phase 3 wall of Room 7 (Wall X) built directly on top of Phase 2 surface, itself partially excavated to reveal the Phase 1 surface of crushed yellow bedrock aggregate.

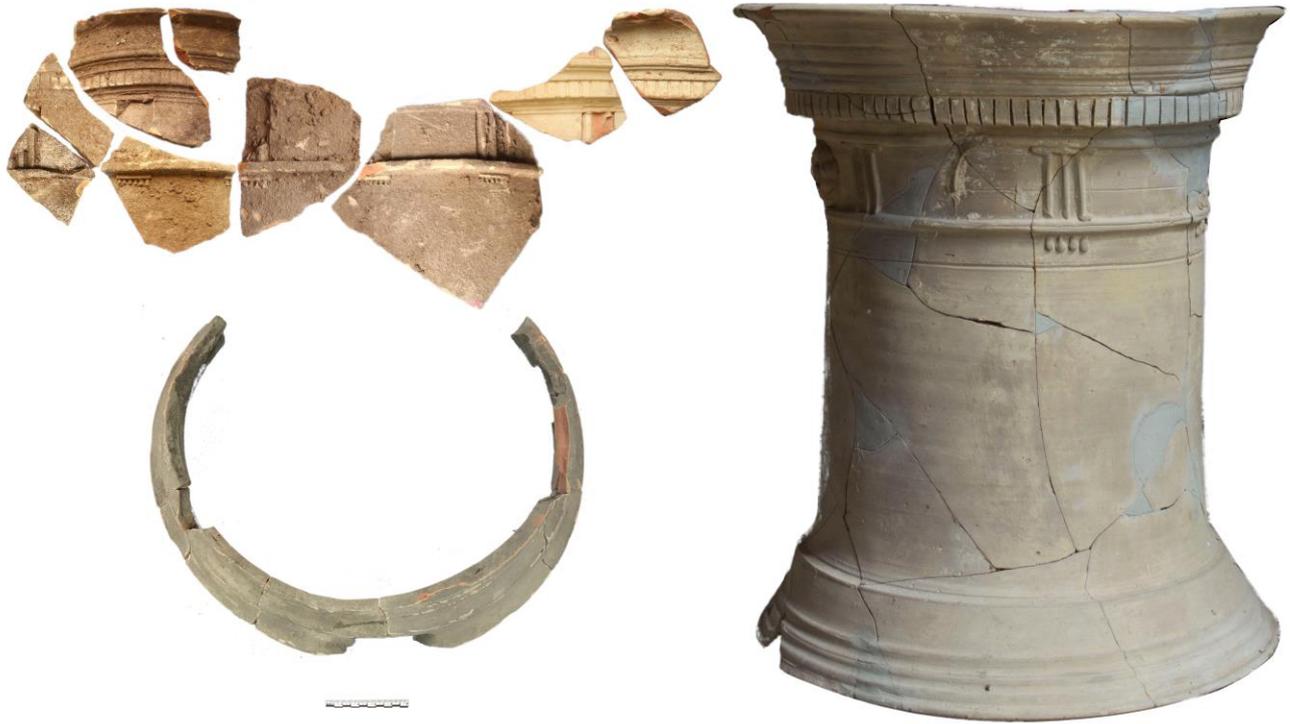
Fig 14. At left, fragments of terracotta altar found on Phase 3 surface of Room 15; at right, a complete altar from Morgantina for sense of scale and form.

A range of materials was found resting directly on top of this Phase 3 floor surface, including many objects associated with religious practices. Among these were the remains of a large cylindrical terracotta altar, measuring 50cm in diameter, which we discovered scattered in the northern area of Room 15 (fig. 14)²⁴. Nearly

the full circumference of its base was preserved, and the rim and upper body could also be substantially restored. The altar's decorative scheme features a cornice with dentils overhanging a Doric frieze, making it quite similar in appearance to the large terracotta altars found elsewhere at Morgantina, including in the House of Eupolemos and the North and South Sanctuaries²⁵. The large size of the altar, its relatively complete condition, and the fact that its fragments were found on a surface suggest that it was probably used not far from the concentration of fragments. We note that a circular pit filled with gray ash and charcoal lay just to the east of these altar fragments in the southern part of Room 10, which was not separated from Room 15 by any architectural feature. While the process leading to the formation of the pit is not known for certain, its proximity to the altar raises the possibility that it may have contained burnt refuse from sacrifices.

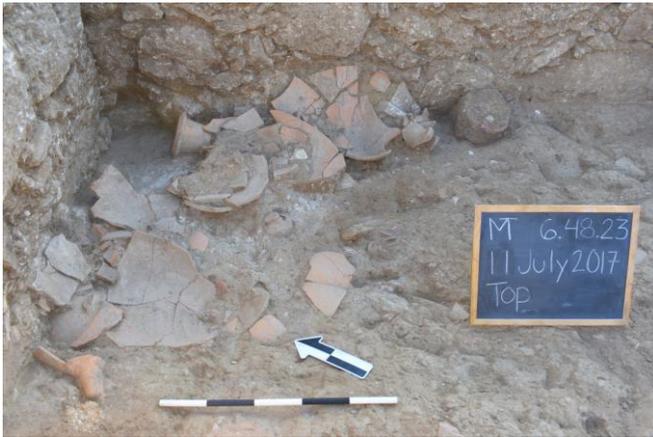
Fig. 20. Room 12b, looking east. Greco-Italic amphorae and cooking wares smashed against Phase 3 surface.

Immediately to the south of Room 11b, Trench 48 documented little substantial activity in Phase 3. Occupation is attested by several vessels found resting on the last surface of Room 12b, including the remains of four nearly complete Greco-Italic amphorae and a concentration of assorted cooking and dining vessels, which had been smashed in the northeast corner of the room (fig. 20). This concentration of vessels may be an indication that Room 12b served as a storeroom during this last major phase of occupation.

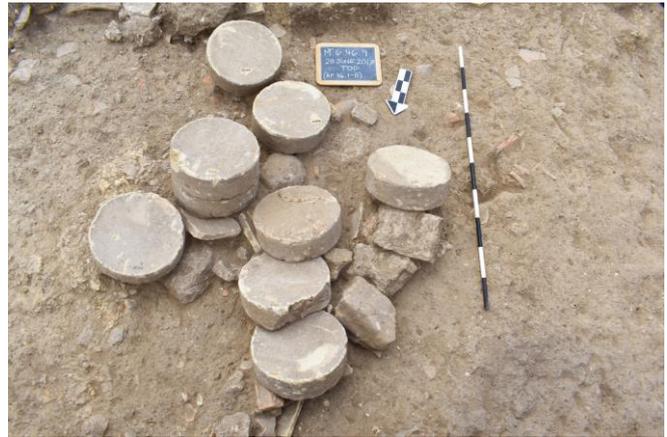
Fig. 21. Room 9, looking south. Terracotta column drums resting in situ on Phase 3 surface.

A toppled stack of nine terracotta column drums was also found at the eastern end of the corridor, resting on the Phase 3 surface (fig. 21). Their orientation suggests a collapse *in situ*. The addition of this small column may have lent heightened formality to the entranceway leading into the building’s courtyard. In this respect, the addition of the column follows on the modest monumentalization efforts attested elsewhere in the building during Phase 2.

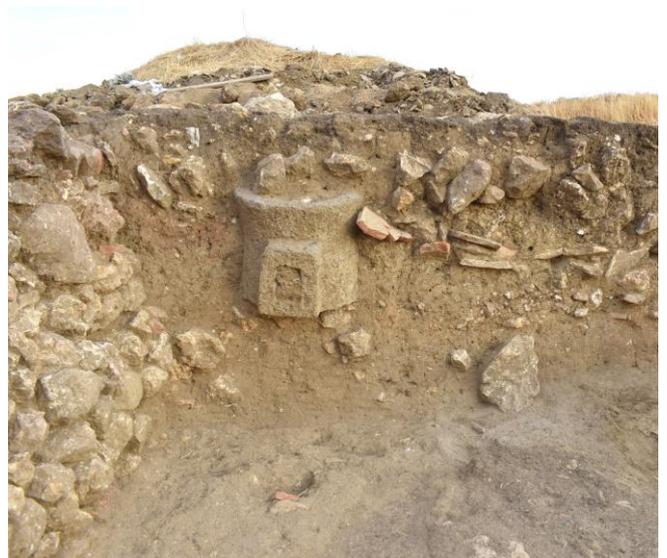
Fig. 22. Room 13, looking south. Catillus of a second Morgantina-type rotary millstone resting against the building's southern lot wall.

Finally, in Room 13, the *catillus* of a second Morgantina-type rotary millstone like that found in Room 11b was discovered resting on a beaten-earth surface against the building's southern lot wall (fig. 22). Much of Room 13 had been disturbed by modern activity, including excavations carried out in the early 1970s by Dr. Hugh Allen, but the southern- and easternmost portions of the room had remained untouched. The placement of the *catillus* in the room clearly predated the collapse of the building, as indicated by the layer of roof tiles and rubble that ran above the top of the millstone³⁵. This *catillus* was likely originally joined in Room 13 by a *meta* discovered in the neighboring House of

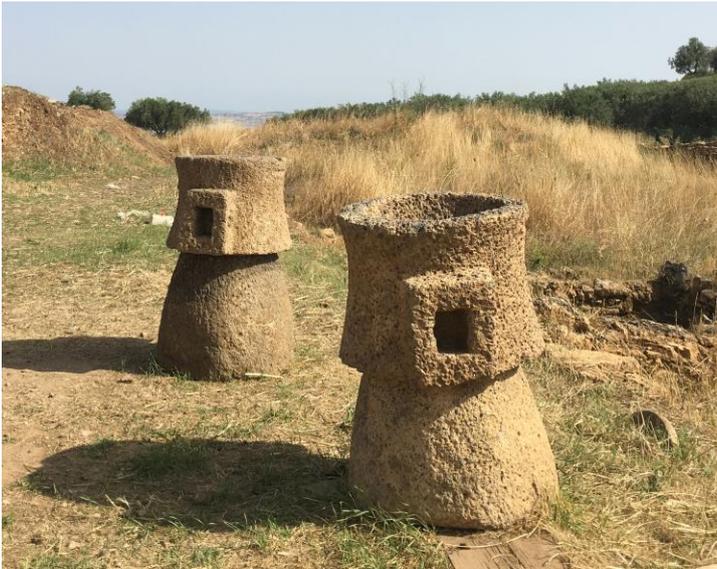
Fig. 23. Rotary millstones from Southeast Building. In foreground, catillus from Room 13 placed on top of meta found in the House of Two Skeletons in 2004; in background, catillus and meta from Room 11b.

the Two Skeletons in 2004³⁶. To test this hypothesis, we placed the *catillus* on top of the *meta*, and then traced a line around the point at which the two pieces met with a piece of chalk. Upon removing the *catillus*, we found that the wear pattern visible on the upper portion of the *meta* matched precisely with the area covered by the *catillus*, leaving us with little doubt that the two were used together in antiquity (fig. 23).

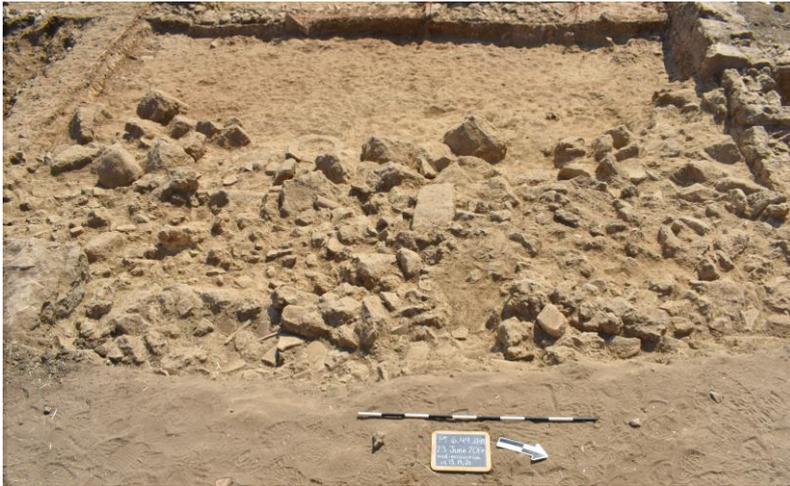
Fig. 24. Room 11b, looking west. In foreground, large masonry blocks and rubble from toppled eastern wall visible; across western half of room, the exposed layer of disintegrated rammed-earth walls is visible.

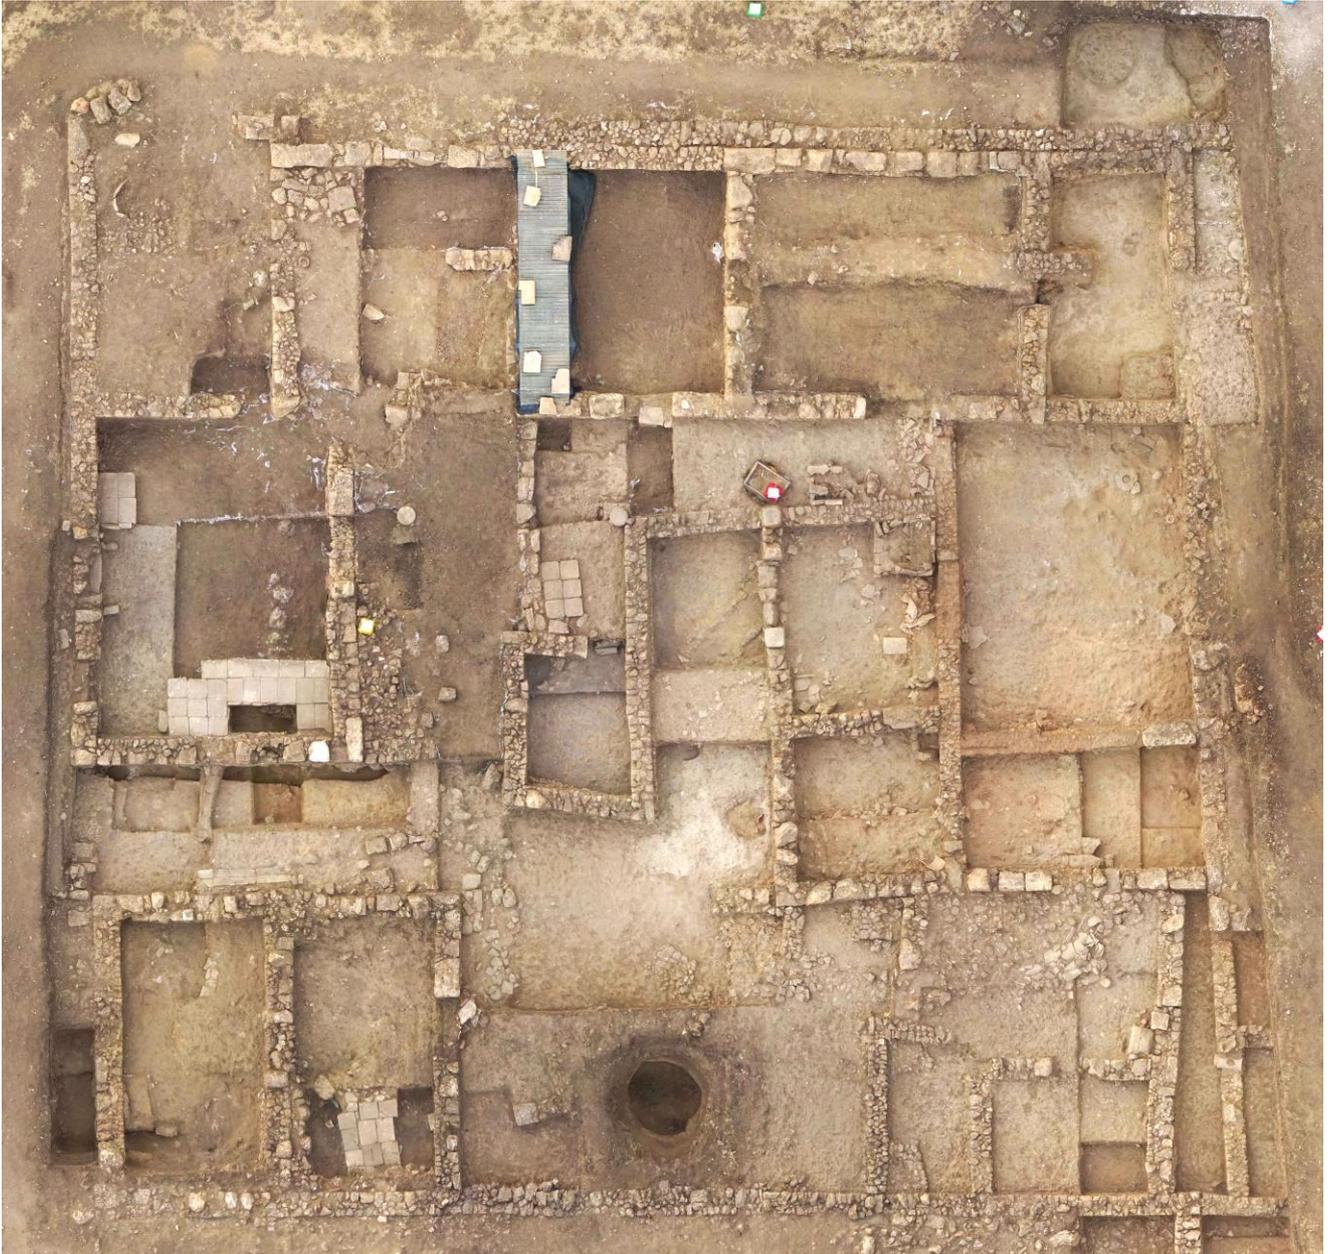
Fig. 26. Aerial orthophoto of the Southeast Building at the conclusion of the 2017 season.

By the close of the 2017 season we had finished defining the limits of the property, as nearly every room of the building was at least partially excavated (fig. 26). Nevertheless, some questions could not be directly addressed this season. Targeted excavations in the future could clarify the phasing of the western boundary wall, identify Phase 1 surfaces in the southern part of the building, resolve the relationship between the Southeast Building and the property to the east, and explore Room 1, which was exposed in previous seasons, but only partially excavated. Further excavations could also refine the absolute chronology of the construction, occupation, and abandonment of the Southeast Building.
