Preliminary Report on the 2018 Season of the American Excavations at Morgantina: Contrada Agnese Project (CAP)

In its sixth season, the American Excavations at Morgantina: Contrada Agnese Project (CAP) continued archaeological investigations inside the House of the Two Mills, a modestly-appointed house of Hellenistic date located near the western edge of the ancient city of Morgantina. This report gives a phase-by-phase summary of the significant discoveries from the 2018 excavation season, highlighting the architectural development of the building as well as evidence for the various activities that took place there over the course of its occupation.

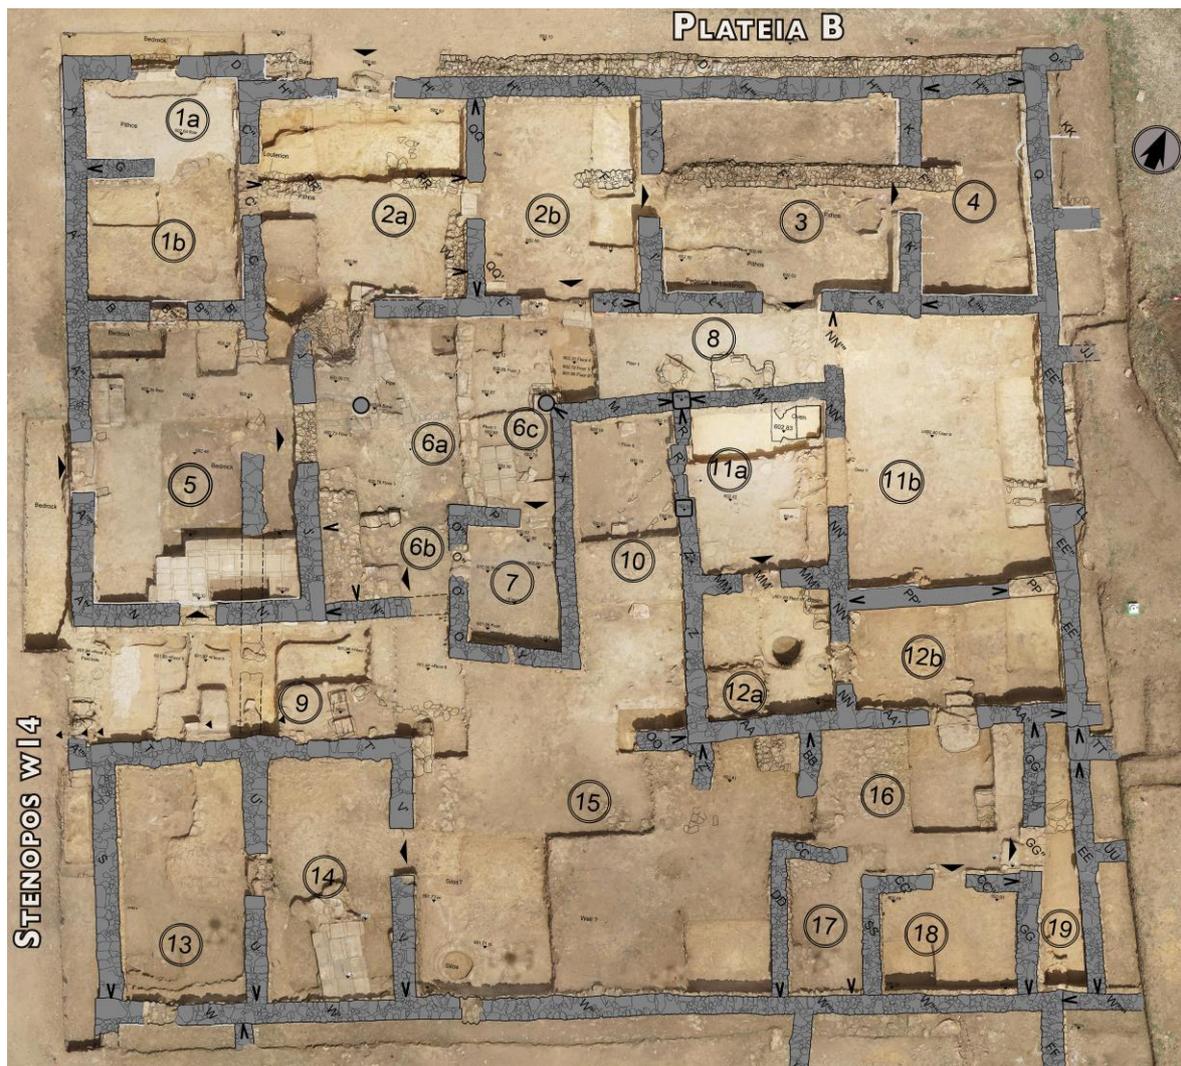
Fig. 1. Orthorectified aerial photo of the House of the Two Mills, with overlaid state plan, indicating room numbers and wall names. Drawing by G. Filantropi. Orthorectified photo by R. Gorham.

This account of the 2018 excavation follows the same system of room numbers and wall designations used in the report of the 2017 season (fig. 1). To aid in understanding the multiple occupation phases, we continue to include our internal seven-digit designations for stratigraphic units corresponding to floors².

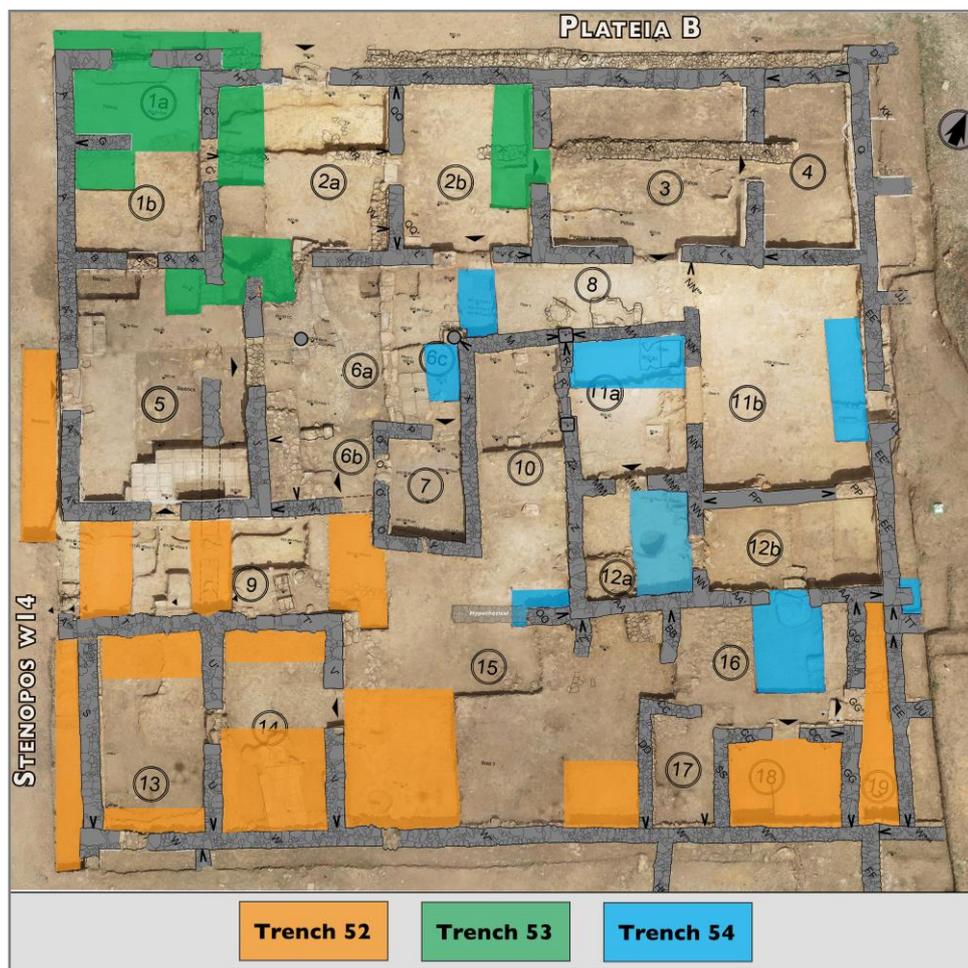
Fig. 2. Figure 1 modified to show locations of the 2018 trenches.

In 2018, our investigations extended over three broad areas of the building. These were selected with the aim of answering persistent questions about the stratigraphy, phasing, and architectural relationships between the rooms. Because the building's architectural footprint was already exposed at the start of the 2018 season and since most rooms had undergone some excavation in previous seasons, our work this season generally took the form of smaller, targeted *saggi* rather than large, open area trenches as in years past (fig. 2).

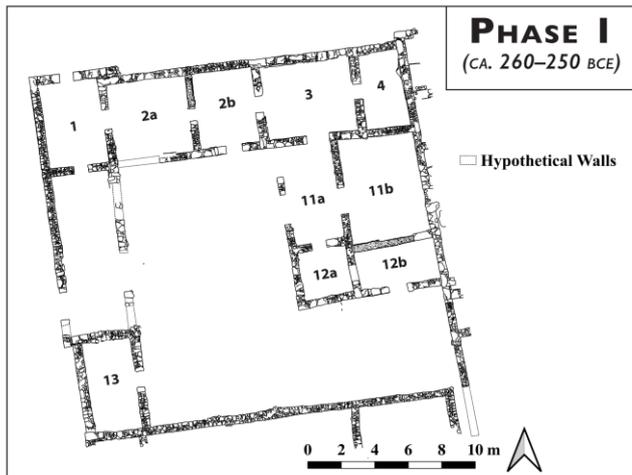
Fig. 4. State plans showing construction phases (1-3) in the House of the Two Mills. Drawing by G. Filantropi & J. Benton.

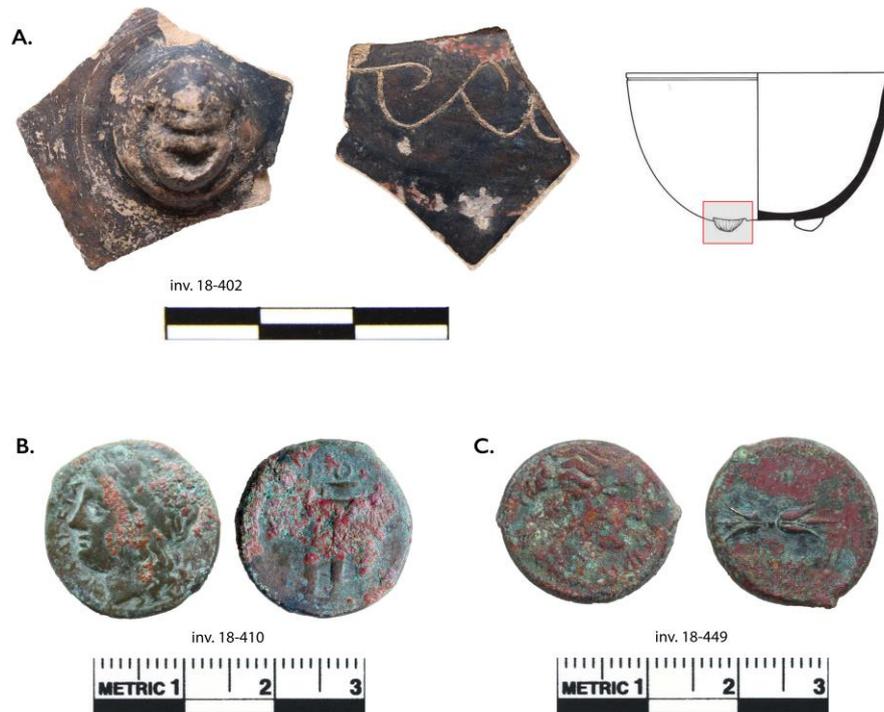
Fig. 5. A: Inv. 18-402. Fragment of a hemispherical bowl with molded feet from the fill below the Phase 1 floor in Room 1 and a profile of a similar vessel (drawing by S. Stone; see MS VI, pl. 4, 24B); B: Inv. 18-410. Bronze coin of Tauromenium also from the fill below Phase 1 floor in Room 1; C: Inv. 18-449. Bronze coin of Agathokles from matrix of Phase 1 floor surface in Room 2a.

The earliest surface associated with Room 1 was a crushed yellow bedrock aggregate (6053051), a composite material that was used for surfaces throughout the building in every phase. This floor was best-preserved in the southern half of the room. The diagnostic material recovered from the fill below the floor—including several bronze coins and part of a deep hemispherical cup with molded feet in the form of theatrical masks (fig. 5, A–B)—fits the proposed mid-

¹⁰ Three coins came from this fill, including two halved Syracusan bronzes of the “large-flan” Poseidon/Trident series (ca. 269-240 BCE; inv. 18-406 and 18-408; ref. MS II, no. 367) and one bronze of Tauromenium that was struck ca. 336-317 BCE (inv. 18-410. AE. 5.85g, 19.81mm, 2h; *Obv.* Head of Apollo l., laureate; at l. APXAGETA / *Rev.* [TAYPOM-ENITAN]; Tripod. Date: ca. 337-317 BCE. Ref. MS II, no. 401. Illustrated above.). The deep hemispherical cup with molded feet (inv. 18-402) is of a type well-represented at Morgantina (see MS VI, cat. no. 24E-F) and was also locally produced at the site; for the date of these vessels, see Stone’s discussion in MS VI 91-92.

¹¹ Inv. 18-449. AE. 8.34g, 20.78mm, 2h. Syracuse (under Agathokles). *Obv.* [ΣΩ]TEIPA, Bust of Artemis r. / *Rev.* [BAΣΙΛΕΟΣ] ΑΓΑΘΟΚΛΕΟΣ, winged thunderbolt. Date: ca. 304-290 BCE. Ref.: MS II, no. 328.

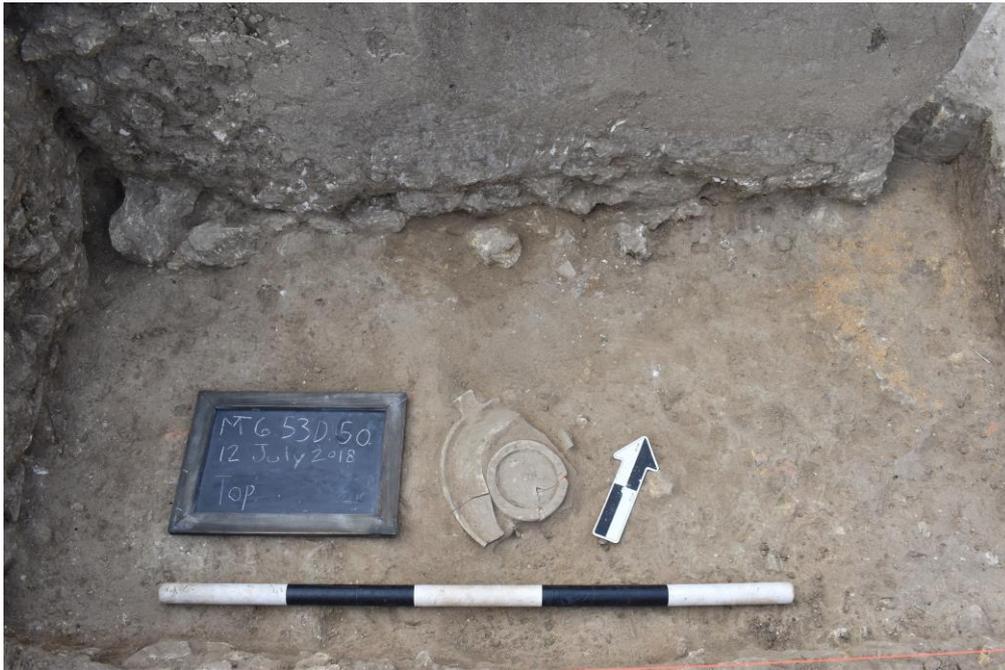
Fig. 6. Ceramic mortarium (P19-22) lying on the Phase 1 floor in Room 1.

third-century date for Phase 1¹⁰. Lying immediately above the Phase 1 surface was most of a ceramic mortarium (P19-22), also datable to the mid-3rd century BCE (fig. 6). Additional evidence for Phase 1 construction activity was encountered in Room 2a, where excavations reached the foundations of Wall H, the northern boundary of the property. A portion of the construction trench associated with Wall H was excavated, revealing that the foundations were set directly on cuts made into the bedrock (as observed in the abutting Wall D). Wall H was also bonded with the north-south wall that separated Rooms 1 and 2a (Wall C). A beaten-earth surface of hard-packed yellow brown soil (6053041) was laid down in Room 2a at this time; a Syracusan bronze *litra* of Agathoklean date (see Fig. 5, C; inv. 18-449; struck ca. 304-290 BCE) found embedded in the matrix of the surface supplies a *terminus post quem* of approximately 290 BCE¹¹. A contemporary surface, composed of the same hard-packed material as that used for the floor in Room 2a, was observed in Room 2b (6053016).

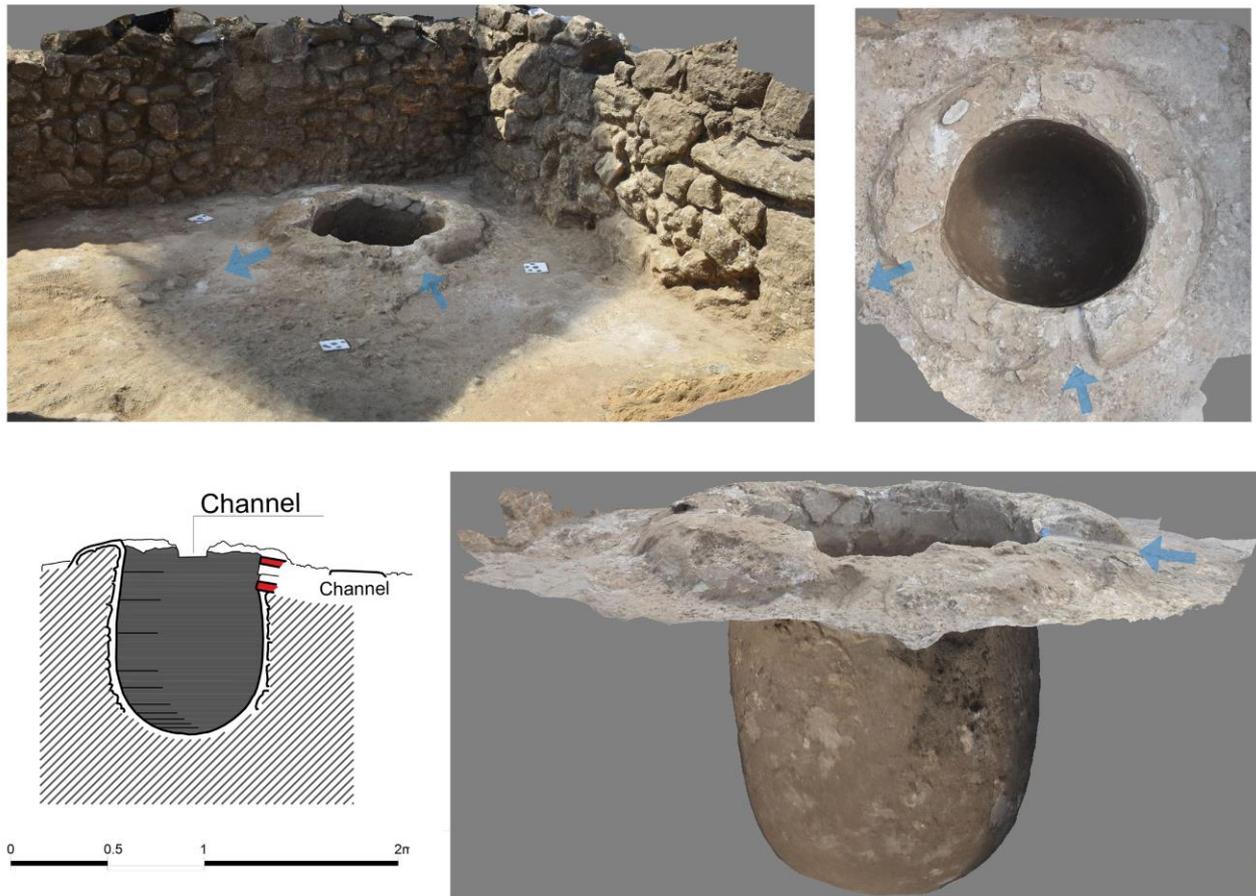
Fig. 7. 3D photogrammetric model (multiple views) and section drawing of the settling basin in the courtyard (Room 15). Blue arrows indicate the channels leading to and from the basin. Section drawing by G. Filantropi; models by R. Gorham.

¹⁴ The basin measures roughly 0.65m in diameter and .96m in depth with a depth of 0.88m below the lower lip of the outlet channel that ran off to the east.

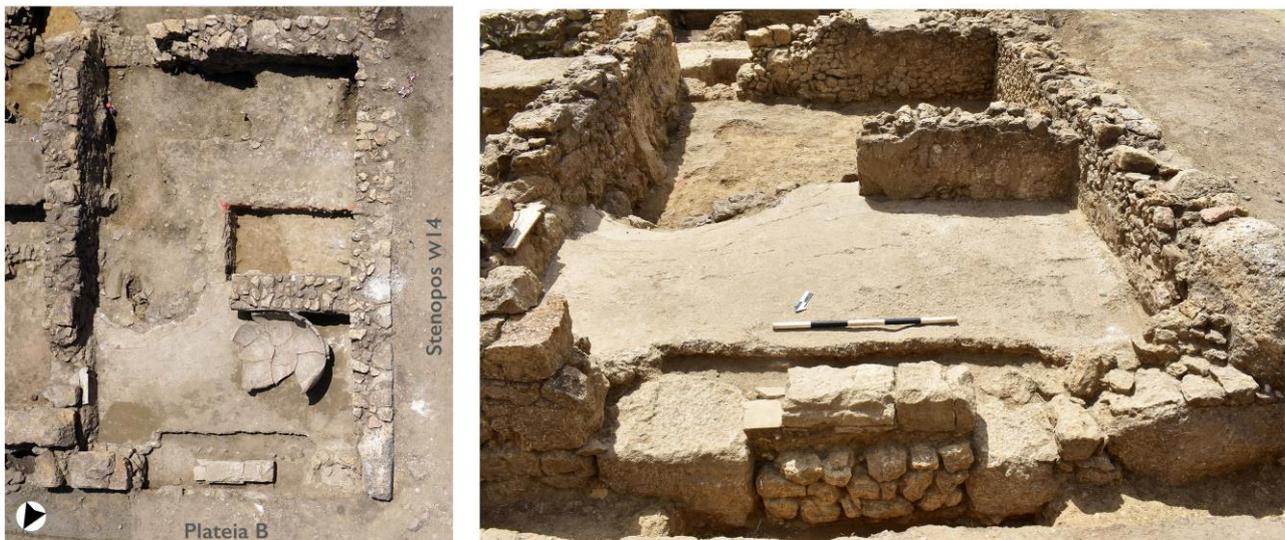
Fig. 8. Left: Aerial photo of Room 1 in Phase 2, when the room was divided into north (1a) and south (1b) spaces. The cocciopesto floor and remains of the pithos found in situ are visible. Right: Photo of Room 1 after we removed the remains of the pithos, looking south.

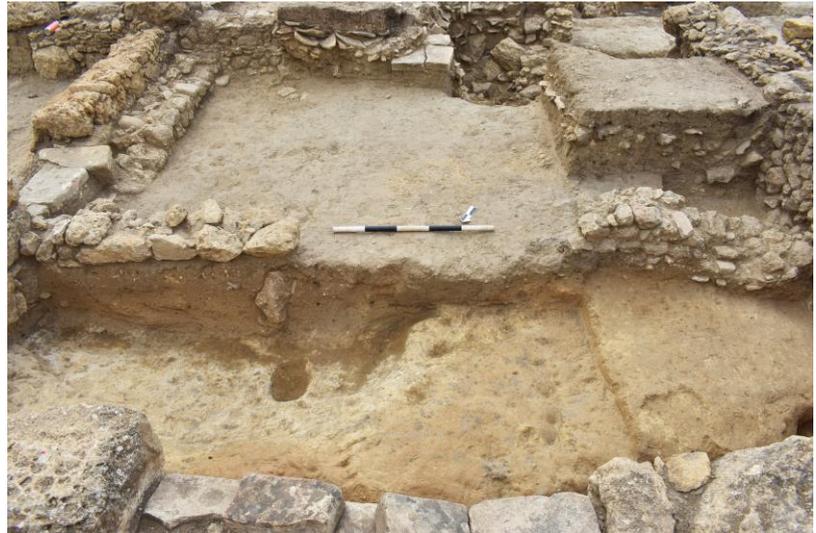
Fig. 9. Room 2a, looking south. The foundations of the two partition walls added in Phase 2 are visible in foreground on either side of the meter scale.

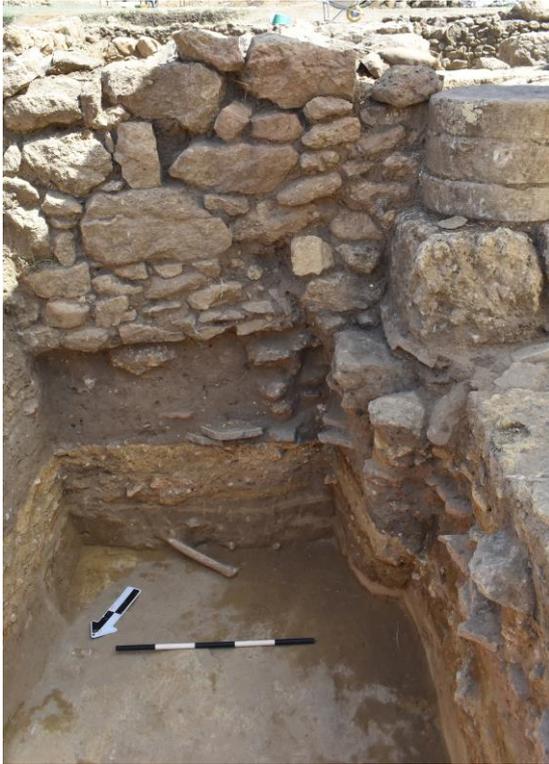
Fig. 10. Photograph of the section under Wall M exposed by Trench 54 saggio in Room 8, showing floor surfaces and column base construction, looking south.

This season's excavations also refined our understanding of developments in the center of the lot, as the house's open-air courtyard was gradually filled in by new construction. In Phase 2a, a new pavement was added over the northern area of the courtyard²¹. This floor (6054063) rested on a substantial fill that raised the courtyard's surface by about 30cm over the earlier Phase 1 levels. Our work in previous seasons had exposed the remains of a small portico that we believed was built along the north side of the courtyard in Phase 2b. The sequence of construction is visible in the section of a small *saggio*, centered on one of the portico's columns, that was first begun in 2016 and completed this season. We determined that a cut was indeed made in the Phase 2a floor to make space for the stone base on which the terracotta column drums were set; the cavity was then refilled with a rubble packing around its base. Finally, a new pavement of crushed bedrock aggregate (6043084) was added to bring the elevation of the floor surface flush with the top of the stone column base (fig. 10)²².

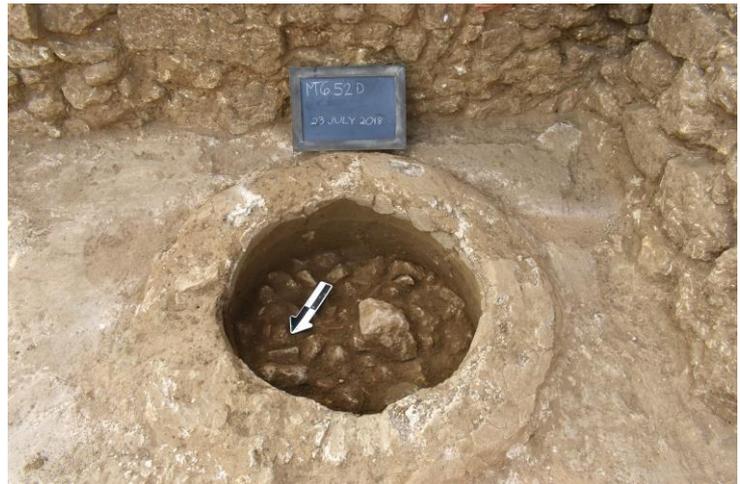
Fig. 11. Settling basin in the courtyard (Room 15) showing rubble packing inside, looking south.

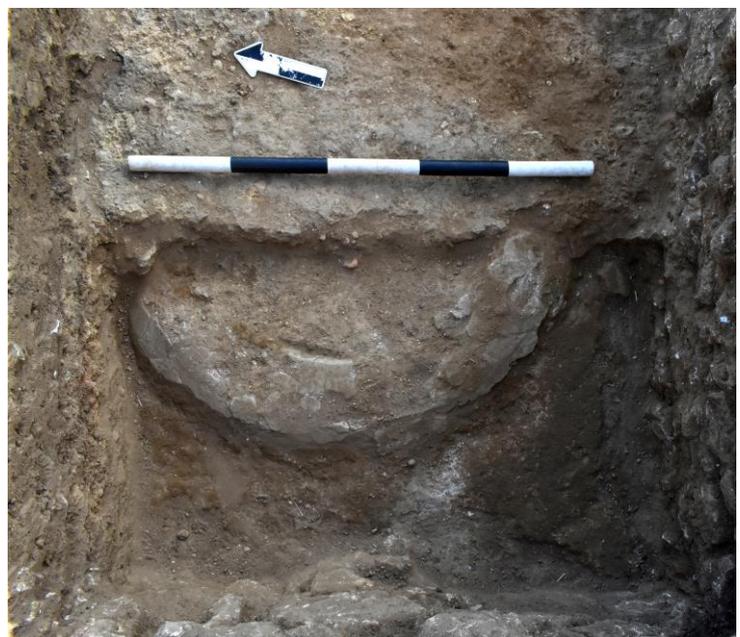
Fig. 12. Settling basin in the courtyard (Room 15), showing the Phase 2 floor effectively sealing off the feature, looking east.

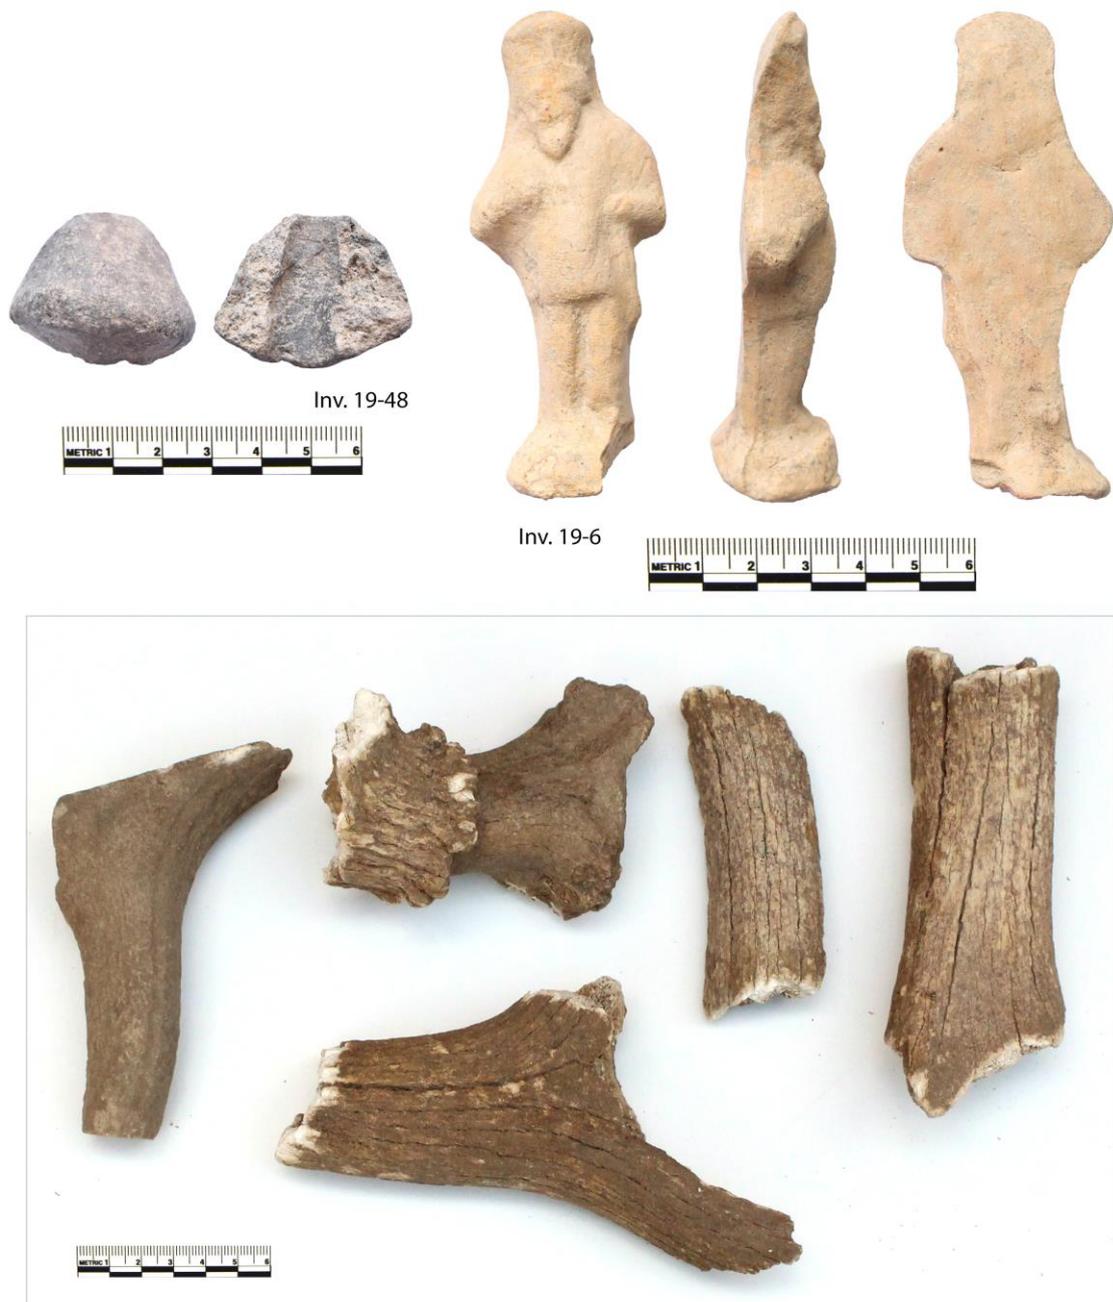
Fig. 13. Clockwise from upper left: fragmentary spindle whorl (inv. 19-48), terracotta figurine (inv. 19-6), and selection of deer antlers and bone, all recovered from the fill of the basin.

The southern portion of the courtyard (Room 15) was partially distinguished from the northern portion (Room 10) during Phase 2 by the addition of Wall OO²³. Here too, a substantial amount of fill was added over the earlier Phase 1 surface and a new pavement of crushed yellow bedrock aggregate was laid down²⁴. Once installed, the new Phase 2 surface completely covered over the settling basin in the southern courtyard. The basin itself was deliberately filled with large pieces of debris and was capped with rubble before the Phase 2 levelling fill and surface were added (figs. 11-12). Among the objects recovered from the basin were an intact unguentarium (inv. 19-9), half of a burned spindle whorl (inv. 19-48), several discoid loom weights (inv. 19-4, inv. 19-5, inv. 19-7, inv. 19-55), a fragment of a molded-lip kantharos (P19-38), a bronze coin struck at Syracuse during the reign of Agathokles (inv. 19-2), and an intact terracotta figurine in the form of a comic actor (inv. 19-6)²⁵. In addition, a large quantity of animal bone and deer antlers had been tossed inside (fig. 13).

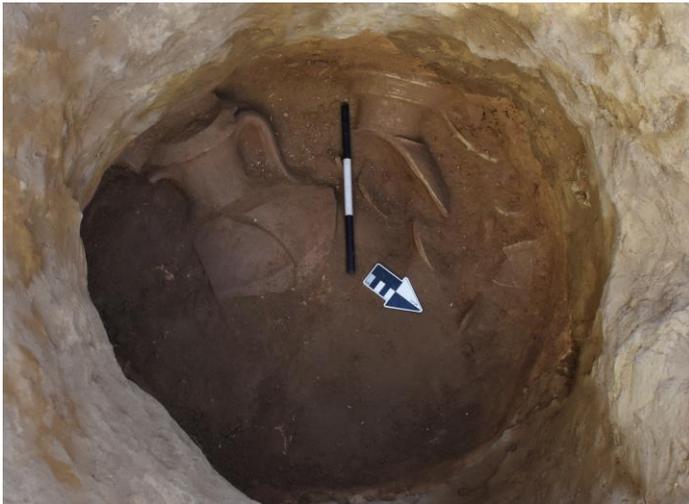
Fig. 14. Upper portion of a Greco-Italic amphora and the base of a Centuripe-ware lekanis resting in situ within the fill inside the rock-cut cistern or well in Room 12a.

In Room 12a, Phase 2 was characterized by the addition of a new beaten-earth floor (6054042, 6054023), which appears to have effectively covered over the cistern or well located in the center of the room. At this point in our excavations, we cannot yet determine whether the fill inside the cistern was deposited when this new floor was installed or if the feature had been backfilled long before the construction of the Phase 2 surface. In either case, the new floor permanently sealed off the feature. In 2018, our excavations inside the cistern stopped at a point roughly 130cm below its opening in the floor surface due to concerns for safety and timing. The fill inside the cut contained an array of artifacts, including a nearly-intact terracotta altar (inv. 18-448), a

disc-shaped lead weight (inv. 18-466), an intact miniature terracotta bowl (inv. 18-537), and a Syracusan bronze coin that was struck during the time of Hiketas (ca. 287-278 BCE; inv. 18-509)²⁶. The fill also contained a fair amount of building material (principally roof tiles) and ceramics, including two nearly complete Greco-Italic amphorae and the better part of a Centuripe-ware *lekanis* or *krater* (fig. 14)²⁷. The good condition of the terracotta altar, the amphorae, and other ceramic materials suggests that, like the fill of the settling basin in the courtyard, this material was purposefully deposited in order to close up the open cavity.

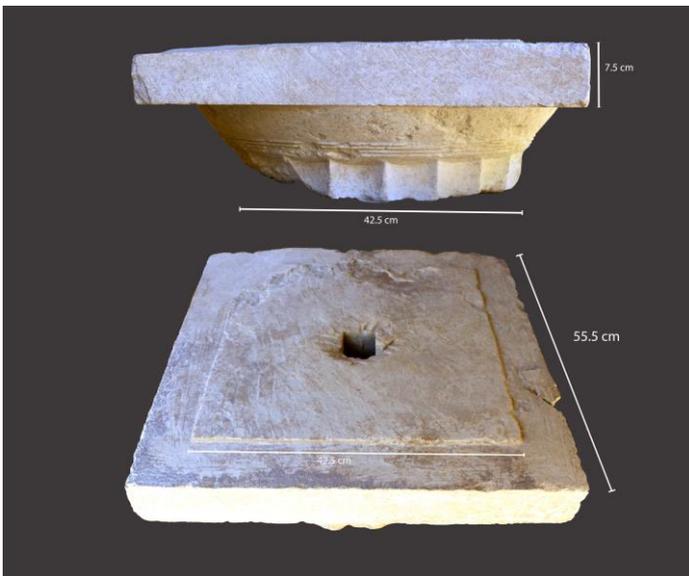
Fig. 15. Photos of the Doric column capital (AF54-5) found in Room 12a.

Certainly, the most striking discovery associated with the Phase 2 renovations in Room 12a was a large Doric column capital carved of a light fine-grained limestone. The capital was found upside down and embedded in the soil that formed the new floor surface of the room (fig. 15). With a shaft diameter of 42.5 cm, the capital might have originally sat atop one of the columns formed of terracotta discs found inside the house. Those found toppled in Room 6, for instance, have a diameter of 35 cm²⁸. A plaster casing for the terracotta drums that was molded in the form of fluting—fragments of which were found inside the house—might easily have made up for the difference in diameter. Why this capital had been seemingly tucked away inside one of the smaller, interior rooms of the House of the Two Mills is an open question. Perhaps the occupants of the house planned for another round of renovations and so removed this large capital block to keep it safe, or perhaps they acquired it solely for its bulk. One hint of the capital's potential function within the house is the visible pattern of wear along the upper edge of the abacus, which suggests that it had been used as a stepping stone

or threshold block for some period of time. Its location in the room may further corroborate this hypothesis, since it was found in close alignment with what we believe to have been a doorway added in this phase between Rooms 12a and 12b. The doorway between Rooms 12a and 11a appears to have been filled in during this period, closing off access between the two spaces.

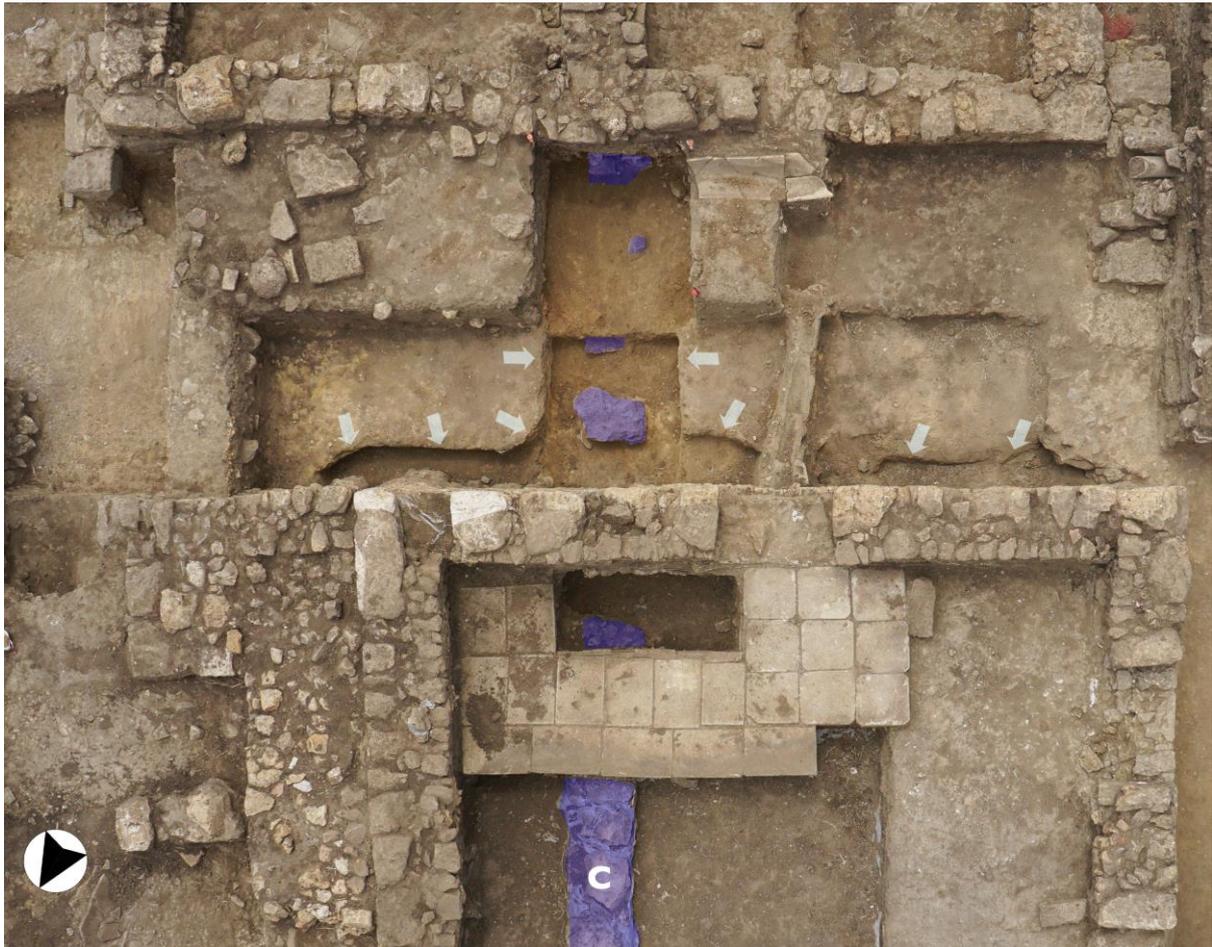
Fig. 16. Aerial photograph of Room 9 showing cuts through Phase 1 floor (indicated by arrows) for the demolition of Wall C, the remains of which are highlighted in purple, and for the construction of Wall N.

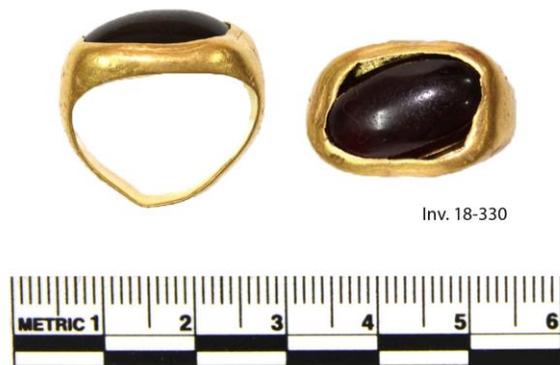
Fig. 17. Gold finger ring with a cabochon cut gemstone (inv. 18-330).

gio was opened in Room 5 in order to reveal a section of Wall B by removing an undisturbed portion of the pavement's subsurface fill. In this stratum we discovered a gold ring with a cabochon cut gemstone of deep red hue, probably garnet, in the bezel (fig. 17; inv. 18-330). This is without a doubt the most valuable artifact recovered from the House of the Two Mills, where the objects are typically of poorer materials and workmanship than artifacts discovered in the more elite houses at Morgantina. In fact, a very similar ring was found inside the so-called House of Ganymede, one of the better-appointed houses on the East Hill, during excavations in 1959³¹. We can only speculate as to why an object of such great value was buried in Room 5. While accidental loss cannot be ruled out, it may be that the ring was buried for safe keeping around the time of the Roman assault on the city in 211 BCE and simply never recovered by its owner. In such a scenario, the ring's owner would have pried up one of the bricks in the pavement, which we believe extended across the entirety of Room 5 in Phases 2 and 3, and then buried the ring in a shallow cut, replacing the brick after stashing the precious object. It would certainly not be the first such object of value seemingly hoarded prior to the Roman assault of 211 BCE³². Moreover, such a scenario would account for how the ring ended up near the top of the subfloor fill, not necessarily where one might expect to find such a valuable object.

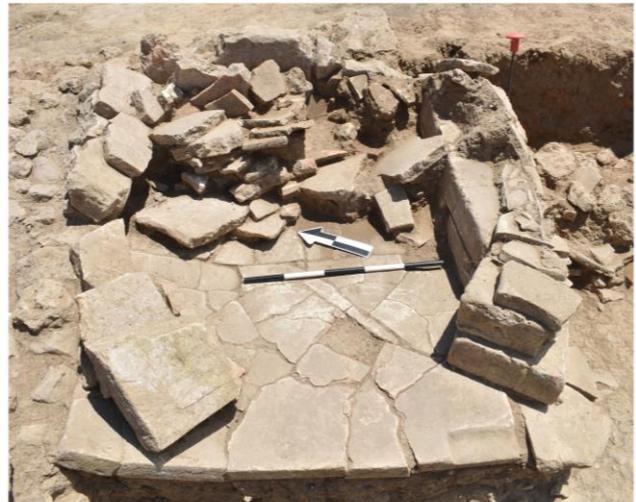
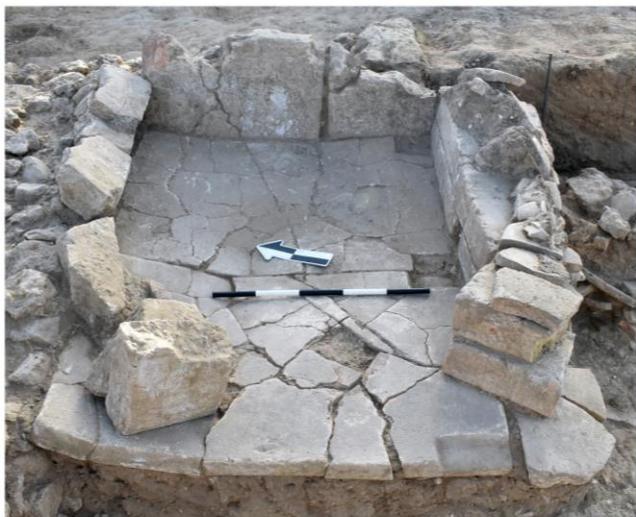
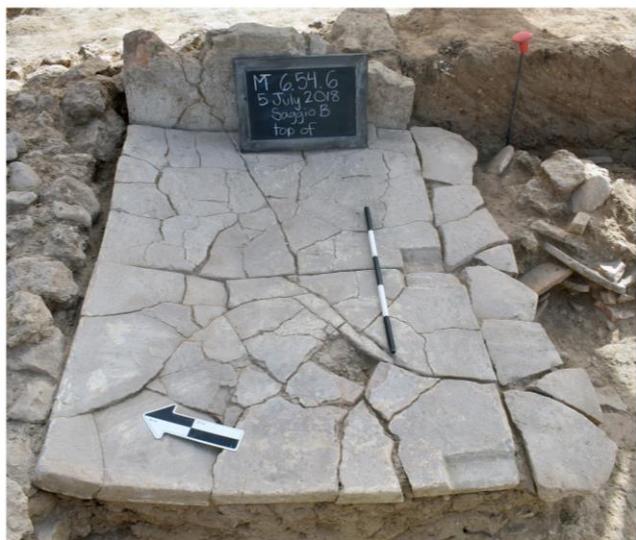
Fig. 18. Photos of the oven in Room 11a taken in progressive stages of excavation to show details of its construction.

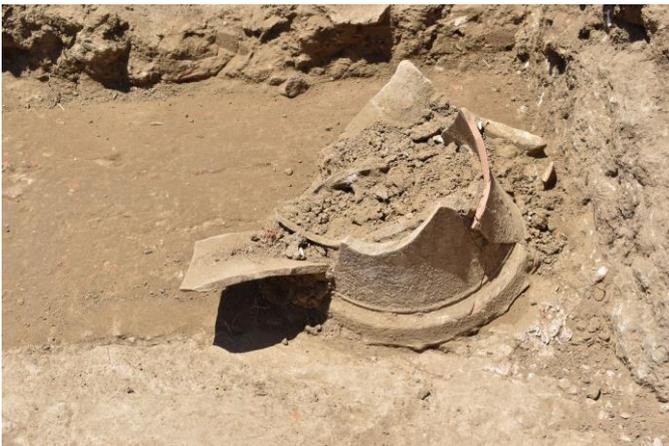
Fig. 19. Terracotta altar base (inv. 18-130) standing on cocciopesto pavement, mid-excavation, in Room 1a.

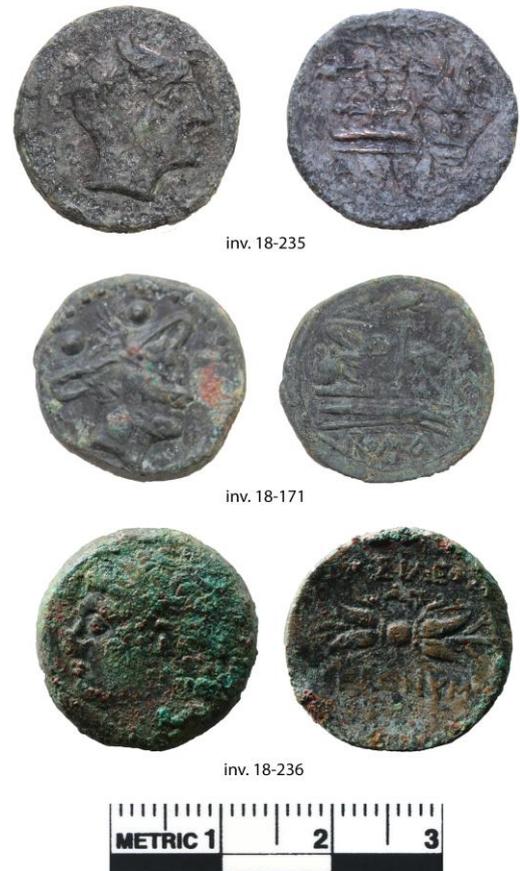
Fig. 20. Coins found on and in the soil immediately above *cocciopesto* pavement in Room 1a (from top: inv. 18-171, inv. 18-235, inv. 18-236).

³⁷ All three of the Roman coins are *sextantes* (RRC 69/6) bearing the types, *Obv.* Head of Mercury r. / *Rev.* Prow r.; above, corner; below, ROMA; at right, KA or IC or C. At least two of these coins (inv. 18-171 and inv. 18-423), possibly all three, appear to be overstruck on Poseidon/Trident coins issued by Hieron II.

³⁸ Inv. 18-236. AE. 8.35g, 21.14mm, 9h. *Obv.* Head of Hieronymos I., wearing diadem. / *Rev.* ΒΑΣΙΛΕΟΣ [Ι]ΕΡΩΝΥΜΟ[Υ]; Winged thunderbolt; above ΑΠ or ΑΓ. Date: 215-214 BCE. Ref. MS II 370 and, for further discussion, see HOLLOWAY 1969.

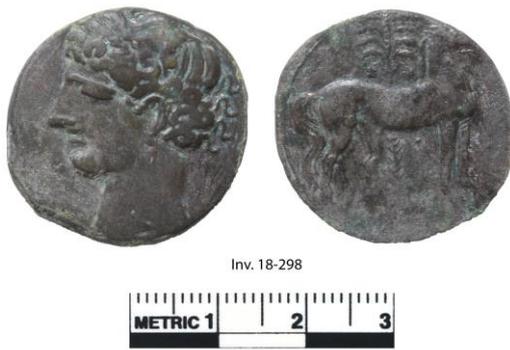
Fig. 21. Billon coin struck by a Carthaginian mint during the Second Punic War (inv. 18-298).

and large pot sherds, including some semi-intact vessels. Nearly a dozen bronze coins were also recovered from this context; these were mostly large bronzes of Hieron II of the Hieron/Horseman series. One coin, however, that stands out from this group is a silver-and-copper billon tridrachm that was struck at Carthage during the Second Punic War (inv. 18-298; fig. 21)³⁹. As far as we can tell, this is the first such coin discovered in Sicily through controlled archaeological excavation. Among the other noteworthy finds from this debris layer in Room 12a was a miniature ivory figurine of apparently Egyptian or Egyptianizing style (fig. 22). The subject of this tiny object appears to be a deity with a crown on their head, whose identity remains uncertain⁴⁰.

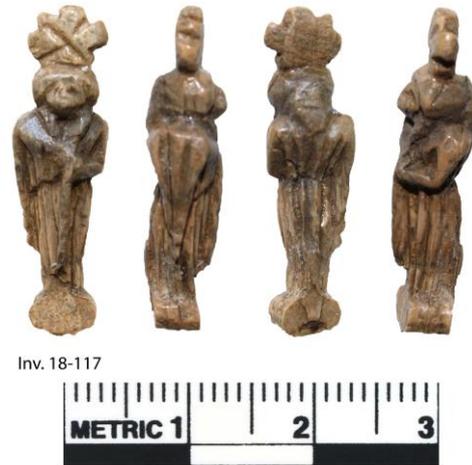
Fig. 22. Miniature ivory figurine of a goddess carved in an Egyptian or Egyptianizing style (inv. 18-117).

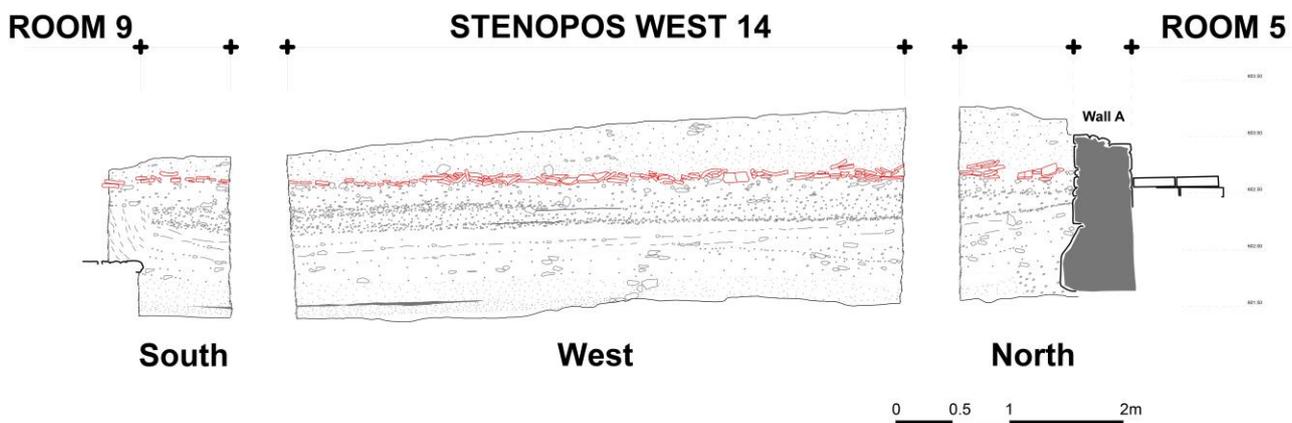
Morgantina, CAP 2018
2018 VI.14 - Section 3/18

Fig. 23. Section drawing through Stenopos W14 from the Trench 52 saggio, with tile fall layer in red. Drawing by G. Filantropi.

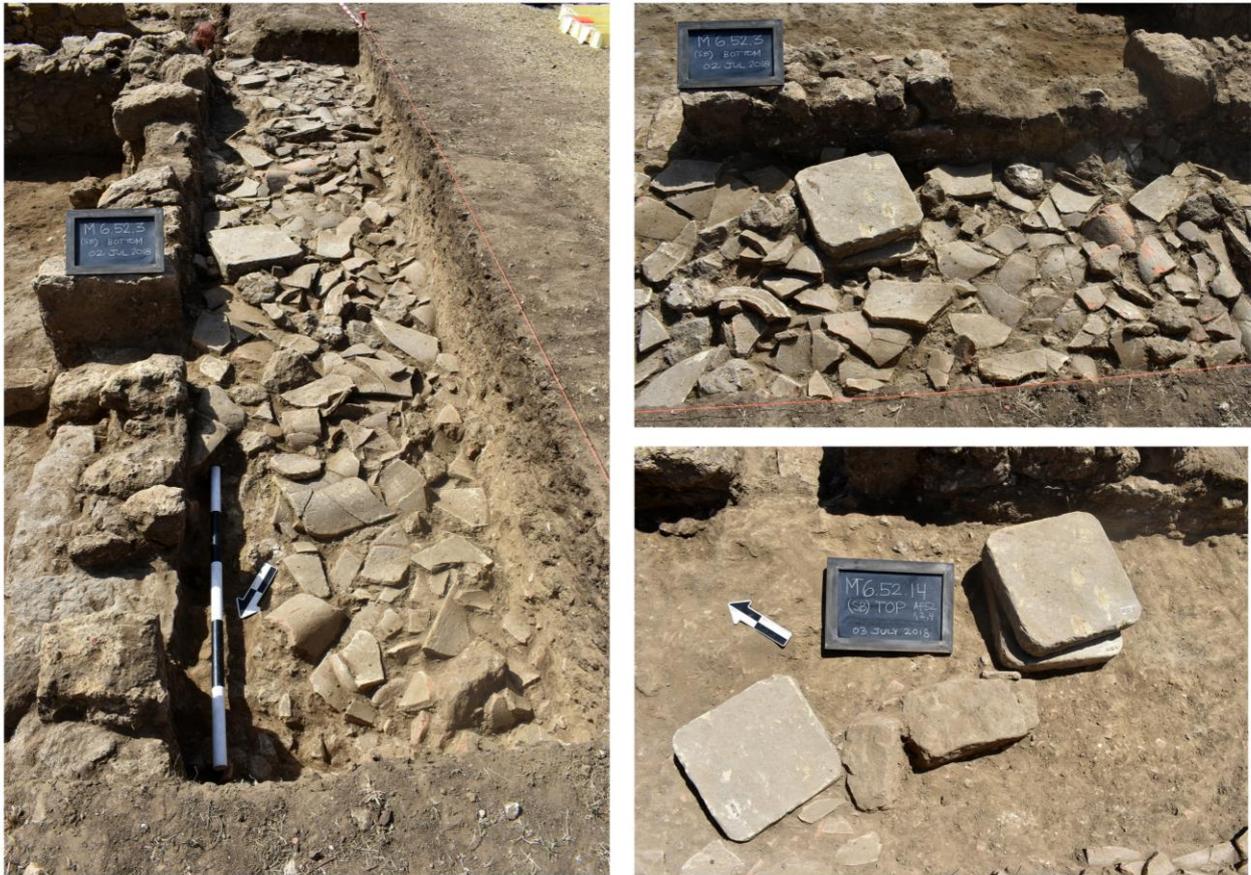
Fig. 24. Views of Stenopos W14. Left: layer of roof tiles and debris covering the surface of the street, looking south; upper right: same layer, looking east; lower right: bricks resting on the Phase 3 surface of Stenopos W14, looking east.

those used for pavements in the house (fig. 24). The presence of these bricks scattered in the street immediately outside of the building accords with our hypothesis that architectural materials from the house were being spoliated during this abandonment period. These may have come from Room 5, on the other side of the wall immediately to the east, where identical bricks formed the Phase 2 pavement⁴¹.

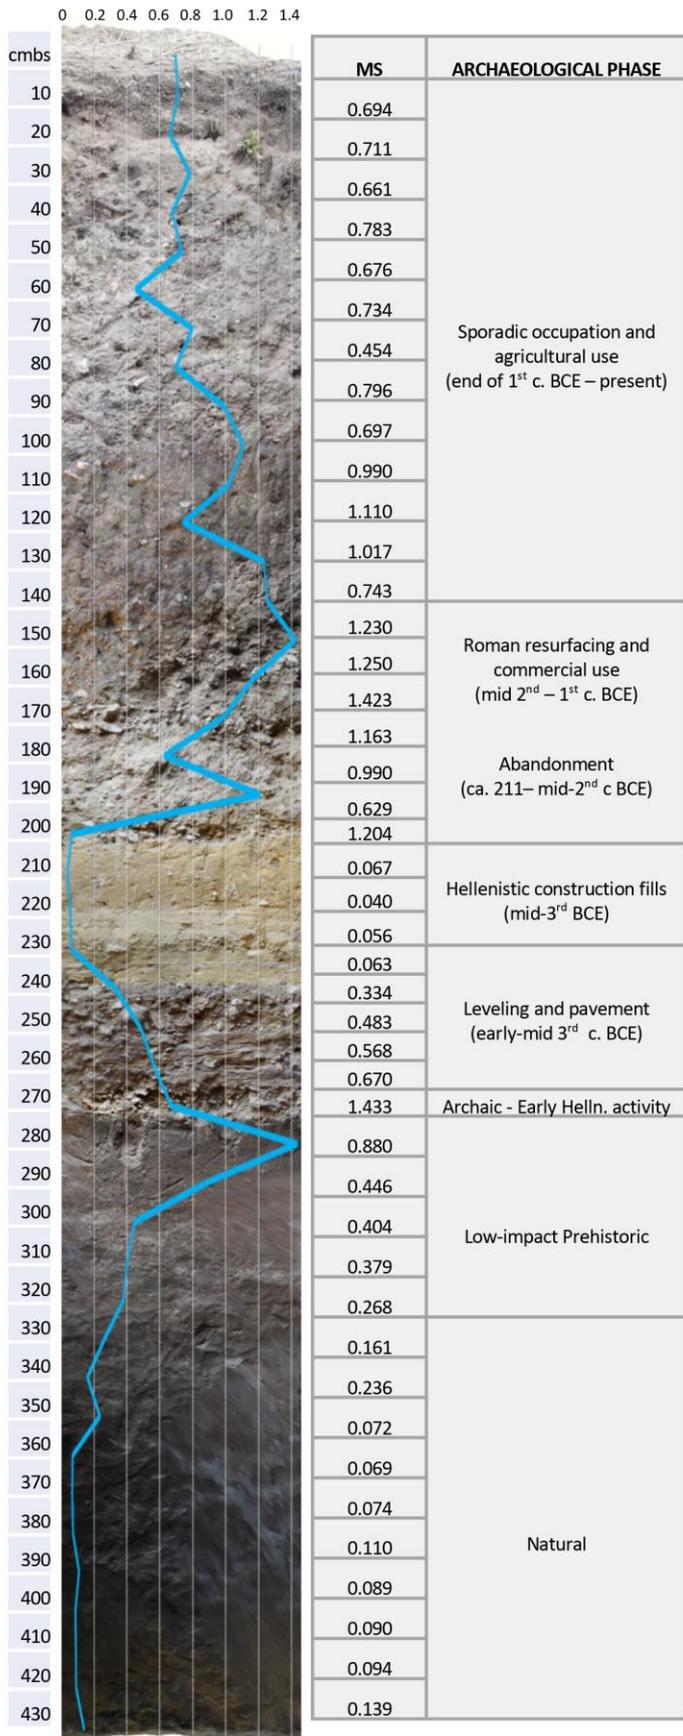
Fig. 25. Magnetic susceptibility readings taken in 2018 projected over the east profile of Trench I.151.

magnetic susceptibility readings peaked in later strata that we have linked with activity in the Roman-era *macellum* (fig. 25). Allowing for natural variations across soil and sediment types, elevated phosphates are indicative of intentional (e.g., manuring) or unintentional (e.g., waste disposal) human interventions, while relatively higher magnetic susceptibility functions are a general index of anthropogenic disturbance through burning, industrial activities, and other forms of land-use. Both remained high in the dark matrix above, a buried soil that corresponds to the use of the agora valley for agriculture from late antiquity through the early modern period⁴⁴. Measuring phosphates and magnetic susceptibility has a long history of use in archaeological fieldwork as a quick and inexpensive means of assessing human impacts to sediments. At Morgantina, they confirm that human activity in the agora valley continued long after the abandonment of the ancient city.
