Excavations at the so-called Villa di Tito, Castel Sant'Angelo (RI), May to June, 2022

Martin Beckmann - Myles McCallum - Matthew Munro -
Rebecca Payne - Simone Nardelli

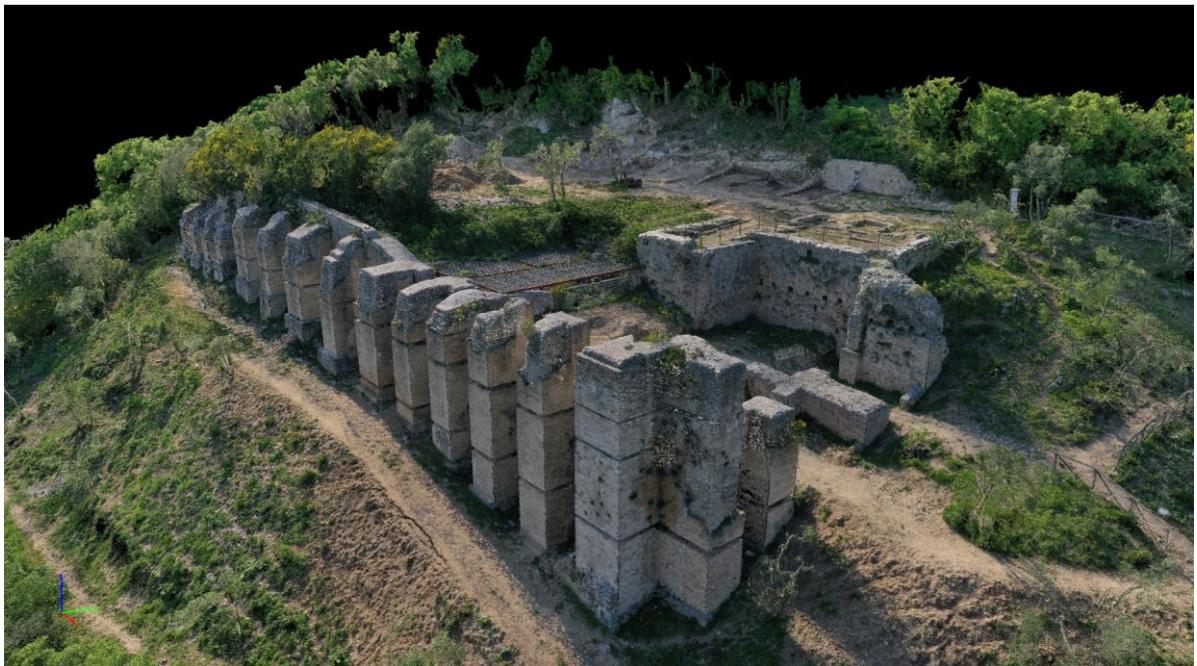
Fig. 3. Drone photomosaic of the Villa of Titus seen from the southeast. Greg Baker, Saint Mary's University.

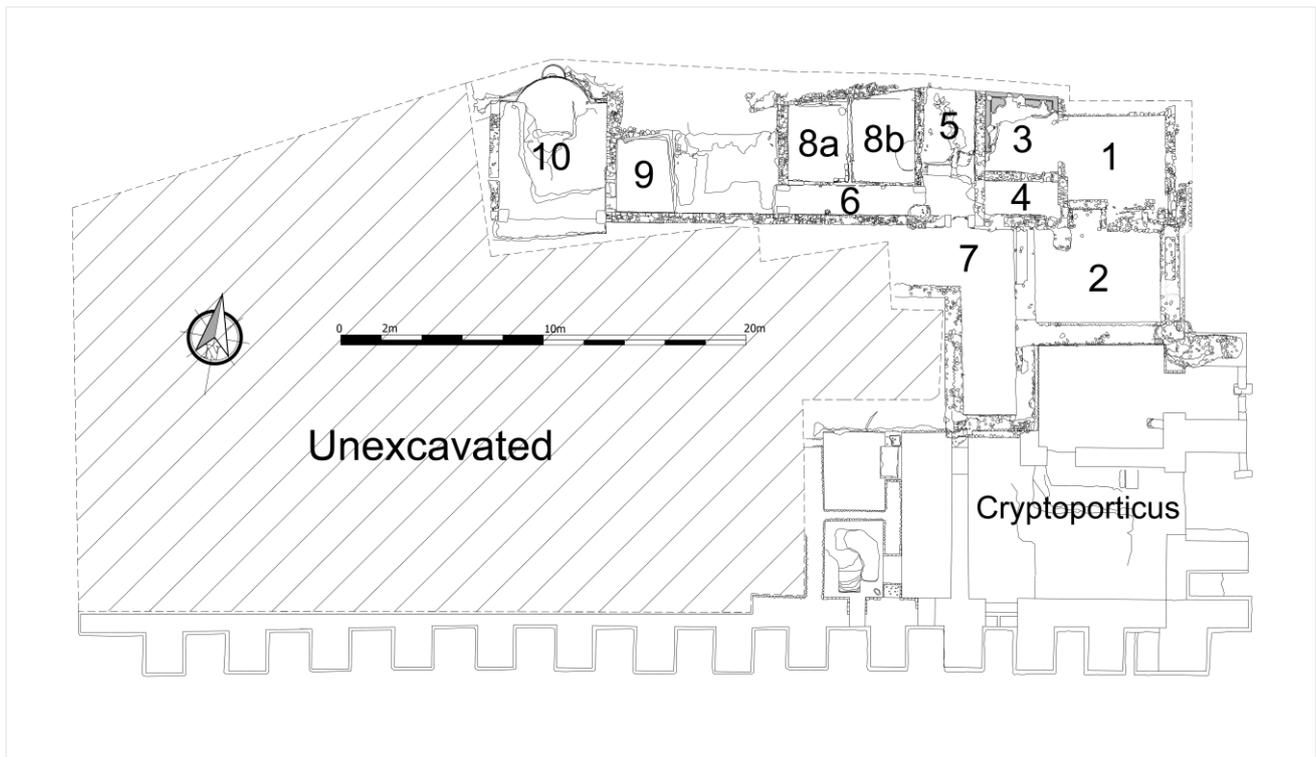
Fig. 4. Plan, Villa of Titus excavations, 2022, with room numbers indicated. Plan courtesy of Marco di Lieto, independent researcher, and Matthew Munro, University of Calgary.

ed by the building techniques employed and the decorative elements. These excavations uncovered a series of rooms (Rooms 1-7 in our plan below, fig. 4, and fig. 5) in the northeastern corner of the terrace, one of which, Room 3, has a geometric black-and-white mosaic, the creation of which can be related to the building renovation program mentioned above. GPR surveys conducted by Piro and Zamuner in 2010/2011 revealed the presence of an apse within the structure, which roughly corresponds to the one excavated in 2018 and 2019 (our room 10) and identified at least one large building in an olive grove located northeast of the structure⁴.

Room 6 (figs. 4, 5 and 7) is a long (18 m) east-west corridor, 1.5 m wide, that begins in front of Room 5 and runs west past Room 8 to Room 9, linking these three rooms, before ending at Room 10. The corridor appears to have once given access to Room 10, but the entrance had been blocked (see discussion of Room 10, below). The part of Room 6 in front of Room 5 and a portion of Room 8 was excavated to its floor level in 2019. The floor was revealed to be plain, waterproof concrete. Large rectangular stones were set into this floor in pairs where the corridor passed between the rooms, perhaps as bases for wooden door jambs (see discussion of Room 10). It may also be that for some part of its length, this corridor, in particular to the immediate east of Room 10 where it skirts the southern edge of Room 9, functioned as a portico, which opened onto a courtyard or peristyle to its south. Further excavation is necessary to confirm this.

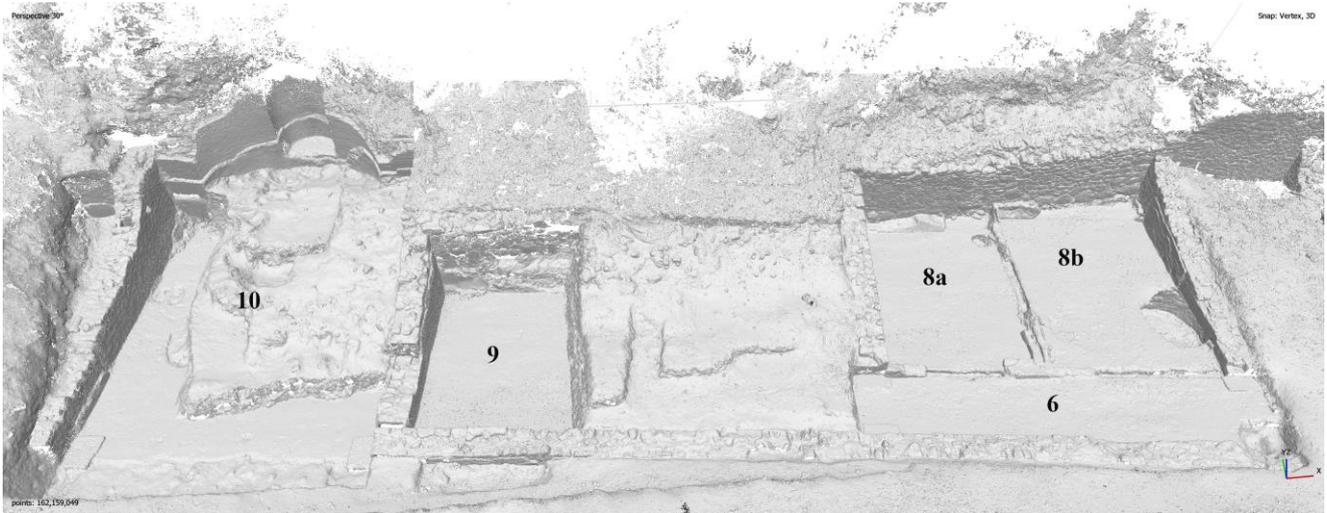
Fig. 5. 3D model of 2022 excavations, Rooms 8 to 10. Model courtesy of Marco di Lieto, independent researcher.

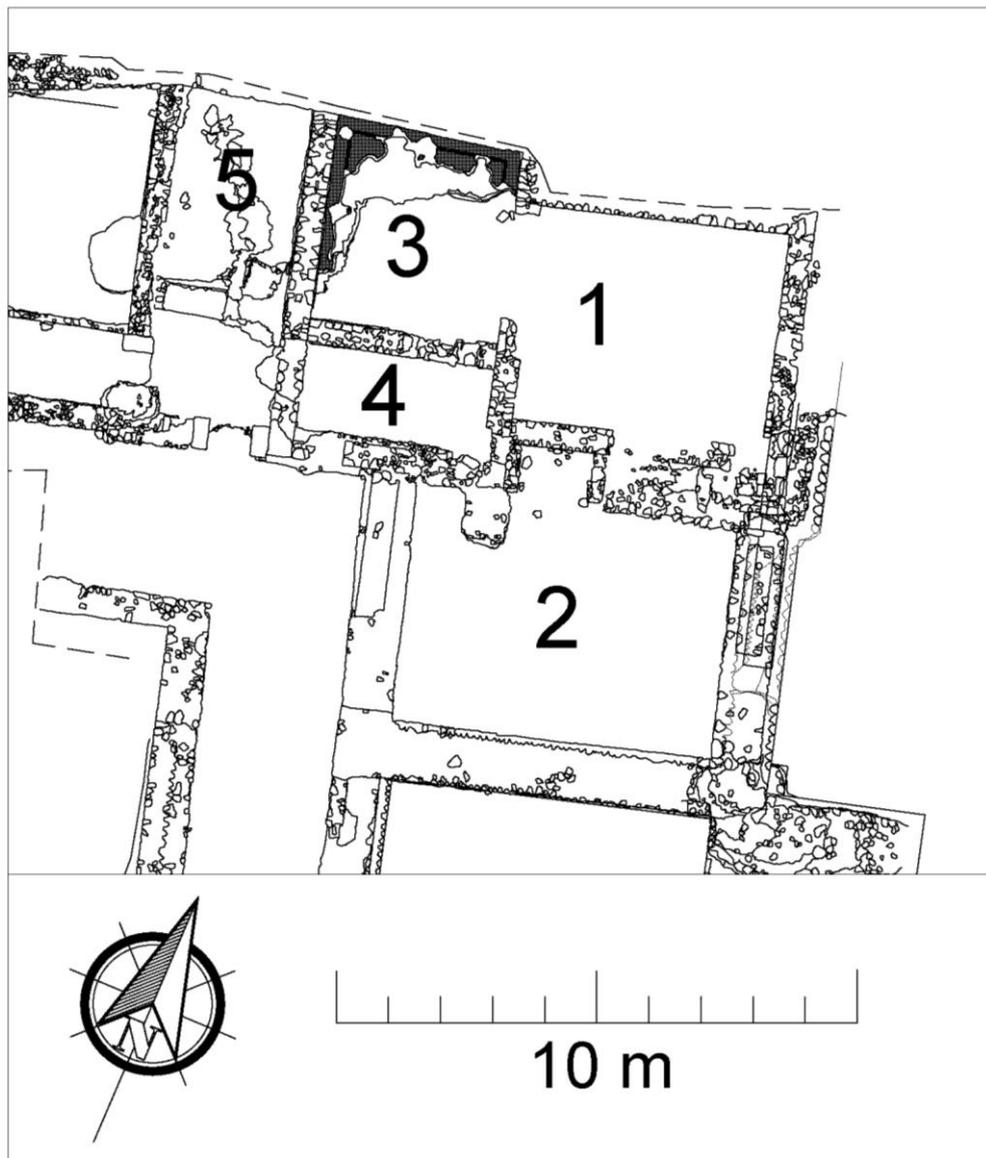
Fig. 6. Plan showing Rooms 1 through 5, Villa of Titus, 2022. Plan courtesy of Matthew Munro, University of Calgary.

Rooms 1 to 5 (fig. 6) were excavated by Alvino in 2011 and appear to be a series of spaces giving access to the rear areas of the terrace from the east. Room 3 contains a damaged black and white mosaic which we cleaned, conserved and re-buried under a layer of protective material in 2018. Room 5 was excavated in 2019 and proved to contain a sub-floor leveling layer with pottery and coins dating to (and not later than) the mid-1st century CE.

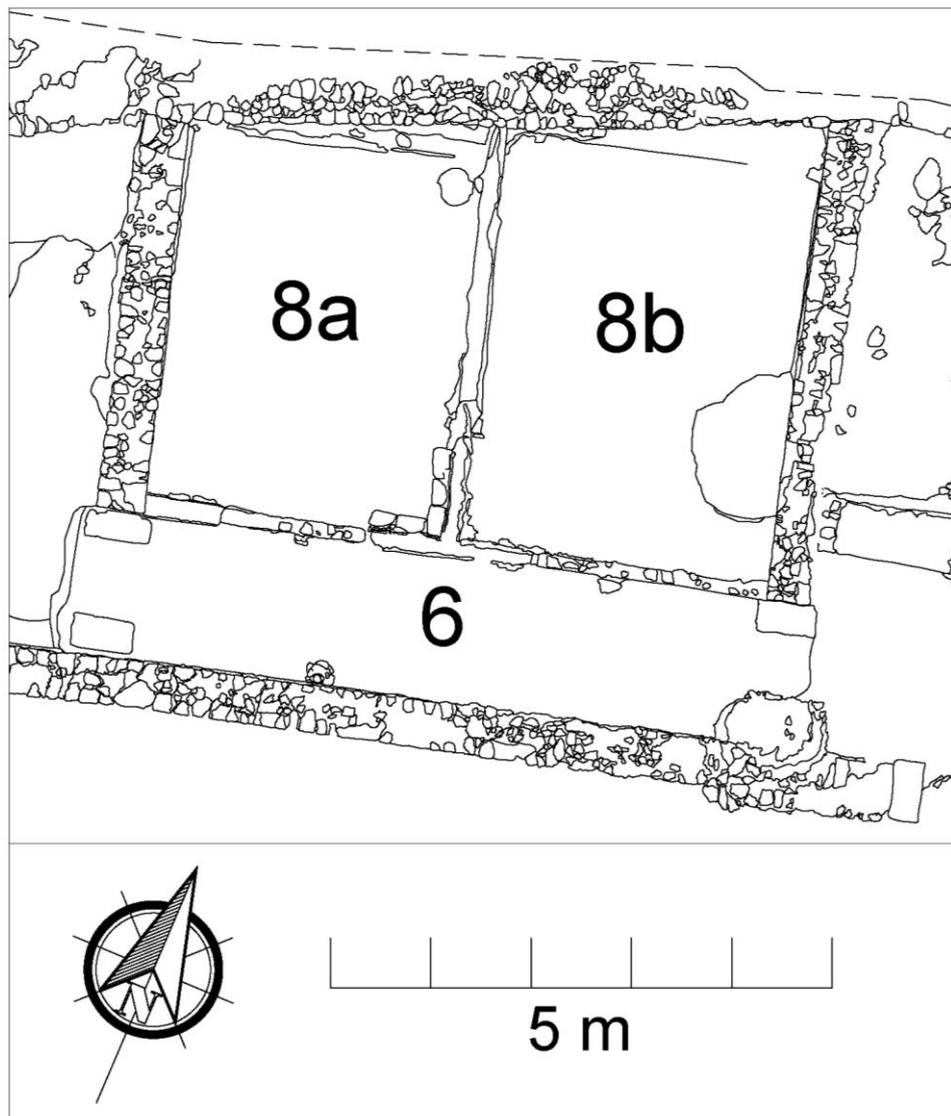
Fig. 7. Plan of Rooms 8a, 8b, and corridor 6, Villa of Titus. Plan courtesy of Matthew Munro, University of Calgary.

Room 8 (figs 7 and 8) lies north of corridor Room 6, between Rooms 5 (to the east) and 9 (to the west). Room 8 is a large, irregularly shaped space measuring 6 meters wide. The rear (north) wall is not at right angles to the west and east walls, forming a room that is deeper in the east than in the west (4.6 m vs. 4 m). It is possible that the north wall was constructed at this unusual angle because it follows the line of the natural bedrock behind it. Excavation of Room 8 began in 2018, when a large amount of colluvium and a number of fragments of collapsed concrete and stone masonry, including three very large pieces, were removed. Excavation in 2019 reached the floor in a 1x1m sondage in the NW corner of Room 8. This revealed several layers of plaster collapse above a plain concrete floor, with a modest number of ceramic finds. It also revealed a gap between the plaster on the westernmost N-S wall within Room 8 and the long E-W wall lining the natural rock forming the Room's northern limit, which is discussed in more detail below based on our results from 2022.

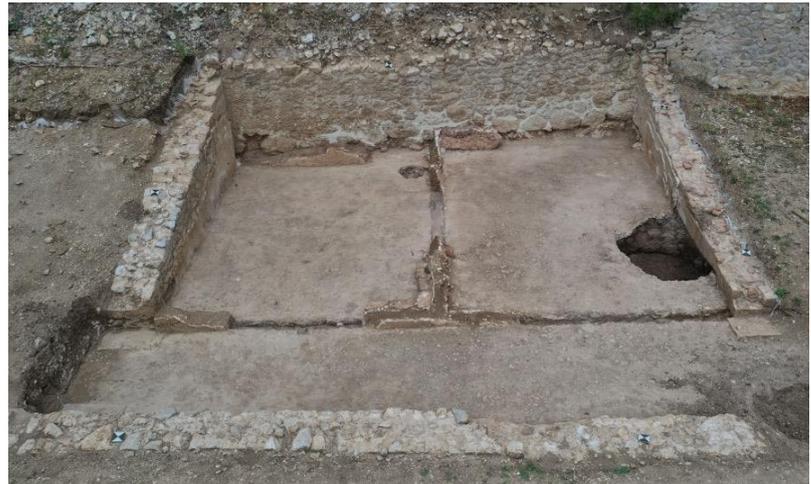
Fig. 8. Photograph of Rooms 8a and 8b with Room 6 (corridor) in the foreground. View from the south. The well, earthen walls, and small hole in the floor of Room 8a are visible. Myles McCallum, Saint Mary's University.

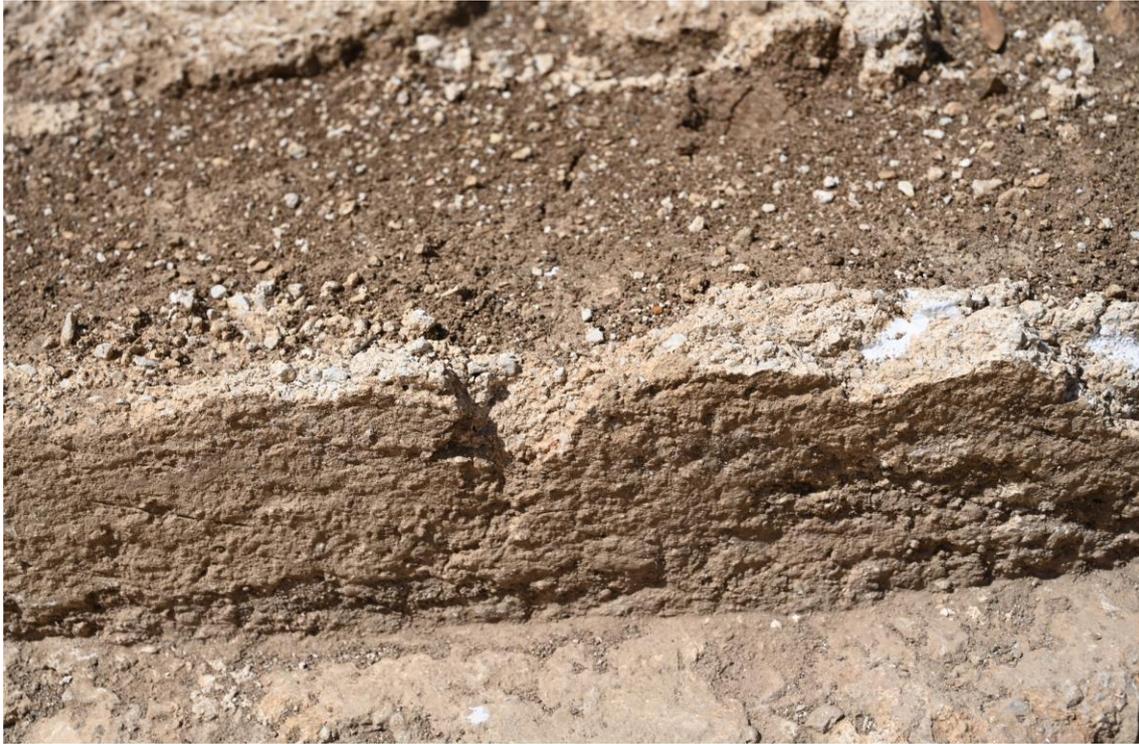
*Fig. 9. Detail of the fill within the cob, pise or opus craticium walls and the wall's exterior surface, Room 8a.
Martin Beckmann, McMaster University.*

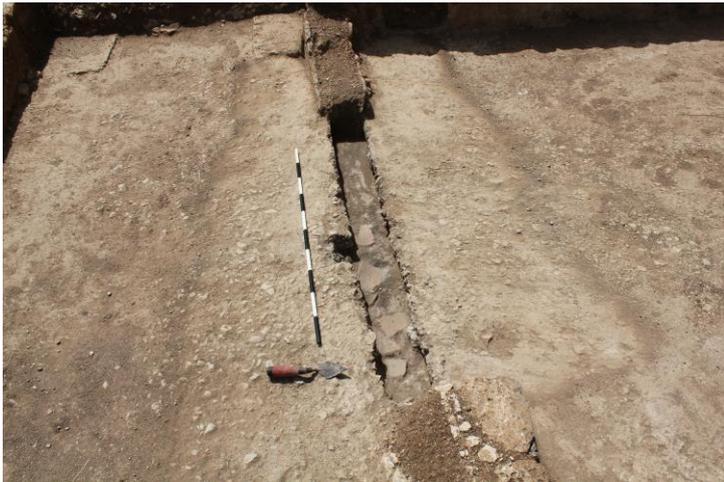
Fig. 10. Detail of slot in floor between Room 8a and corridor 6, used for wooden door sill or framing element. Martin Beckmann, McMaster University.

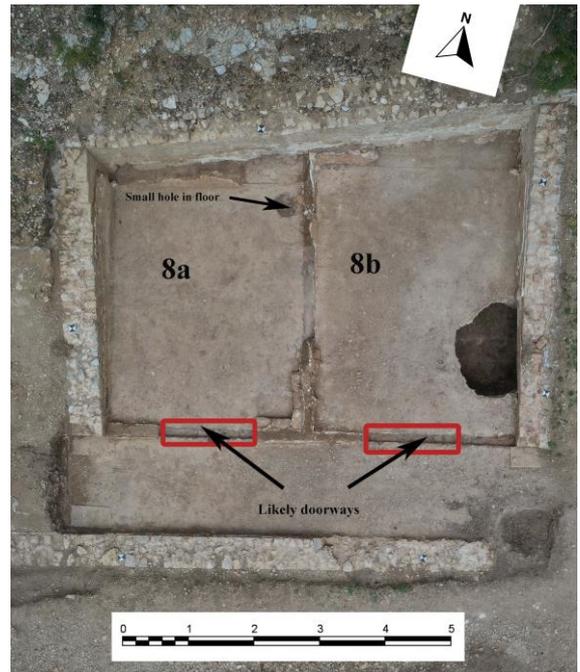
Fig. 11. Photo of Rooms 8a and 8b with possible doorways indicated as well as the hole in the floor of Room 8a. The stones lining the southeast corner of Room 8a are also visible. Myles McCallum, Saint Mary's University.

No evidence of doorways through the partition wall separating these rooms from the corridor was found, but these could have been made of wood and not preserved. No standing wall plaster was found in the central areas of the line of the partition wall between either room and the corridor, indicating that openings in the wall could have existed there (fig. 11).

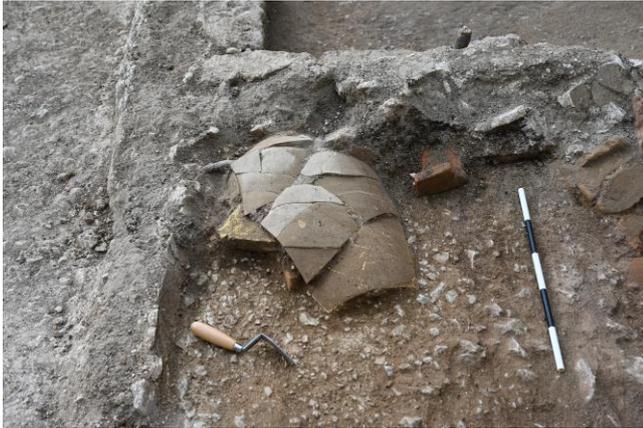
Fig. 12. Mid-excavation photo of the remains of a Dr. 2/4 transport amphora sitting on the concrete floor in Room 8b. View from the east. Myles McCallum, Saint Mary's University.

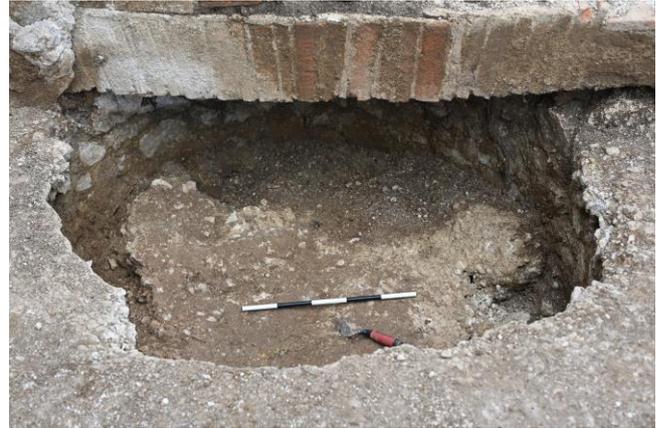
Fig. 13. Photo of the well and piece of subsided concrete flooring within it, Room 8b. View from west. Charles Jackson, Saint Mary's University.

shaped stones coated with a dark pink plaster. Part of the wall of the well extended under the flat brick arch in the east wall of Room 8. The subsided portion of the floor of Room 8b was found inside the well at a depth of approximately 0.40m, apparently having sunk into it after the abandonment and destruction of the building (plaster collapse, similar to that found in the room itself, was found atop the subsided floor). Below the subsided floor was rocky soil containing construction debris including white mosaic tesserae, both cubic and rectangular (of the same type used in the mosaic in Room 3 two rooms to the east), bricks, and a number of brick column segments. This suggests that the well is an earlier structure that was filled in during the construction of Room 8. The fill appears not to have been sufficiently compacted, allowing the floor to subside into the well after the building had been abandoned. The presence of the well also explains the flat brick arch in the east wall: it was built to keep the weight of the wall off the area of the filled-in well.

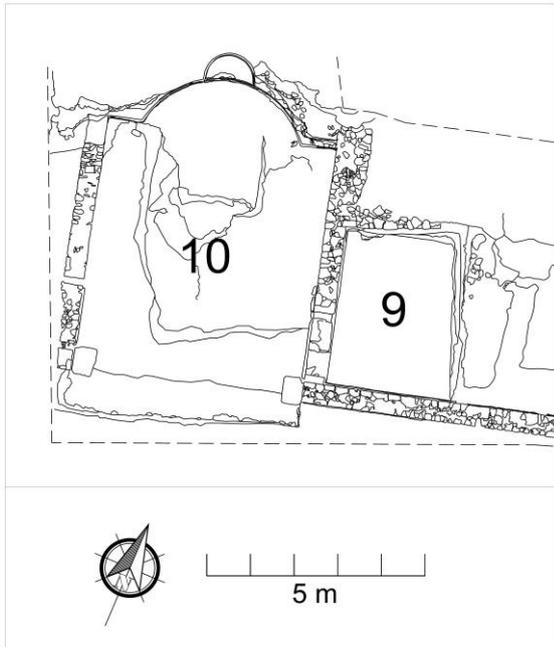
Fig. 17. Plan of Rooms 9 and 10, courtesy of Matthew Munro, University of Calgary.

Room 9 was discovered during the 2018 excavation season (figs. 17 and 18). It appears to follow the same orientation as Rooms 3, 5, and 8, but only approximately one third of the room was excavated. Located in the middle of our trench, the exposed portion of the northern wall is built against the natural rock terrace. Two entrances to Room 9 were identified and include an open doorway with corridor Room 6 on its eastern wall and a blocked doorway with Room 10 on the western wall. This blocked eastern doorway is discussed in more detail in the context of Room 10 below.

Room 10 (figs. 17 and 21) was initially discovered during the 2018 excavations. It is located at the west-ernmost edge of our trench and, like most of the other excavated rooms, its northern wall is built against the natural rock terrace, into which it is also partially cut. This northern wall is made of cement with quasi-reticulate and brick (*opus latericium*) facing. In addition, this wall is not in line with the northern wall of rooms 5, 8 and 9, but instead is set further back into the hillside by more than 2 metres.

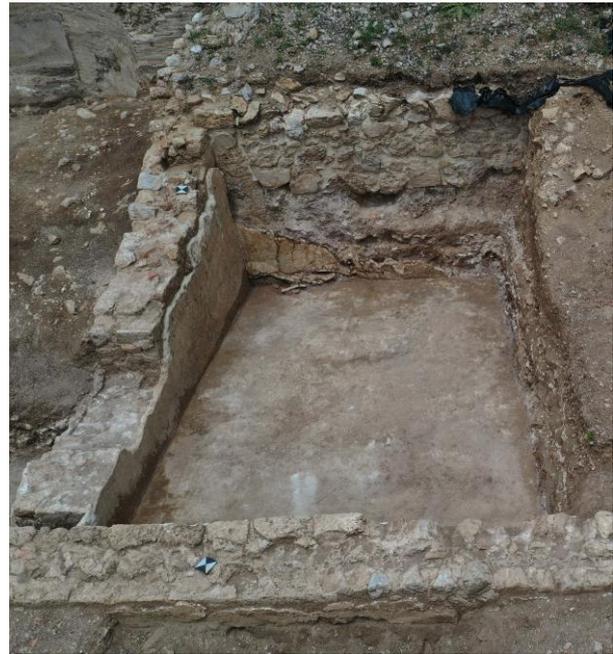
Fig. 18. Photo of Room 9 at the end of the excavation, view from south. Myles McCallum, Saint Mary's University.

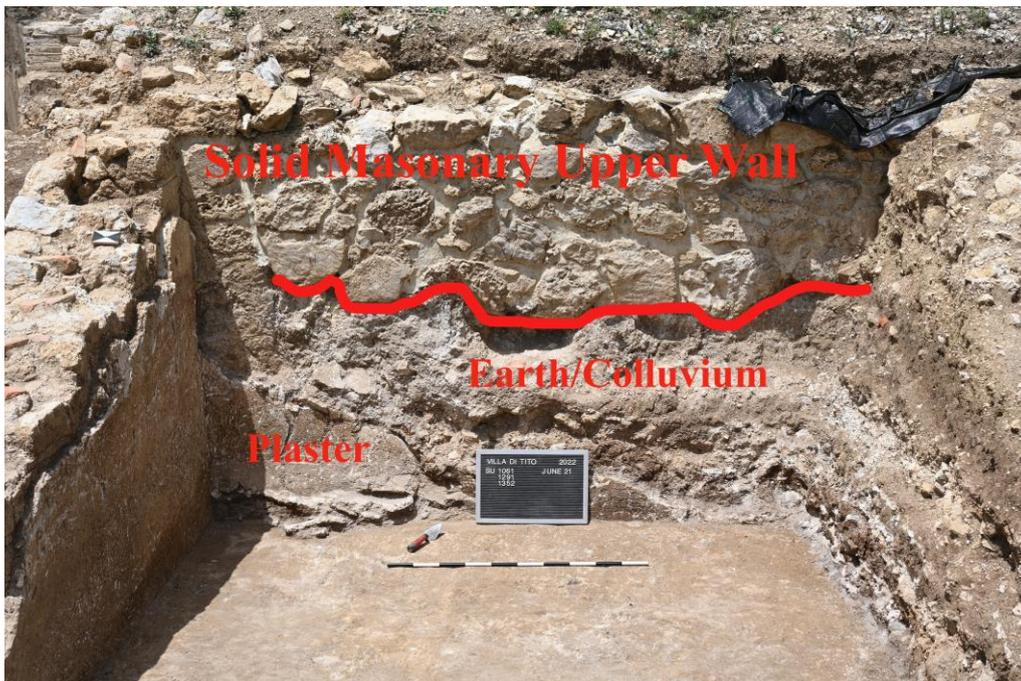
Fig. 19. Photo of N wall of Room 9 as viewed from the south. This shows the solid masonry upper part of the E-W running wall. The area below the red line on the E-W wall is made up of colluvium, which has been plastered over. Myles McCallum, Saint Mary's University.

The exposed portion of the northern *opus incertum* wall in Room 9 revealed an architectural peculiarity. The eastern section of this wall, approximately 0.30 m wide, was identified at the western end and joined to the N-S wall by at least one well-cut masonry quoin. East of this was another section, approximately 2.3 m wide, representing either a partial failure in the *opus incertum* retaining wall or a repair (fig. 19). Interestingly, only the top half of this wall was identified, and it appeared to sit directly on colluvium and behind a layer of wall plaster. Further excavation of this colluvium was not undertaken to help preserve the integrity of the upper wall courses. Further excavation in the eastern end of Room 9 will likely help resolve how and why this northern wall was constructed in this manner.

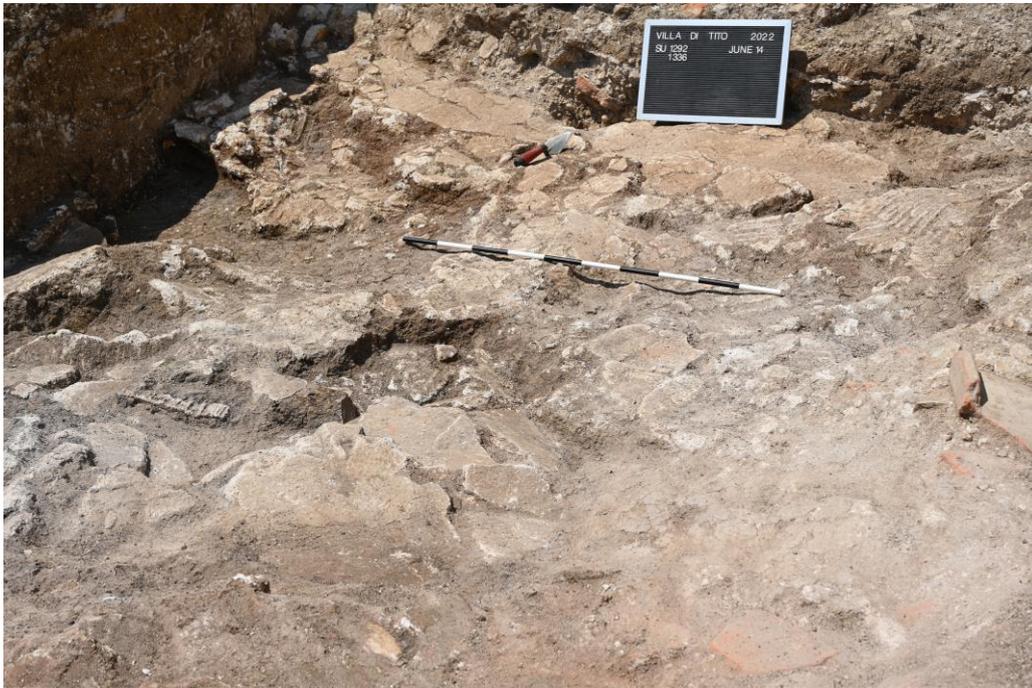
Fig. 20. Plaster collapse and layer of plaster above original concrete floor of Room 9. Charles Jackson, Saint Mary's University.

Large pieces of fallen wall and roof plaster, in addition to flat segments of broken concrete, were also arranged around the room to form a makeshift surface in the post-occupation period (fig. 20). No additional artifacts or features were identified with this surface to help further clarify its function or to provide a date.

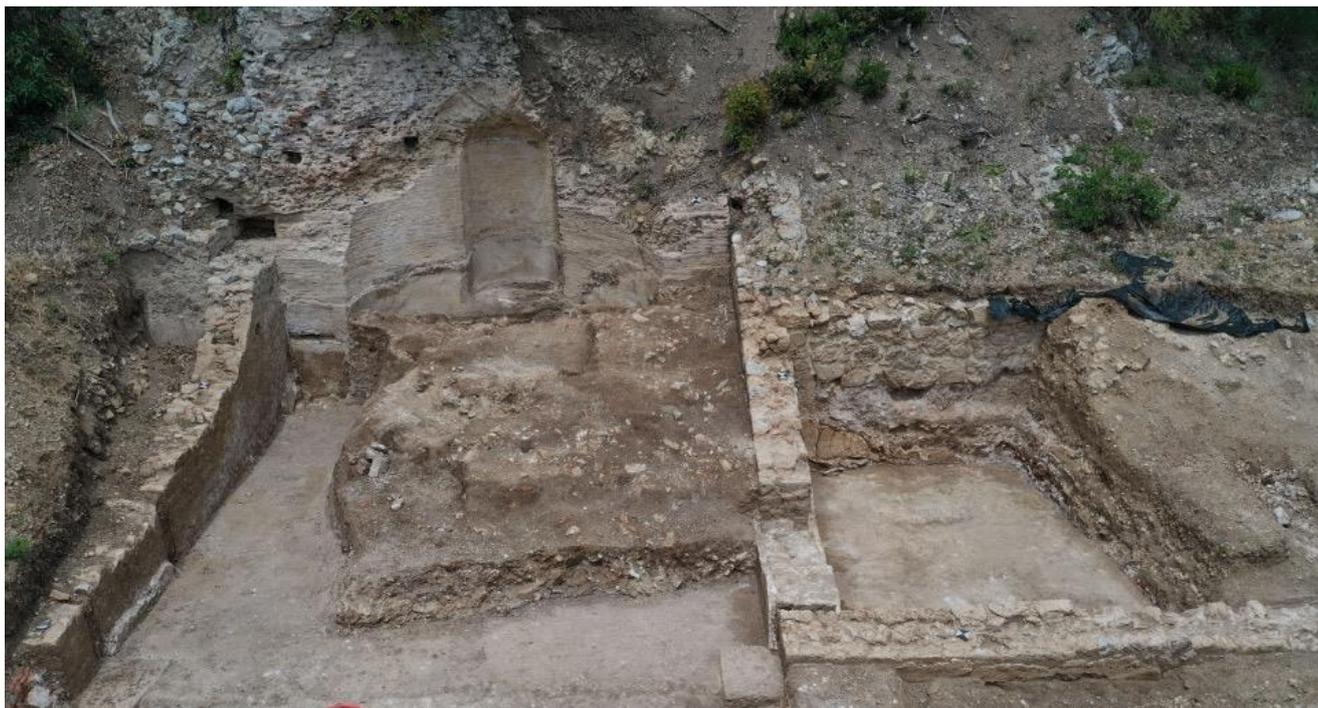
Fig. 21. Rooms 9 and 10 from the south. Myles McCallum, Saint Mary's University.

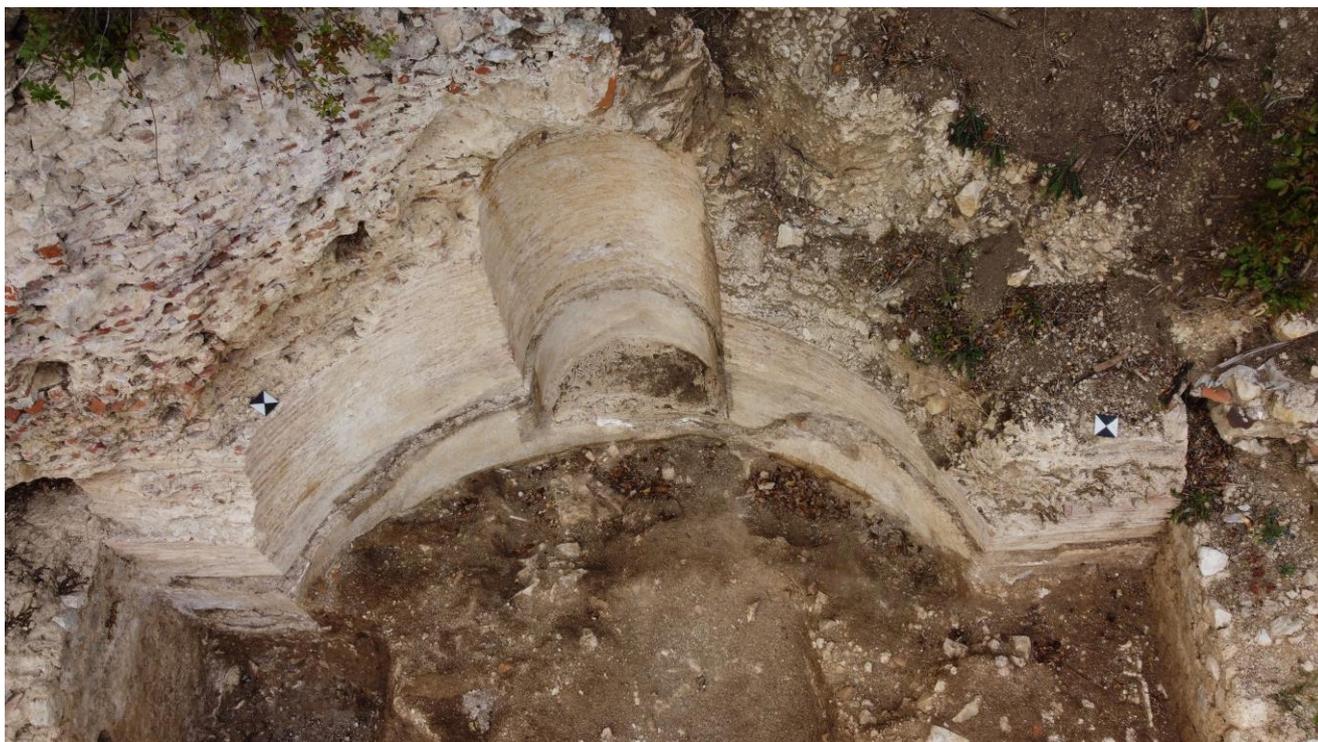
Fig. 22. Detail of apse and niche (north wall) of Room 10. Myles McCallum, Saint Mary's University.

The room itself differs architecturally in other ways as well. The northern wall is apsidal and within it is set a raised and arched, semicircular niche, probably a platform for statuary display (fig. 22). The brick facing within the apse and niche is also exceptionally regular and very well constructed (fig. 23), more reminiscent of the masonry technique employed on public buildings in Rome during the early imperial period than contemporary examples in nearby buildings in the Velino valley or Rieti basin, including that of the nearby Baths of Vespasian or the more distant Villa at Cottanello¹⁷ and the Villa of Quintus Axius.¹⁸ Finally, the apse was covered by a semicircular concrete vault, set above the arched ceiling of the niche.

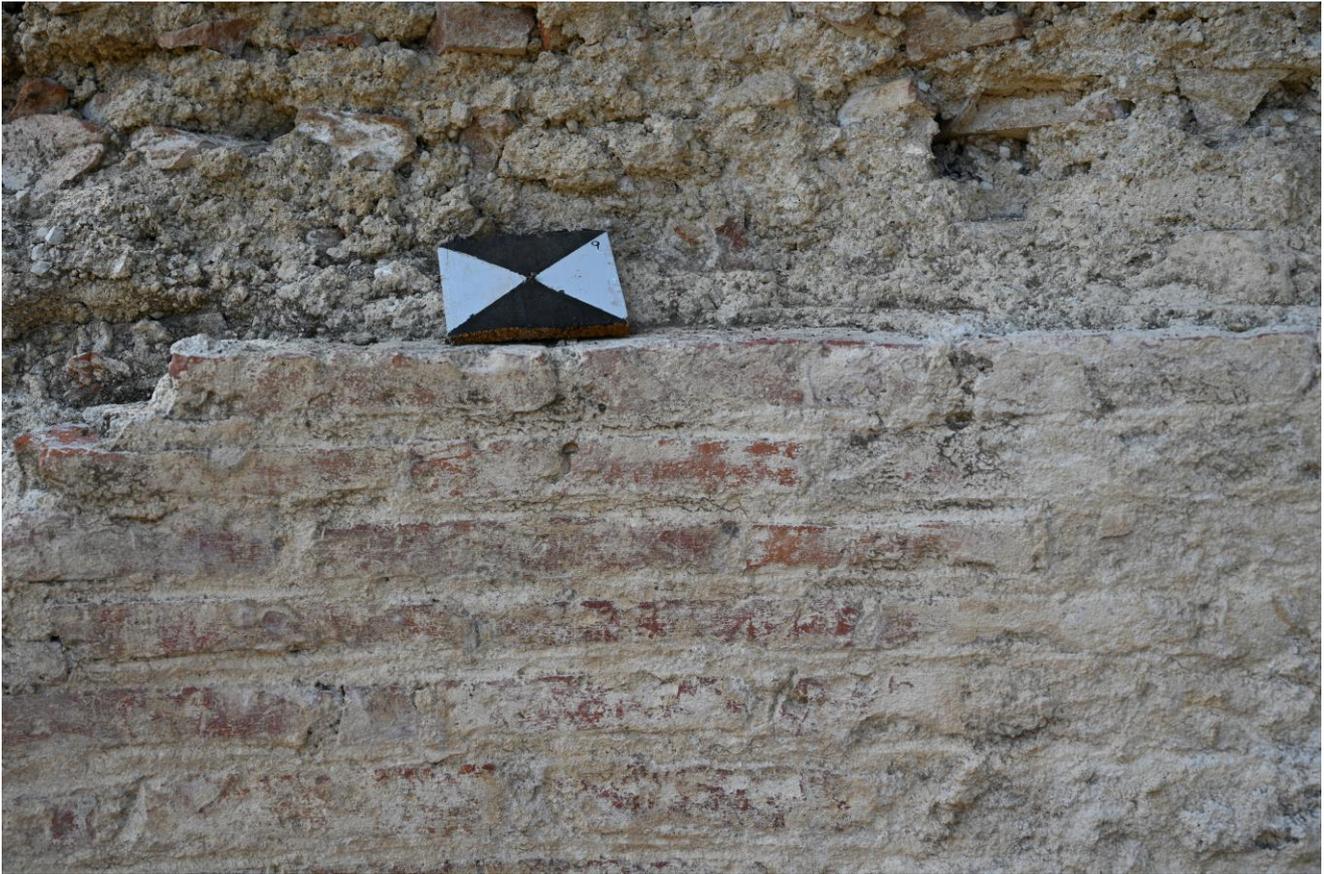
Fig. 23. Detail of opus latericium brickwork in the niche within Room 10. The drone target is 10 x 10 cm. Myles McCallum, Saint Mary's University.

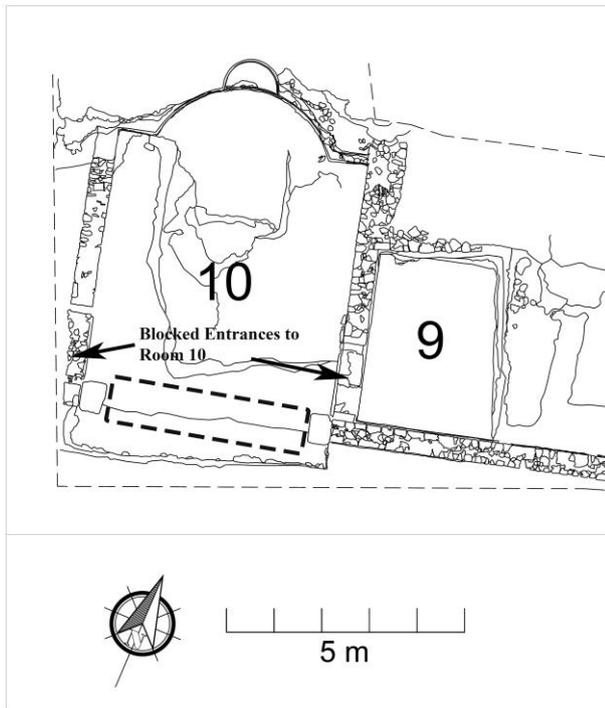
Fig. 24. Plan showing location of blocked eastern and western entrances to Room 10 and broad southern entrance onto possible courtyard. Matthew Munro, University of Calgary, and Myles McCallum, Saint Mary's University.

At present, we know of three entrances to Room 10 (fig. 24). One is from the corridor running east to west, shown on the site plan as Room 6, described above, which reaches this space through the eastern wall; the second is opposite the first on the western wall and probably includes a continuation of this corridor. The entrance to Room 10 from the corridor, Room 6, on its eastern side revealed that the doorway was blocked during renovations to Room 10 (the concrete floor runs beneath the wall plaster and masonry blockage within the doorway had a gap at both its northern and southern ends between it and the adjacent, earlier phase walls. The gaps were plastered over on both sides (within Rooms 9 and 10), but they were filled with dirt. One of these gaps was excavated to its bottom, which provided a great deal of information. The gap was filled with numerous nails and a small silvered medallion (silver plating over lead) likely used to decorate some sort of wooden framing element. At the bottom of the gap were three nails set vertically to the floor (fig. 25), just above a small stone that likely served as a door jamb (see discussion for Rooms 6 and 8 above). The finds indicate that this gap and the identical one to the north of the masonry blockage were once filled with the wooden frame of a doorway. Opposite the masonry blockage and its associated gaps is an identical arrangement on the western wall of Room 10, indicating that both doorways were blocked as part of the same renovations to this space.

The third entrance to Room 10 is to the south and runs the full width of the room, although we are not certain into what this door opens. This entranceway is flanked by two large limestone blocks, ca. 0.30m E-W x 0.42m N-S, on which may have been placed columns flanking the entranceway. The concrete floor also ends at the southern limit of Room 10 with a long cut which we did not excavate, whose edge is defined by a more or less straight line running from east to west in line with the southern wall of Corridor 6. This cut may have once

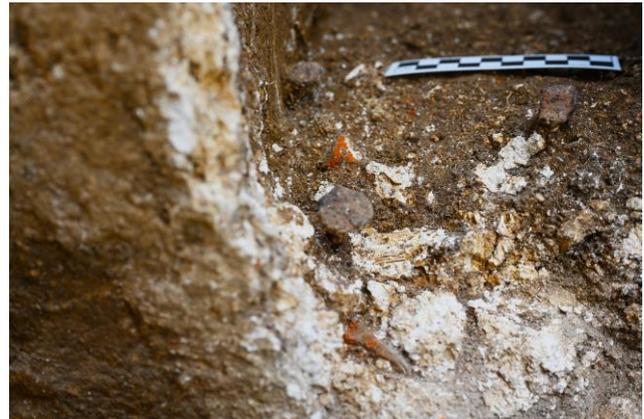
Fig. 25. Nails, possibly *in situ*, excavated from a gap probably left by the wooden door frame between Rooms 9 and 10. Charles Jackson, Saint Mary's University.

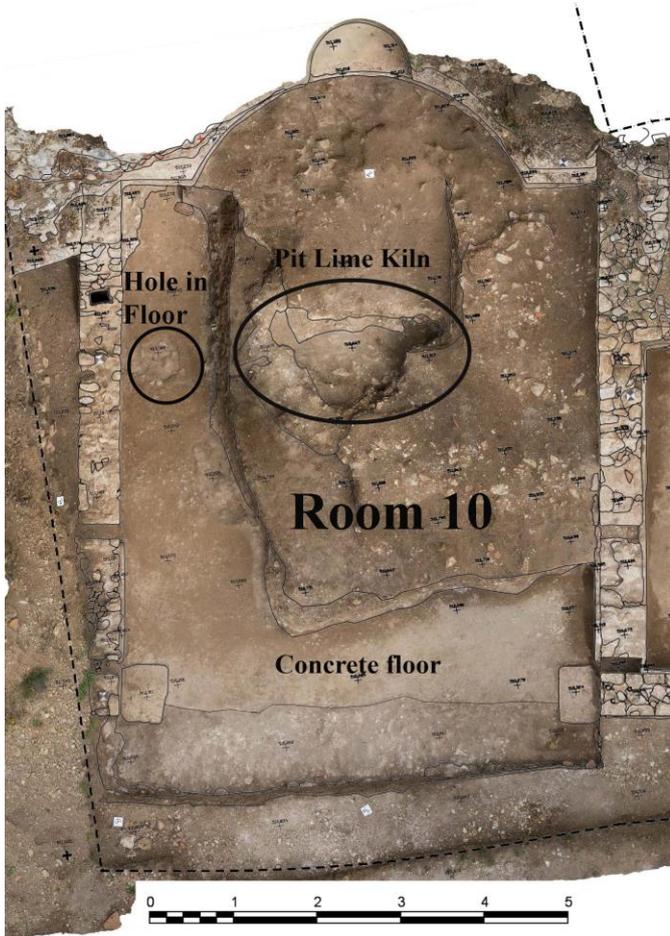
Fig. 26. Room 10 with a hole in the concrete floor indicated. Myles McCallum, Saint Mary's University.

An irregular hole with a diameter of about 0.25m (fig. 26) has been dug in the concrete floor near the room's western wall, and the edge of what appears to be a larger hole towards the center of the room was also identified and defined. A sherd of local *impasto bruno* pottery (ca. sixth century BCE) recovered near the edge of the smaller hole may have come from much older occupation layers below room 10.

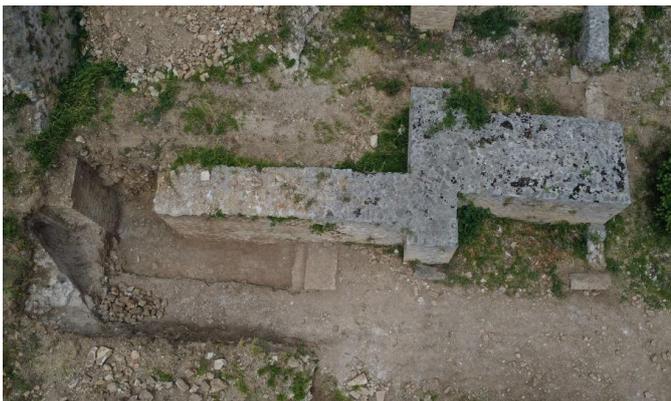
Fig. 27. Aerial view of the test trench within the Cryptoporticus (Room 50). Myles McCallum, Saint Mary's University.

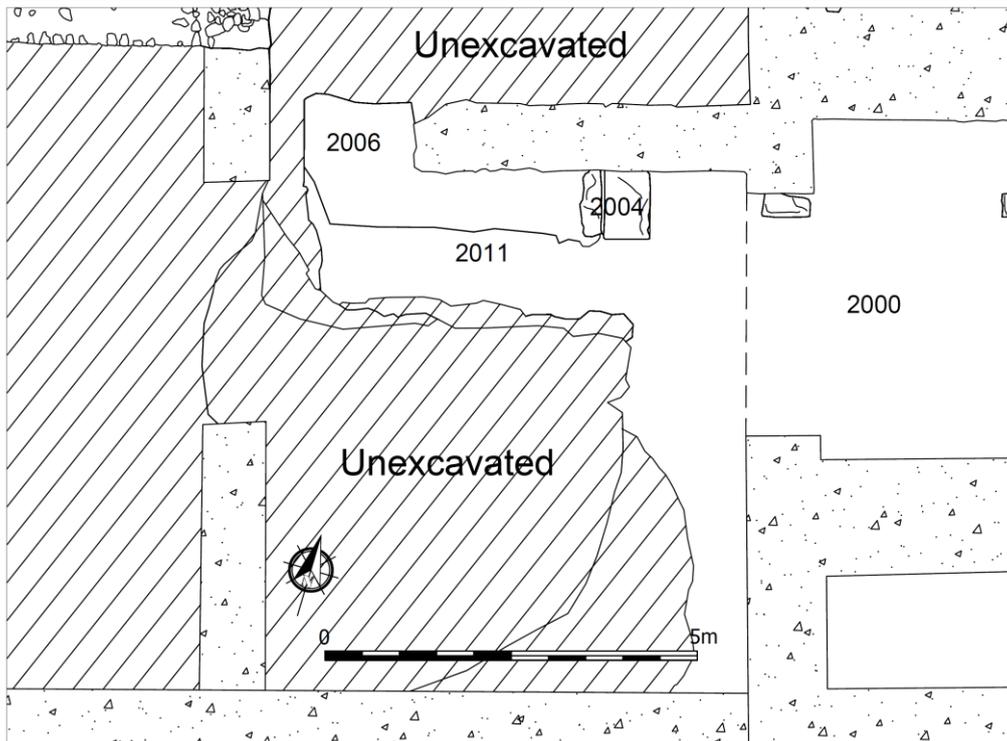
Fig. 28. Plan of excavations within the Cryptoporticus. Plan courtesy of Matthew Munro, University of Calgary.

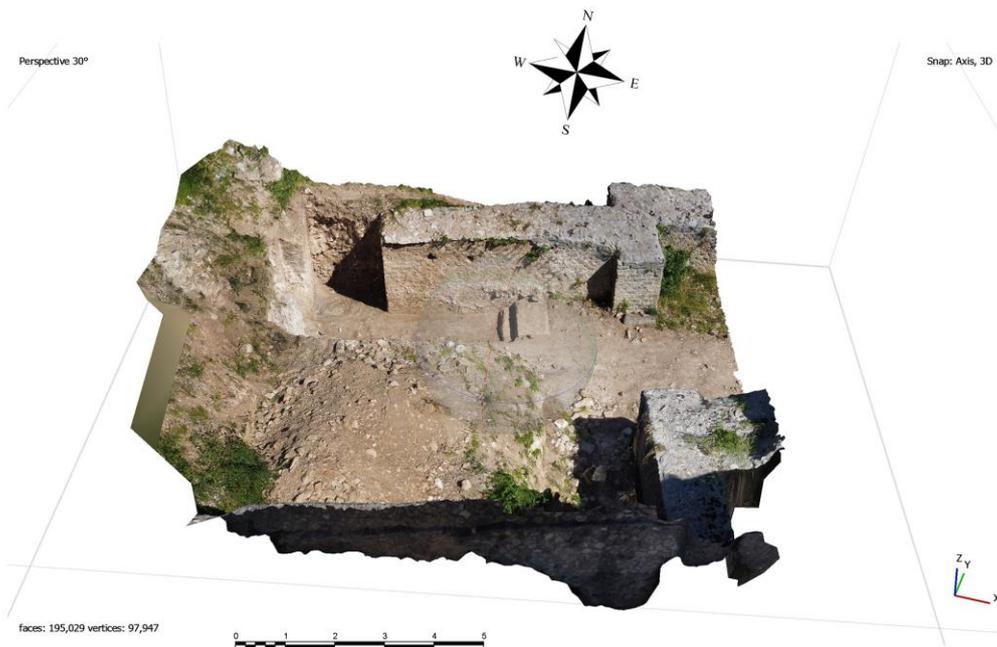
Fig. 29. 3D model of the Cryptoporticus (Room 50) at the end of excavations. View from south. Charles Jackson, Saint Mary's University.

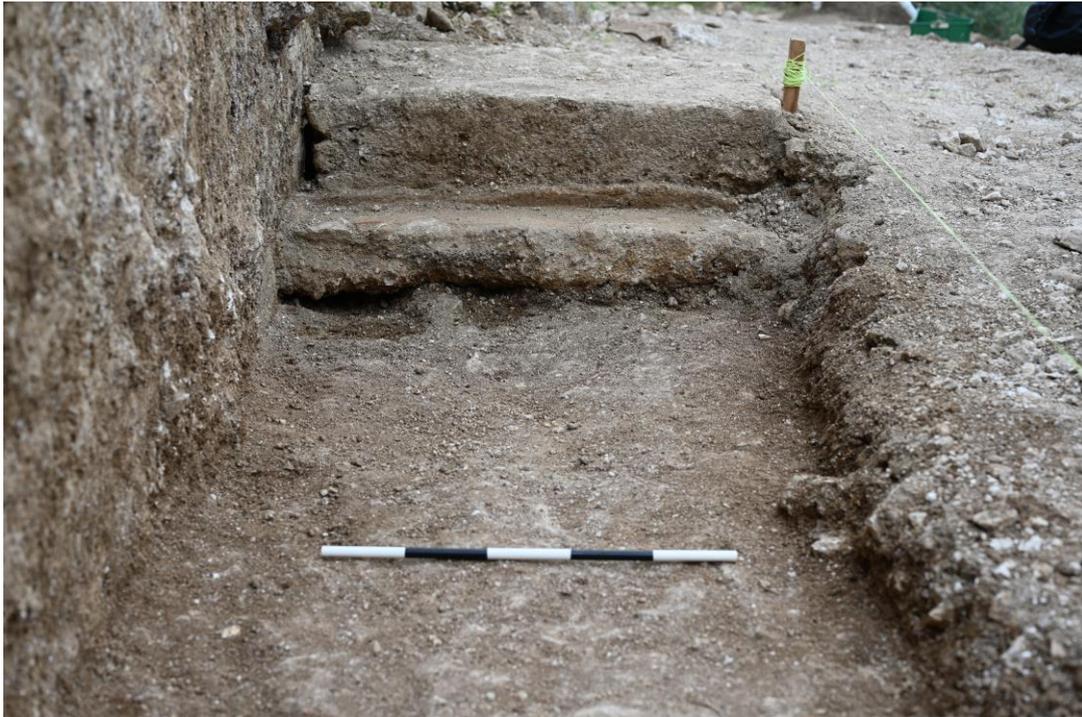
Fig. 30. Photo of possible stairway, Cryptoporticus (Room 50). Charles Jackson, Saint Mary's University.
