The excavations at the so-called Villa of Titus (Castel Sant'Angelo, Rieti)

*Myles McCallum (Saint Mary's University) and Martin Beckmann (McMaster University),
Simone Nardelli and Matt Munro (University of Calgary)*

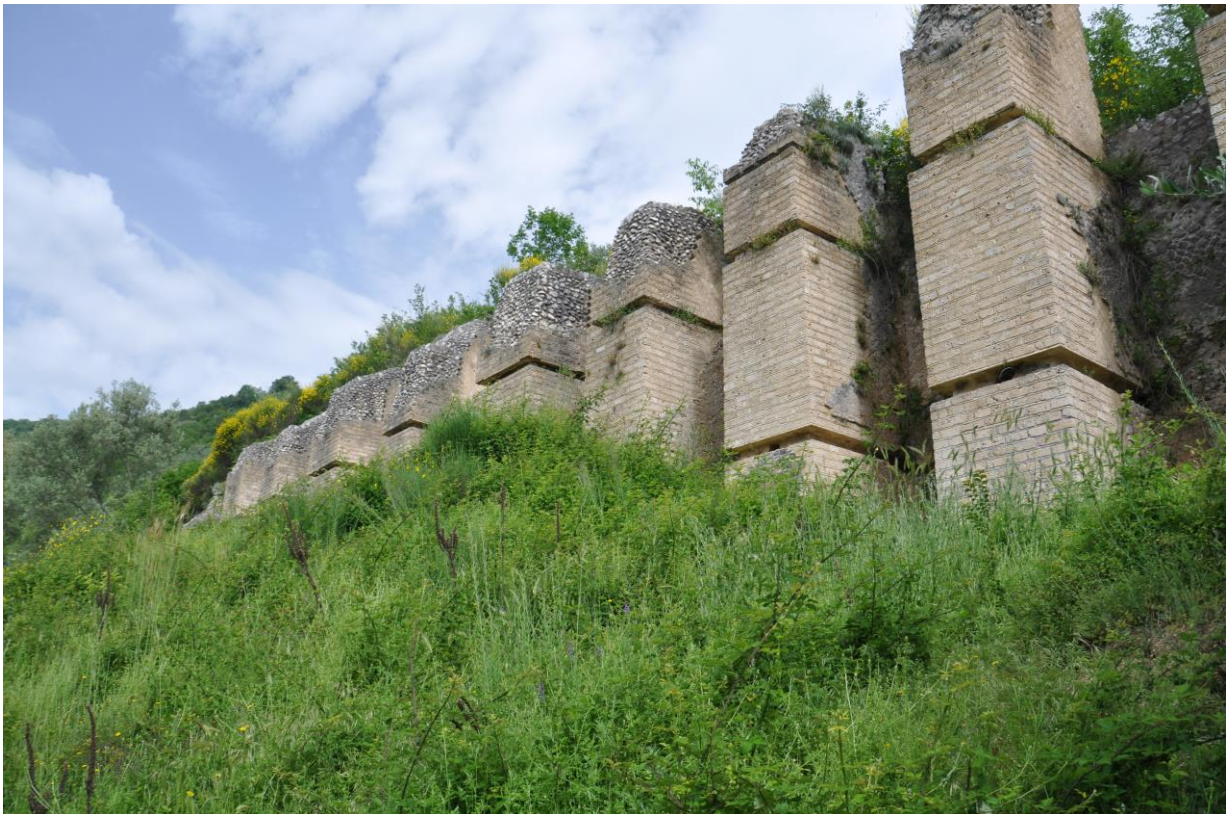
Fig. 2. Southern exterior of concrete terrace structure showing pilasters restored in the 1980s (Myles McCallum).

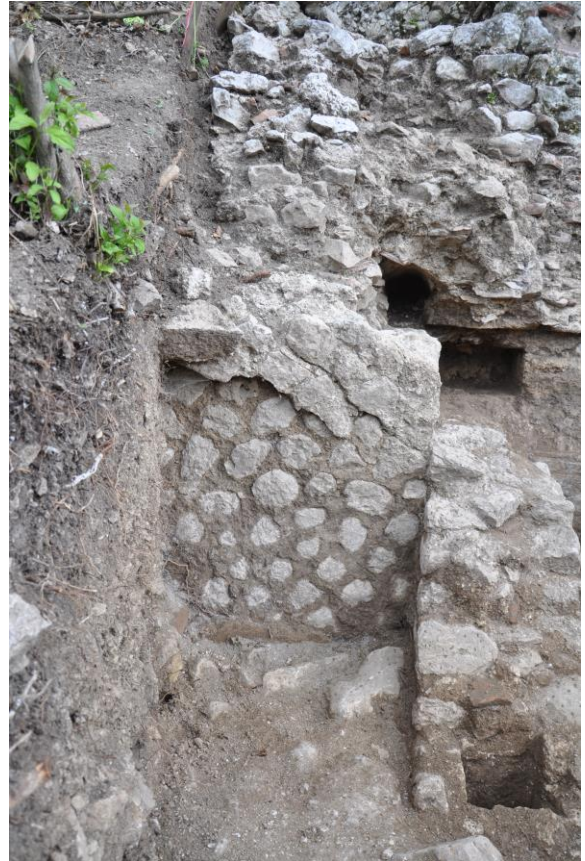
Fig. 3. Concrete wall showing various voids possibly associated with wooden elements or used as water channels (Myles McCallum).

able to observe and so describe the monumental fountain and not the rooms within the concrete terraced structure. The horizontal and vertical recesses within the masonry of the terraced structure (fig. 3) may have accommodated wooden beams, possibly used during construction but perhaps of structural significance, and only careful study of the structure will allow us to accurately reconstruct its original shape and other decorative elements such as columns. It is also possible that some of these voids were water channels. Also, it is unclear to what row of channels used for the transport of water he refers in his description. If they are those 'channels' visible today within the walls of the cryptoporticus, the exact function of these channels is unclear. They may be used for conducting ground water away from the building's foundations, part of the structure of the building itself (possibly used for wooden beams?), or, as he suggests, for conducting water towards a pool of cistern, for use in a pool, as drinking water, or for other purposes.

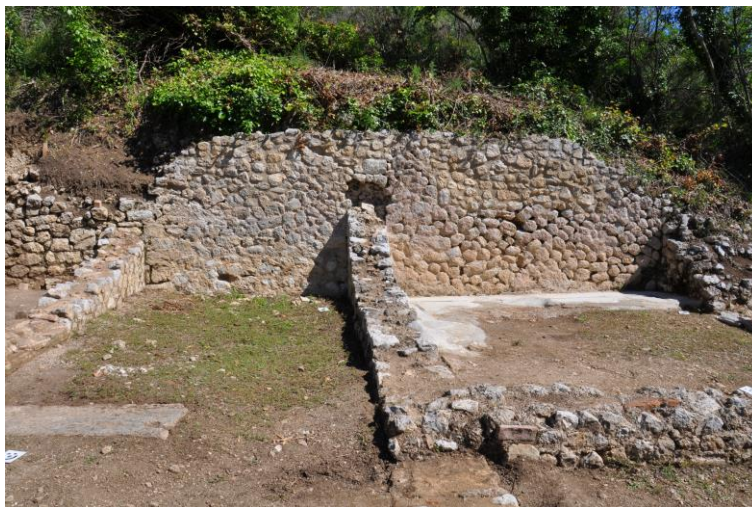
Fig. 5. Wall delimiting the northern extent of the concrete terrace structure excavated in 2010/2011 (Myles McCallum).

Most recently, an excavation campaign was carried out by the Superintendency in 2010/2011², which brought to light three rooms at the eastern edge of the terrace and bounded on the north by a large terracing wall that may be the northern limit of the building itself (fig. 5). While floor levels were not reached in all of the rooms and hallways uncovered by excavators, a black and white mosaic with a simple black-band frame was uncovered (fig. 6). This series of rooms, their arrangement, and the finds found in the archaeological layers associated with them, suggested to the excavators that the building was a villa rather than a bath complex. Unfortunately, these excavations did not discover the means of communication between the lower levels of the structure (noted above); presumably, there must be some sort of internal staircase linking these levels, the traces of which have yet to be discovered.

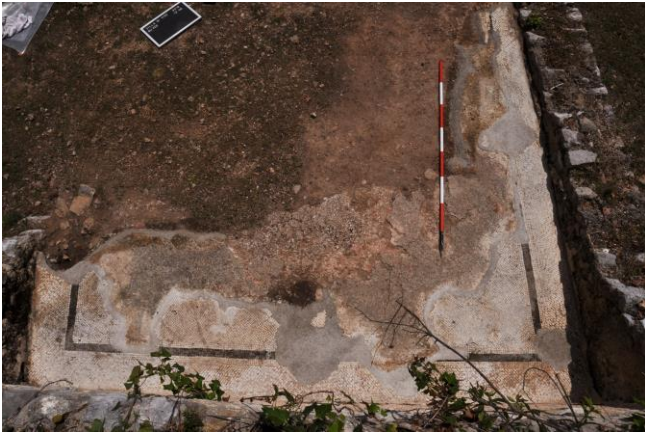
Fig. 6. Black and white mosaic from 2010/2011 excavations, post conservation (Myles McCallum).

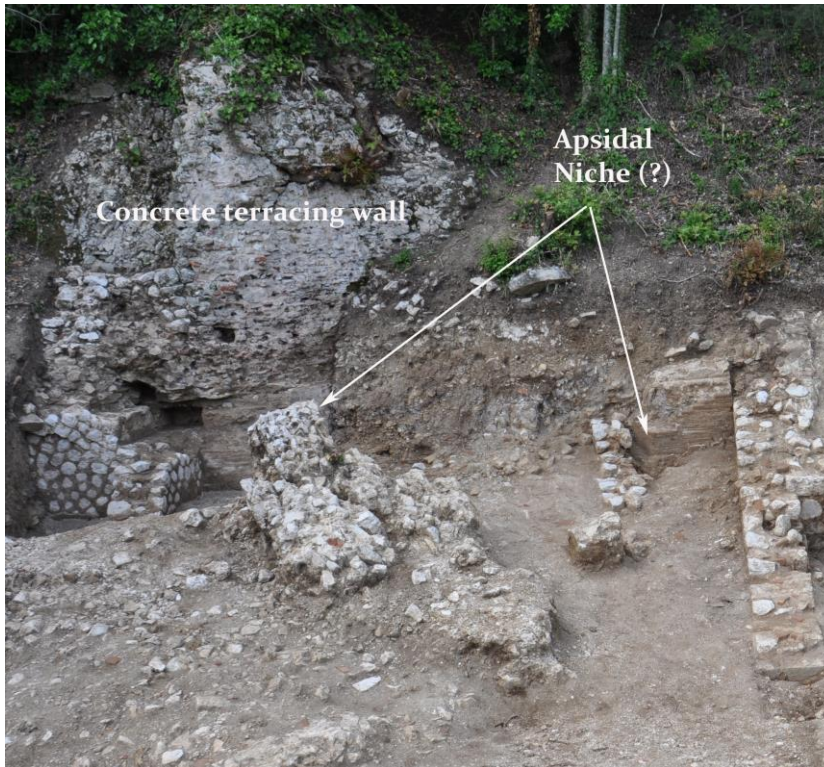
Fig. 8. Concrete core wall during excavations, northwest sector of trench (Myles McCallum).

Room 10, which sits at the westernmost limit of our trench, is the space about which we can say the most. It is connected to Room 6, the corridor, through a door in its eastern wall. The northern limit of this room is significantly different from Rooms 8 and 9, being formed not by a thin wall but rather by a quite thick (ca. 2.47 m) concrete wall preserved to an extraordinary height (ca. 3.08 m) and incorporating an apsidal structure faced with brick (fig. 8).

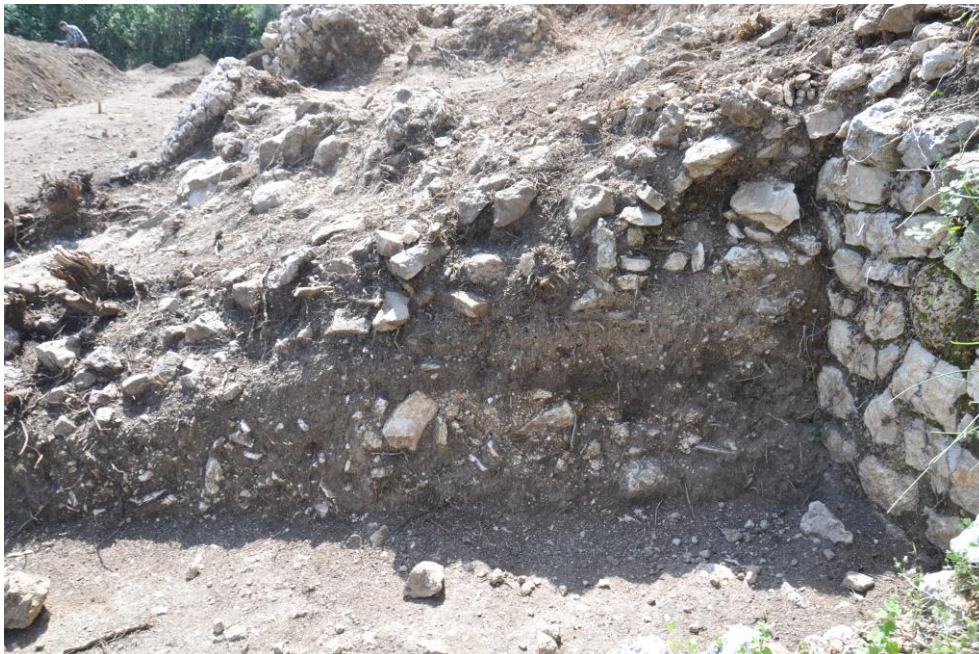
Fig. 10. Stratigraphic section visible at the western edge of 2010/2011 trench (Myles McCallum).

Within the eastern sector, we were fortunate to have preserved the western section wall from the 2010/2011 excavations, which showed the complex stratigraphy of the various colluvial events and collapses associated with the building's destruction. The complexity of this stratigraphy, and the substantial colluvial overburden, greatly affected the speed of our excavation here, however. Still, through concerted effort, we were able to perhaps come closest to the floor in Room 8, although we decided during the final days of excavation to halt digging when we arrived at what is likely a layer of sediment (1023) sitting immediately on top of the most recent floor level, since we would not have had adequate time either to properly excavate and dry sieve this layer or process finds found therein.

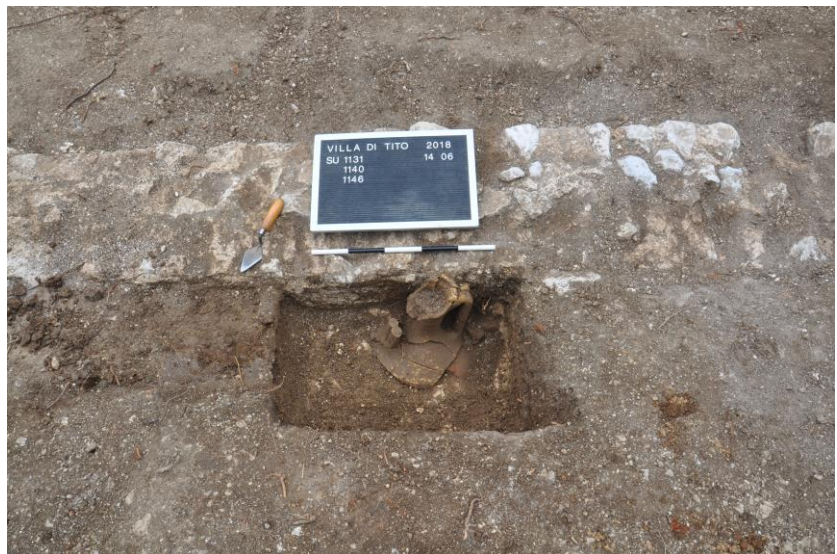
Fig. 11. Upper portion of a Dressel 2/4 amphora during excavations (Myles McCallum).

Based on the use of concrete masonry with quasi-reticulate facing throughout the structure, both that visible from the earlier excavations and that uncovered in 2018, the terrace building must have its origins in the second half of the first century BCE to the early first century CE. Unfortunately, as we did not excavate floor fill or construction trenches, it is not currently possible to provide a more specific or certain date for the building's initial construction. The recovery of two *in planta pedis* tile stamps (*CERDO VOLUM · L · S · F*) datable to the late Republican through Augustan/Tiberian period⁶, is perhaps the most useful dating material for the building's initial construction, although it should be noted that one tile was recovered on the surface and the other from wall or ceiling collapse in Room 10, so not highly reliable stratigraphic contexts (see below for more on this stamp). The majority of datable pottery from the layers of colluvium and collapse (which was not abundant) also date to this period (Dr. 2/4 amphorae and Italian Terra Sigillata) (fig. 11), although, as just noted, this material cannot be used to date the Phase 1 structures.

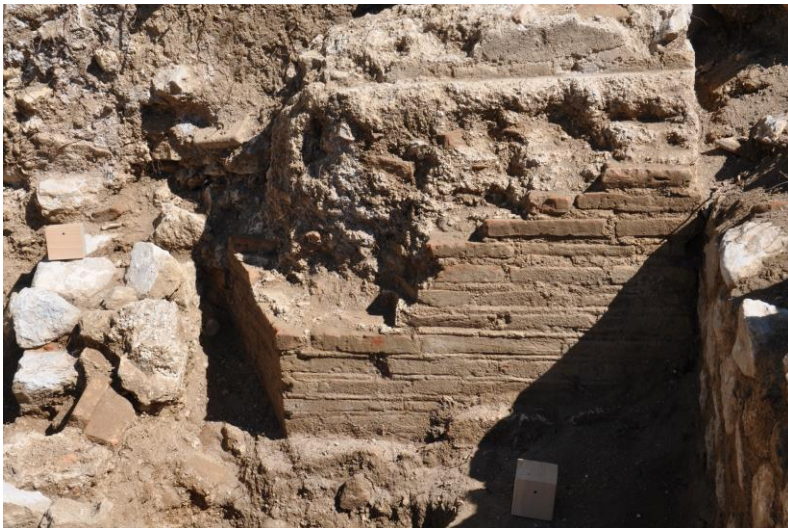
Fig. 12. Opus latericium wall in Room 10 (Myles McCallum).

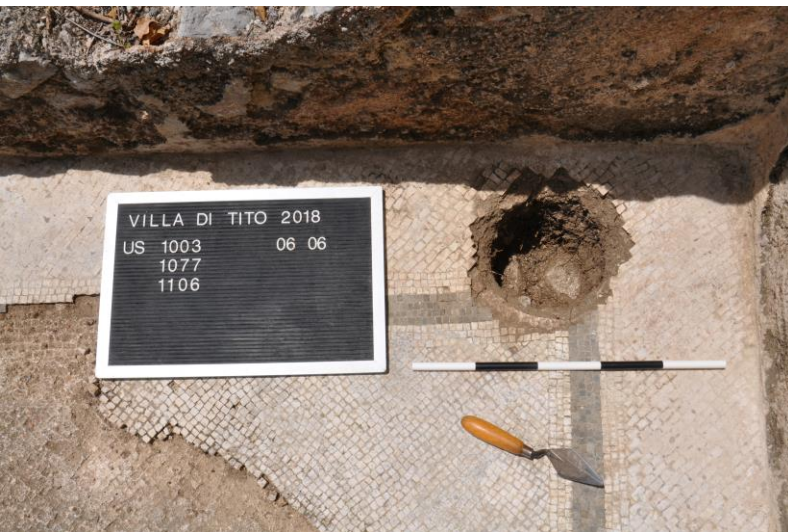
Fig. 13. Post-hole dug through mosaic (Martin Beckmann).

The final phase of occupation at the site is one of reuse. Post-holes (fig. 13) are dug through the mosaic in Room 3, indicating perhaps the presence of a wooden hut of some sort, and a dry masonry wall is inserted within Room 10, which is clearly not in line or phase with earlier, more substantial walls. Again, the date of this final occupation is not clear. Material from colluvial layers above the collapse can be dated to the early Medieval period (so-called Forum Ware), as well as Medieval Lead Glaze and more recent pottery (from the sixteenth through early twentieth centuries). While this does not provide us with dating evidence for the final occupation of the structure, it does indicate that there was activity on and around the site in the Late Roman through Medieval periods. Future excavation campaigns will look for stratigraphy associated with the construction of the dry masonry wall (there was no datable material in the post-holes) in the hopes of finding datable material.

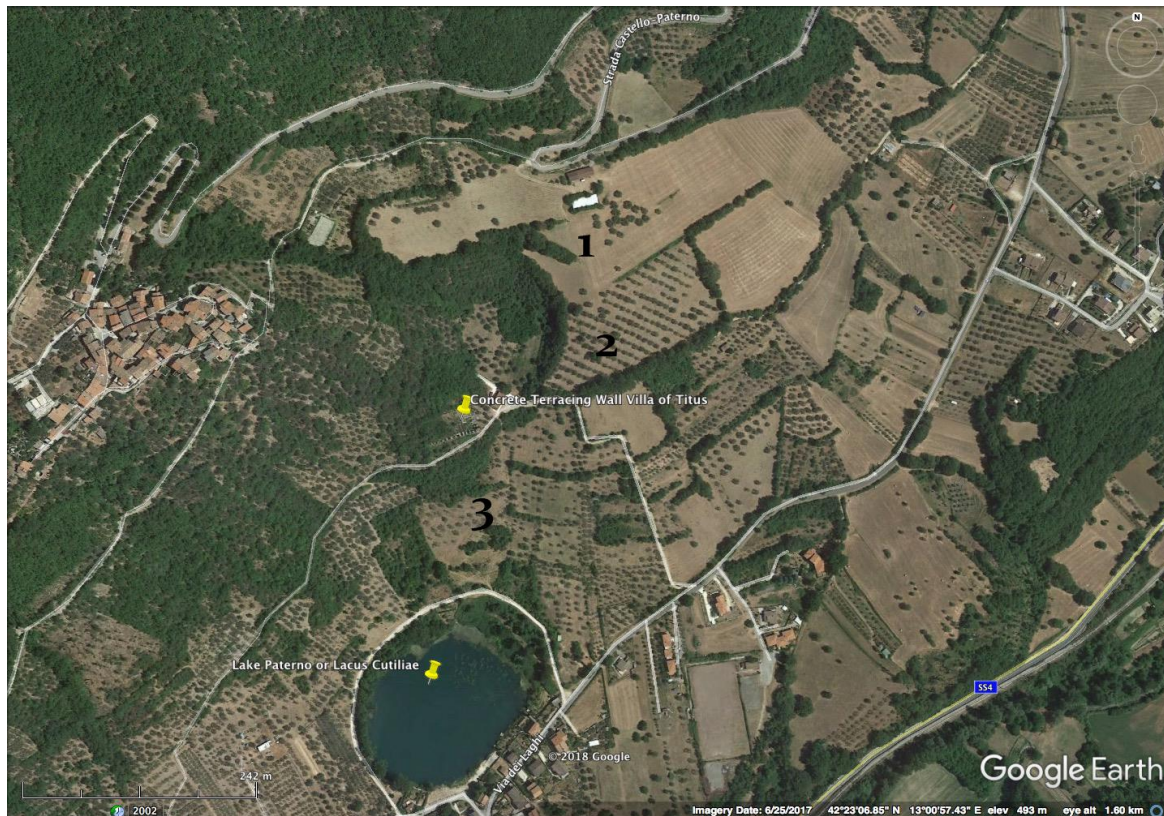
Fig. 14. Google Earth view of fields surveyed (Myles McCallum).

The three fields with some surface visibility are located northeast and south of the terraced structure and are labelled Fields 1, 2 and 3 (fig. 14). Field 1, the most distant field to the northeast and upslope from the terraced villa and the adjacent orchard, contained no ancient material, although there was building debris from an early modern farmhouse currently undergoing renovation.

Building debris that appears to be Roman was noted in the lower parts of Field 2, particularly in the highlighted section. The building debris included chunks of concrete masonry with ceramic inclusions, perhaps Roman *cocciopesto*, roof tiles (*tegulae*), some small wall sherds of what appear to be fine-bodied tablewares (undatable), and two stones from quasi-reticulate concrete wall-facing, quite similar to those recovered during excavations. It should be noted that some of these finds are relatively close to the possible subsurface structures identified previously through gpr survey, and all were noted within 20 meters of the limit of the gpr survey area.

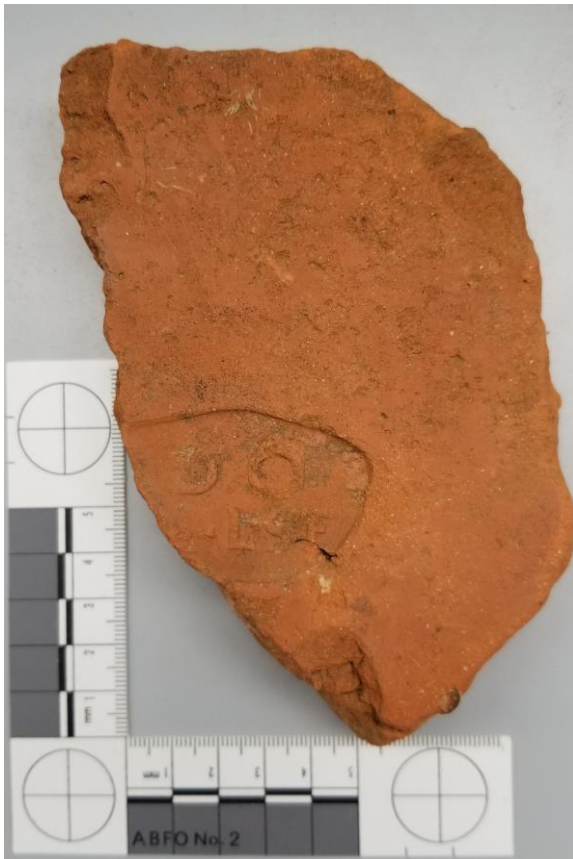
VT 2018
SU 1000
SURFACE FIND AT WEST END OF TERRACE
09/06/18

Fig. 15. Stamped tile #1, photo (Myles McCallum).

Turning briefly to the epigraphic data, the only inscriptions recovered from the site to date are the two stamped tiles noted previously, both of which are impressed with identical stamps, *CERDO VOLUM · L · S · F* (figs. 15 and 16). This stamp presents the name of the *dominus*, or property owner, Lucius Volumnius, as well as the name of his slave, Cerdo, who must have been the *offinator* of a tile production facility¹³. Identical stamps have been recovered elsewhere in the Velino River Valley, and it seems likely that the production centre was somewhere between Cotilia and Castel Sant'Angelo (RI)¹⁴. Unfortunately, the epigraphic evidence tells us nothing about the ownership history of the site. While the tiles were manufactured on the property of a member of the *gens Volumnia*, there is no reason to believe that they were used only in construction projects on properties owned by the family. As is the case in the nearby Tiber Valley, the production of brick and tile for the market was common from the late Republic throughout the imperial period.

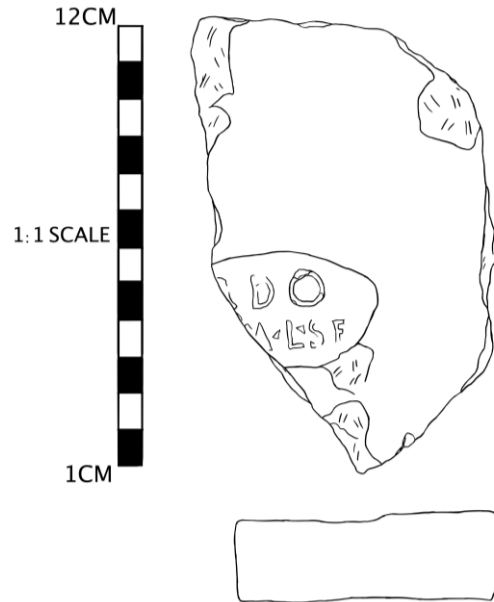
Fig. 16. Stamped tile #1, drawing (Martin Beckmann and Emily Nolan).

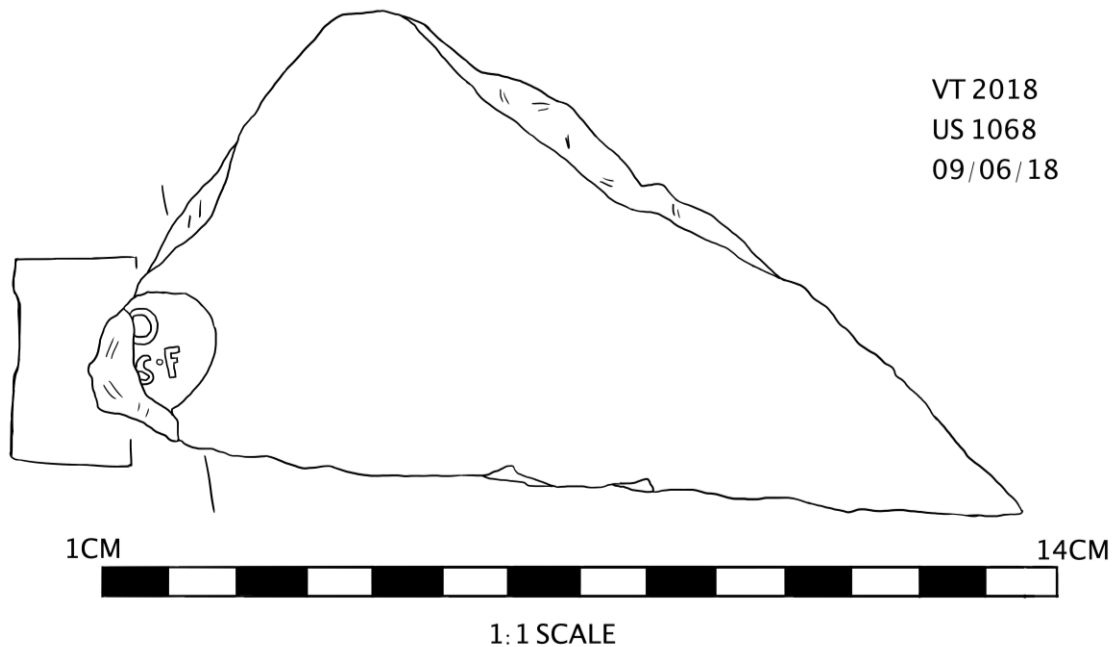
VT 2018
US 1068
09/06/18

Fig. 17. Stamped tile #2, drawing (Martin Beckmann and Emily Nolan).
