Report on the Excavations of the Gioiella-Vaiano Villa 2016-2019

Rebecca K. Schindler - Stefano Spiganti - Giampiero Bevagna - Pedar W. Foss

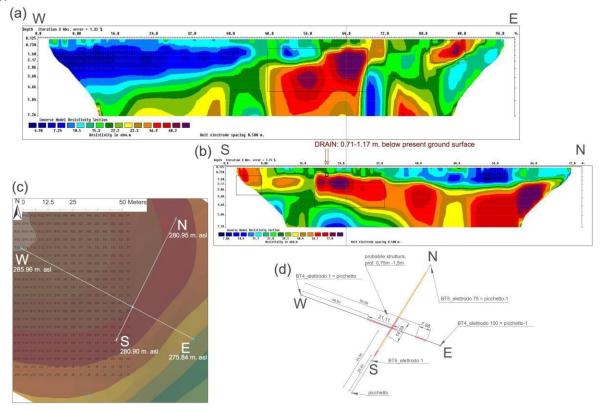
Fig. 3. Results of resistivity testing conducted in 2016: (a) W-E section; (b) S-N section, showing location of the later excavated drain; (c) site plan showing position of the resistivity sections intersecting at the SE corner of A1 (grid is 4 x 4 m); and (d) details of the resistivity setup (Massimiliano Mazzocca and P. Foss).

Prior to excavation in 2016, we carried out a limited geophysical prospection. Initial results looked promising, indicating a potential floor surface in an area where materials collected from the 2015 survey had suggested the presence of a building (fig. 3a, b, d: areas marked in dark red, indicating high electrical resistivity—that is, low moisture content). However, the areas of high resistance turned out to be natural sediment, namely a thick layer of highly porous orange sand, which, when dry, becomes strongly resistant to electrical waves (in the same way as brick or stone). The sand deposits date to the Pliocene²². Although this was not what we initially expected to find, ground-testing through excavation has improved our understanding of the local natural sedimentation, and how it correlates to the resistivity results. For instance, a drain feature excavated in B1 and B2 (described below) precisely matches a decrease in resistivity between two highly resistant patches of soil (fig. 3b). Toward the middle of the 2016 campaign we did a second GPR test, which identified the limits of a large tile deposit in C2, later excavated (see below). A more extensive GPR program is planned for summer 2021.

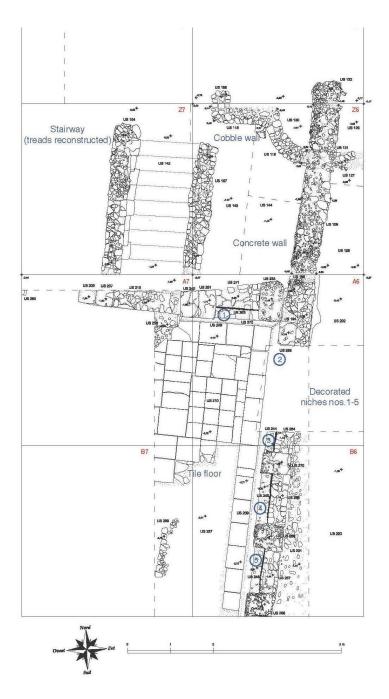
Fig. 5. Plan of the structures excavated in the Central Area, 2017-2019; nymphaeum with tile floor and decorated niches (nos. 1-5, no. 2 is unexcavated) in A6/A7/B6/B7, and stairway to the north in Z7; late cobble and concrete walls to the northeast in Z6 (AutoCad; S. Spiganti).

technique used for the exterior face of a north-south wall in the northeast corner of the building (**194** on the plan, fig. 5). That wall is constructed of well laid but irregular pieces of limestone, except for what appears to be a small window part way down the wall. The top of this aperture is formed by a double row of flat tiles (perhaps repurposed floor tiles) (fig. 14). Since we have not excavated the interior of this part of the wall, the function of the aperture is uncertain, but it was likely for light or ventilation³⁵.

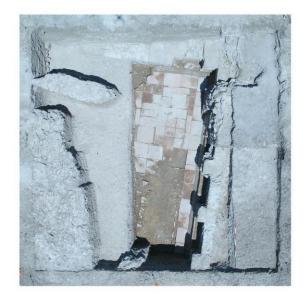
Fig. 6. Aerial photograph of the excavated area of the nymphaeum (A6/A7/B6/B7, 2019); north at the top. Large pieces of collapsed tile and concrete construction are visible to the left (west); deposits below the collapsed concrete remain unexcavated except for the very north of A7. Excavated areas to the north are backfilled in this photograph (photo Soprintendenza Archeologia, belle arti e paesaggio dell'Umbria).

²⁵ For example, in Z6 between the accumulated layers of fill there was a concentration of burnt wood and stones indicative of a campfire. In A6/A7 there is also evidence of persistent burning between the collapsed concrete walls (**161** and **162**, see fig. 6).

³⁷ The larger piece visible in the southwest corner of fig. 6 continues into the unexcavated areas to the south and west. This segment also preserved the arc of the original construction, an indication that is was part of a ceiling vault.

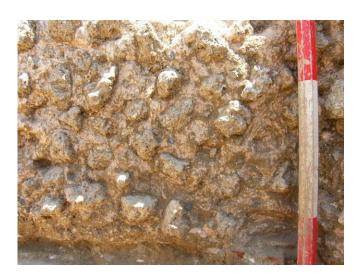
Fig. 10. Detail of niche (no. 5) decorated with plaster embedded with small cobbles and pieces of blue pasta vitrea creating the effect of a grotto (2019) (photo S. Spiganti).

The back wall of each niche is surfaced with *cocciopesto* itself embedded with small, rough limestone cobbles, and pieces (*tesserae*) of blue glass paste (*pasta vitrea*), which would have reflected light from the water in the basin below (fig. 10). The textured surface of the niche walls and the reflective pieces of glass paste were intended to give the appearance of a "natural" grotto wall. This constrasts with the "artificial" decoration of the pilasters, which were surfaced with a base layer of cement and then decorated with painted plaster in solid colors (red, yellow, white, and black). Although there are a few places where the plaster appears to have slipped off the walls and accumulated against the pilasters, none of the painted pieces are preserved *in situ* and it is not yet possible to reconstruct a decorative scheme. Some of the recovered fragments show evidence of having been repainted, suggesting a renovation to the building²⁸.

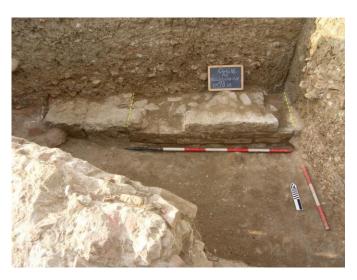
Fig. 12. Bottom of the stairway in the north wall of the nymphaeum (A7, 2018); view north. Limestone ashlars are in line with the stair walls excavated in 2017 (marked with a dotted yellow line). Two ashlars can be seen to the west; the east side of the stairway is just visible in the east bulk (photo S. Spiganti).

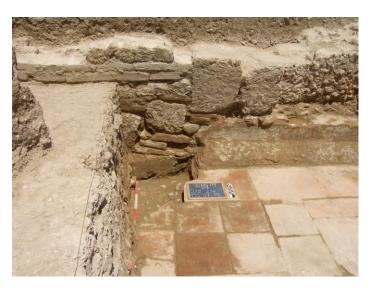
Fig. 13. Detail of the north wall of the nymphaeum showing the two ashlars at the bottom of the east side of the stairs (A6, 2019; see also fig. 11); view north. The rough cobble construction is visible below the tiles at the bottom of the stairs. Also visible is a cut into the cocciopesto basin and broken floor tiles (photo S. Spiganti).

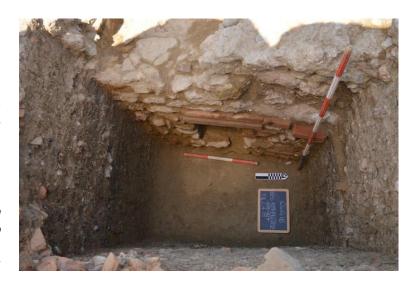
Fig. 14. Northeast corner of A6 (2018); view west of the exterior face of the stone and tile wall with aperture 194 (below) and the concrete wall 189 (above) (photo R. Schindler).

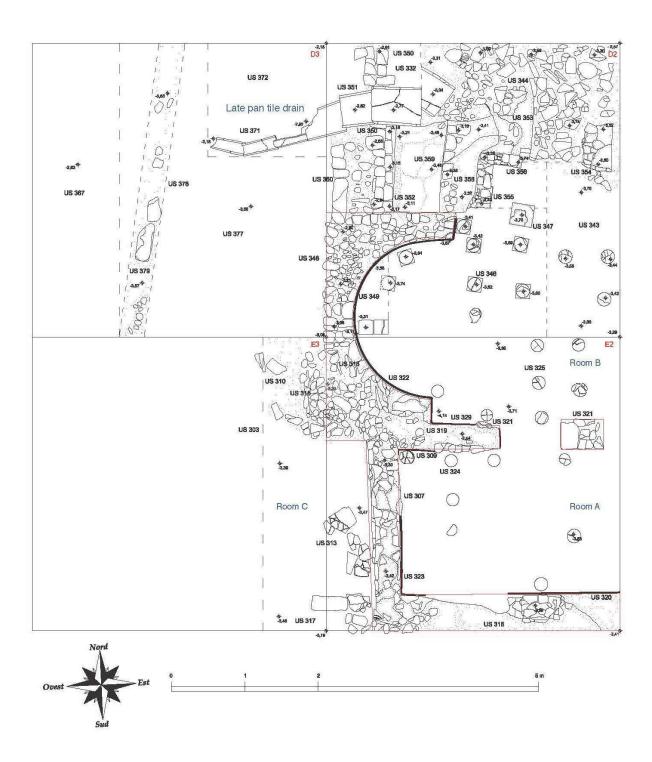
Fig. 17. Plan of the Bath Complex; red lines indicate the preserved walls of the complex and heavy black lines indicate a preserved layer of cocciopesto coating the walls (AutoCad; S. Spiganti).

Removal of the debris deposits in D2 and E2 revealed the substructure of the hypocaust system for Rooms A and B (figs. 17, 19, and 20). Room A, to the south (area E2), is 2.56 m wide and at least 3.14 m long, but the eastern limit is not yet known, as areas E1 and F1 remain unexcavated. The hypocaust system in this room was damaged by the modern back-hoe cut, but at least eight sets of *pilae* preserve one or more circular tiles *in situ*. In order to preserve the *pilae*, not all of the accumulated debris was removed. One column, in the northwest corner of the room, was constructed of quarter-rounds and is slightly wider than the others. Other examples of quarter-round tiles were excavated in the debris layers of A1 and B2 in 2016³⁸. A short opening

To the north, the lower walls and *pilae* of Room B are better-preserved; the modern level of the hill is higher here and therefore this room was protected by deeper fill levels. Room B is 3.63 m wide and at least 3.57 m long from the inside of the apse to the eastern edge of D2. The apse is 2.14 m in diameter (approx. 7 Roman feet) and is positioned closer to the south wall, making the room asymmetrical (fig. 17). On the north

In both Room A and Room B, the interior walls are coated with a layer of fine pink *cocciopesto* (figs. 17 and 20). In the southwest corner of E2, we noted a similar treatment on the west face of the west wall of Room A, indicating a third room (C). This area, however, has not been excavated. To the north, in D3 (fig. 17), excavations in the east half of the square did not reveal architectural remains from the period of the bathhouse. However, at the very end of the 2019 season, a segment of a north-south wall of unworked stones (379), parallel to the walls of the bathhouse, was uncovered 2.2 m to the west of the back of Room B. The preserved top of this

On top of walls 350 and 352, and extending to the west, there is a partially preserved channel constructed from reused roof tiles laid west to east (351, see figs. 17, 20, and 23). Three of these are relatively well- preserved pan tiles, with a possible fourth on the east end. The last pan tile on the west is broken on its north- west corner, creating an angle that directs towards upside down cover tiles that continue the line further west- ward. The beginning and end points of this channel are as yet unknown. It does have the same west-east ori- entation as the channel excavated in B1/B2 and the bottom of both drains are at the same elevation. Both ap- pear related to efforts to channel water away from the Central Area but until we can connect the stratigraphy of the Central Area to the Lower Terrace, we cannot be certain.

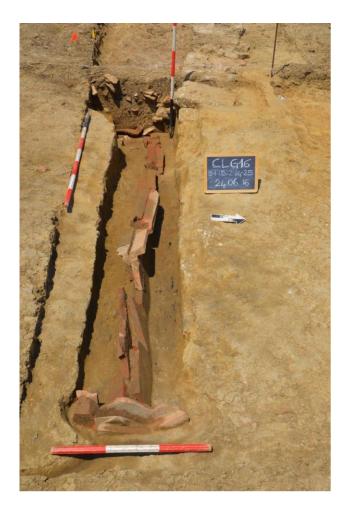
Fig. 19. Hypocaust substructure of Room A and the southern section of Room B (E2, 2017); view west (photo R. Schindler).

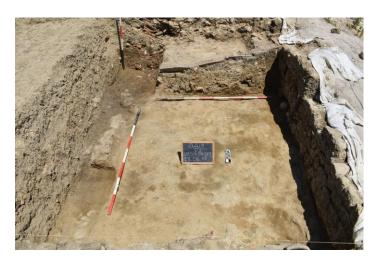
Fig. 23. Excavation area D3 (2019); view north. Segment of early stone wall is visible to the west: the back wall of the bath complex is to the east; and late pan tile drain is to the north (photo R. Schindler).
